THE TOWNSHIP OF BONFIELD

BRIDGE MANAGEMENT STUDY REPORT (DRAFT)

6 BRIDGES / 10 CULVERTS

DECEMBER 2022

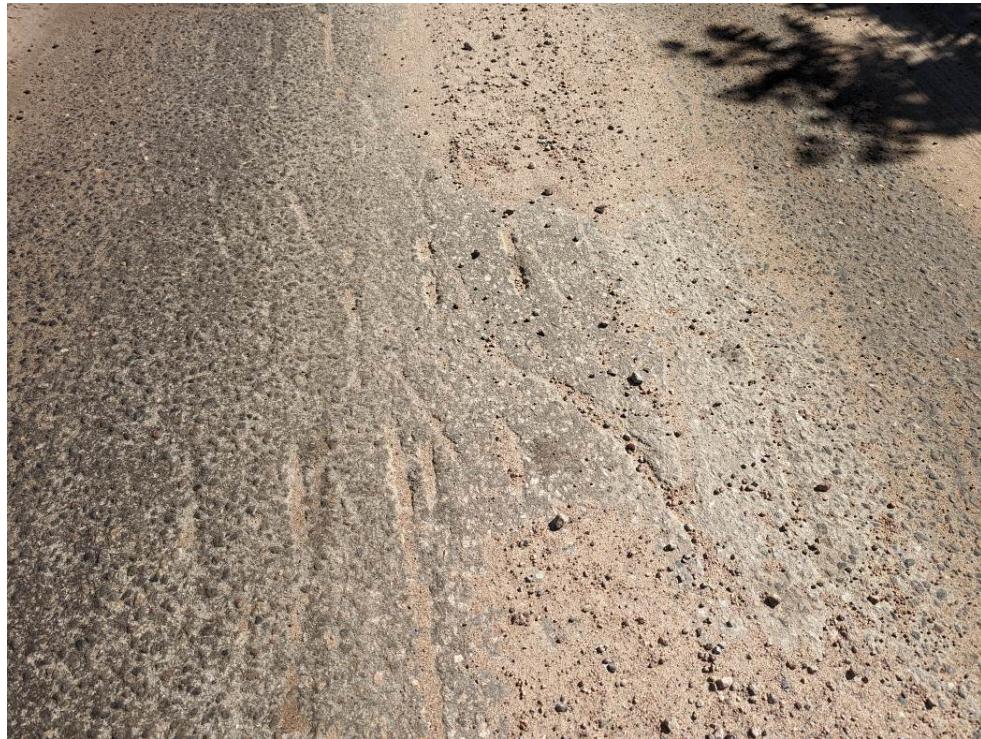
Photo 7 Moderate scaling, tire rutting and gravel accumulation in approach wearing surface (Typical)

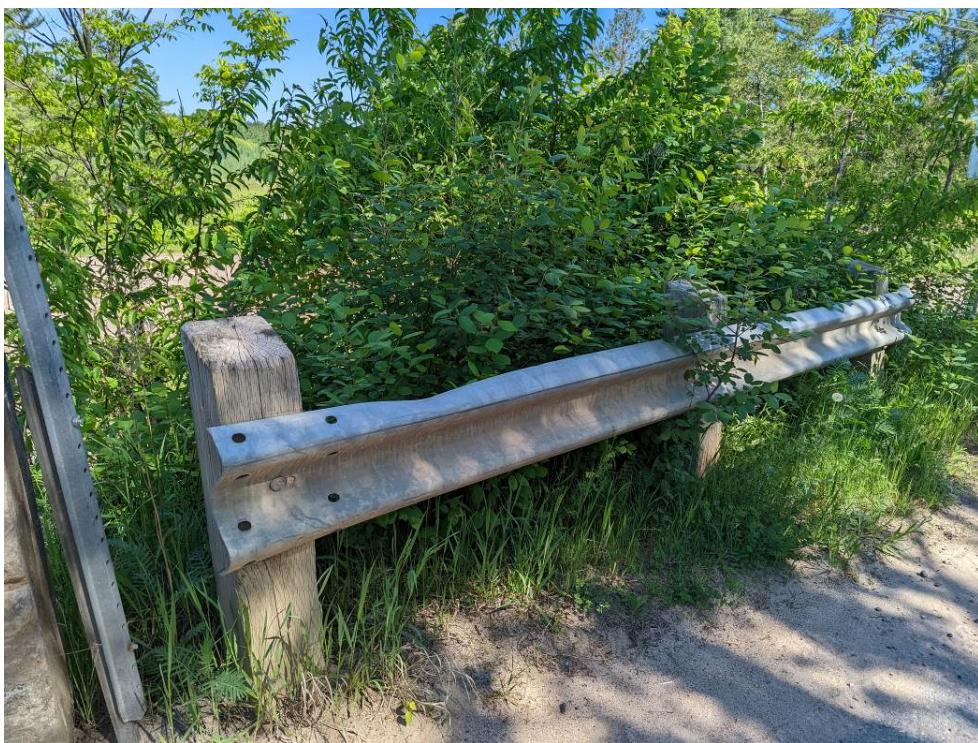
Photo 8 Typical approach barrier at northeast corner with collision damage

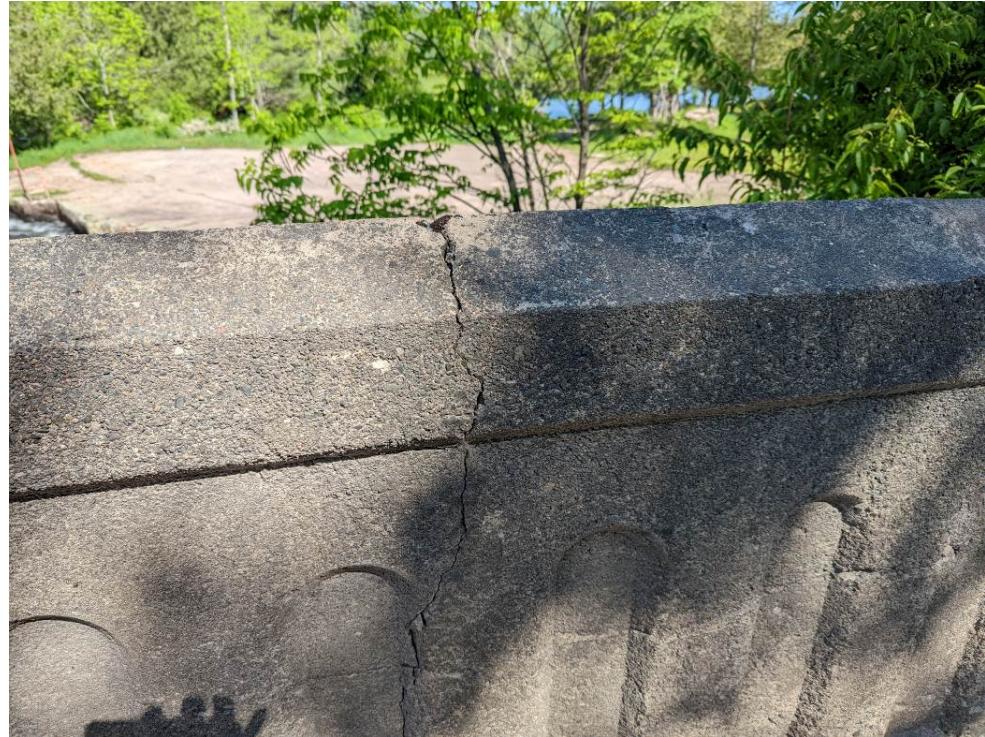
Photo 11 Medium to wide transverse crack noted on parapet wall (Typical)

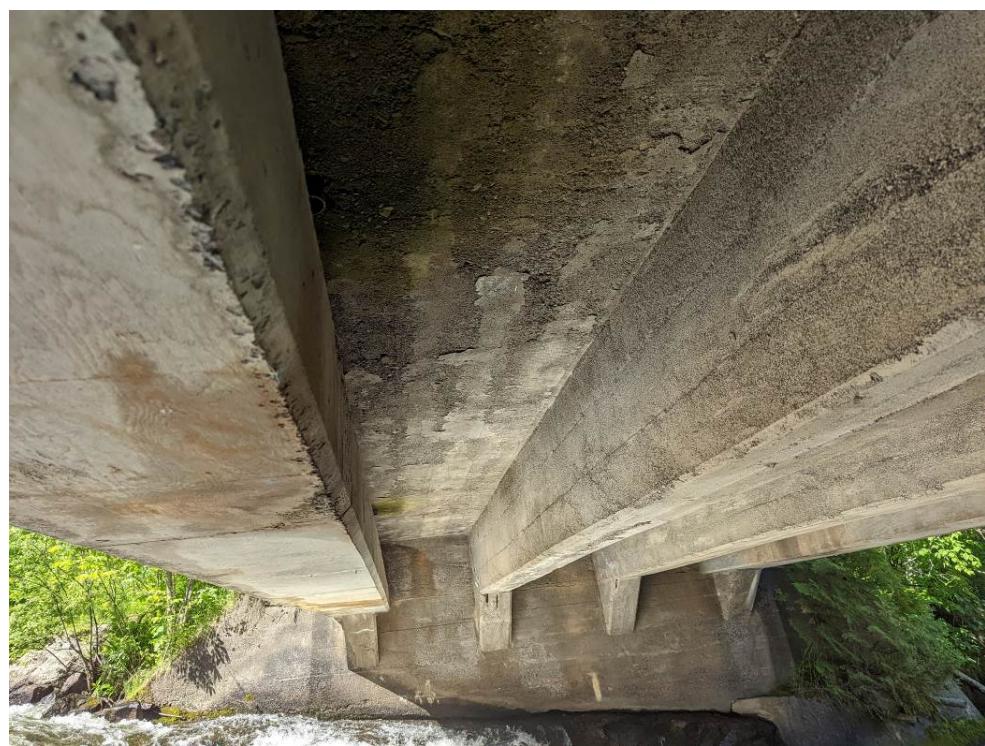
Photo 12 Light scaling on interior deck soffit

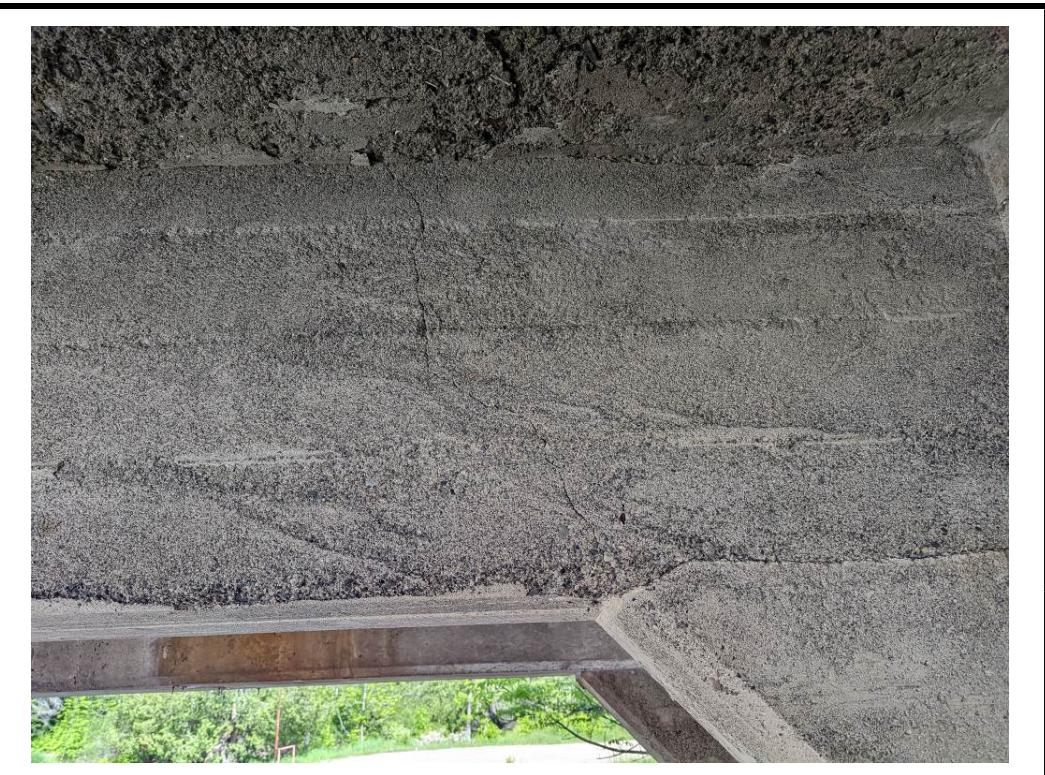
Photo 13 Narrow crack on girder

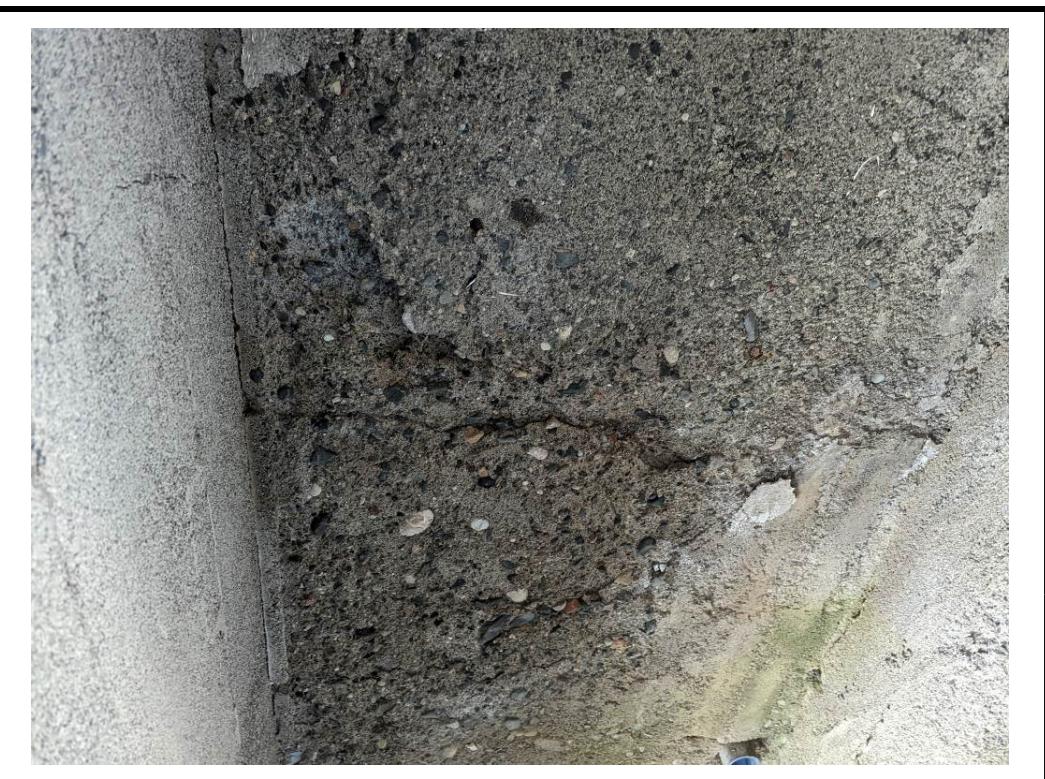
Photo 14 Moderate to severe scaling, narrow cracks and delamination noted on deck soffit

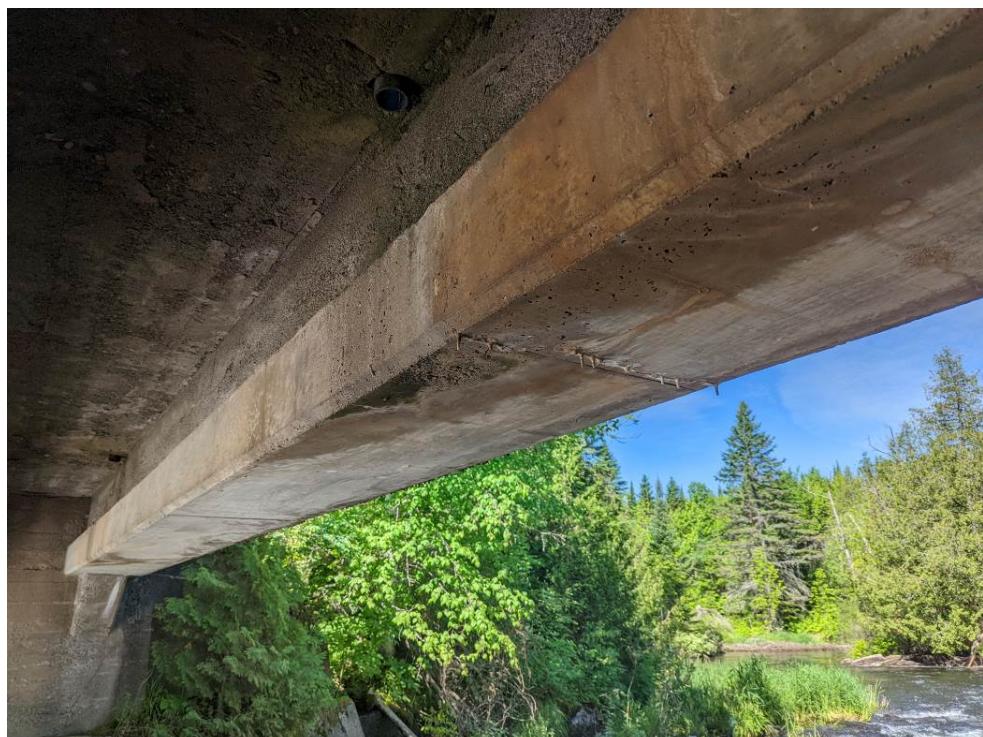
Photo 16 Stalactites observed on previous concrete repairs at girders

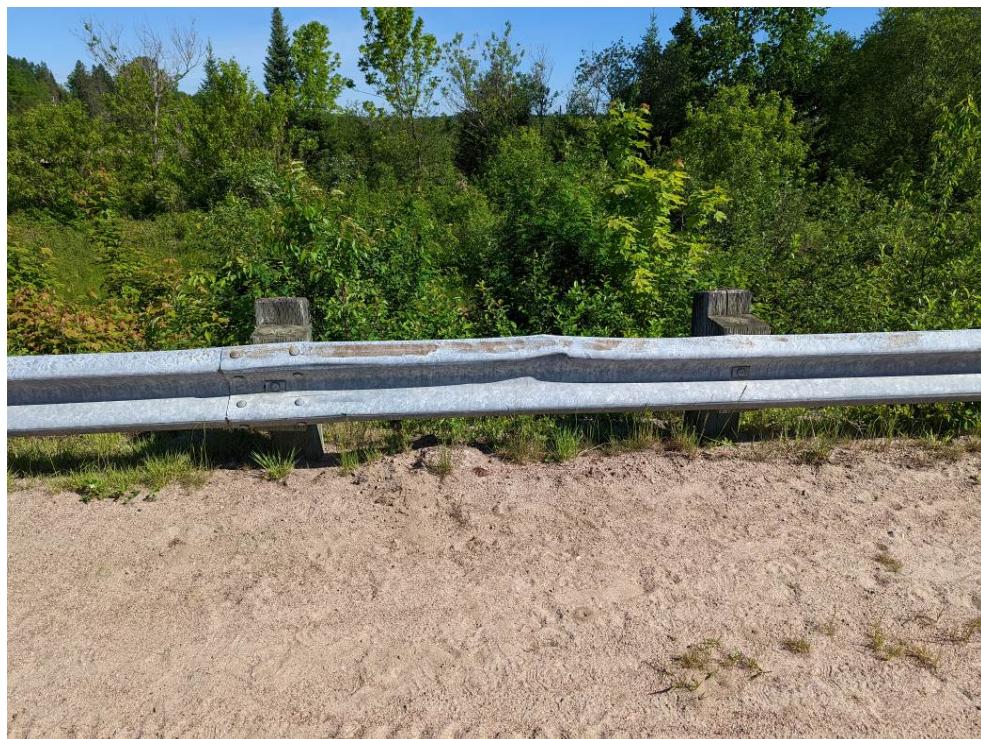
Photo 8 Collision damage noted on approach barrier at southwest corner

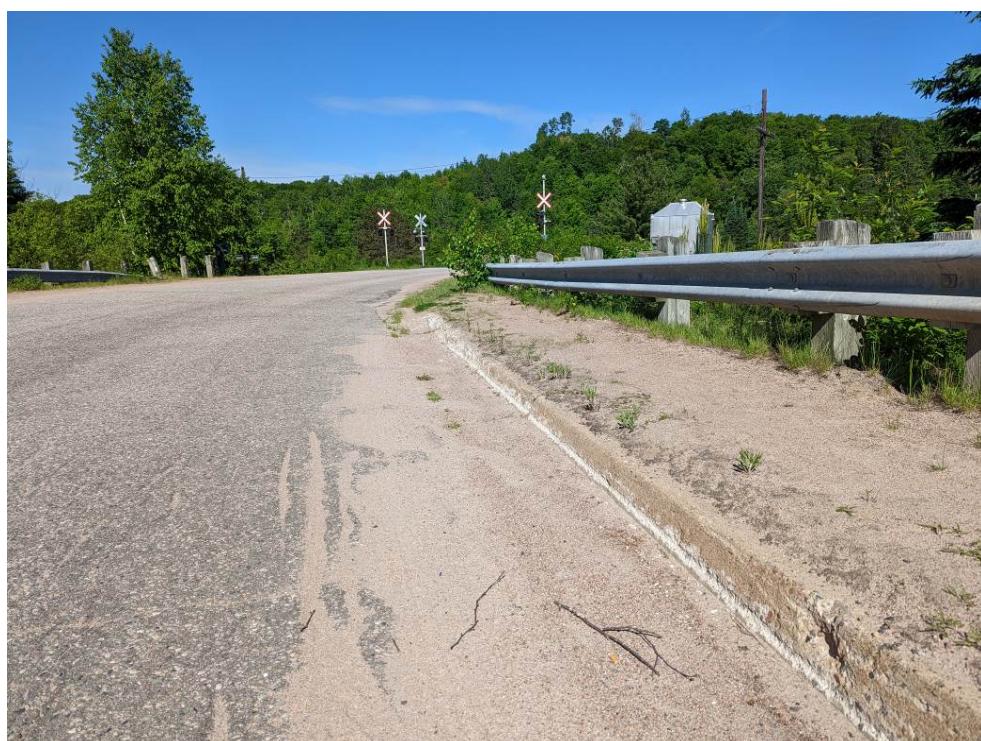
Photo 10 Significant abrasion noted on approach curb at northwest corner

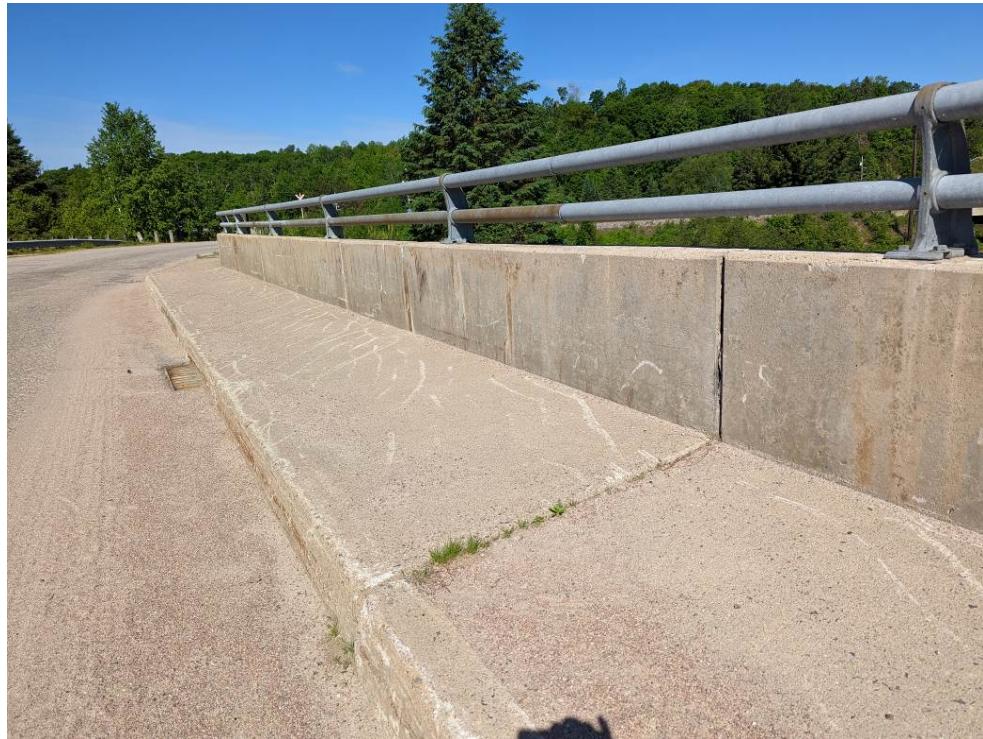
Photo 11 Narrow map cracks with efflorescence and stains with spall on parapet wall

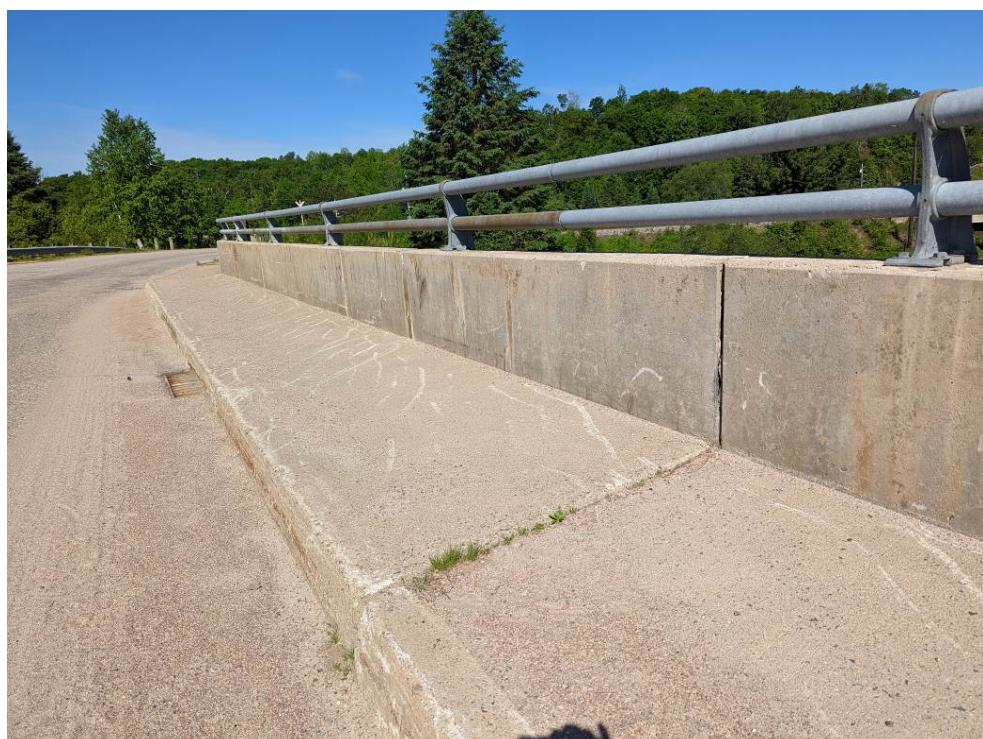
Photo 12 Narrow map cracks with efflorescence and stains with spall on parapet wall

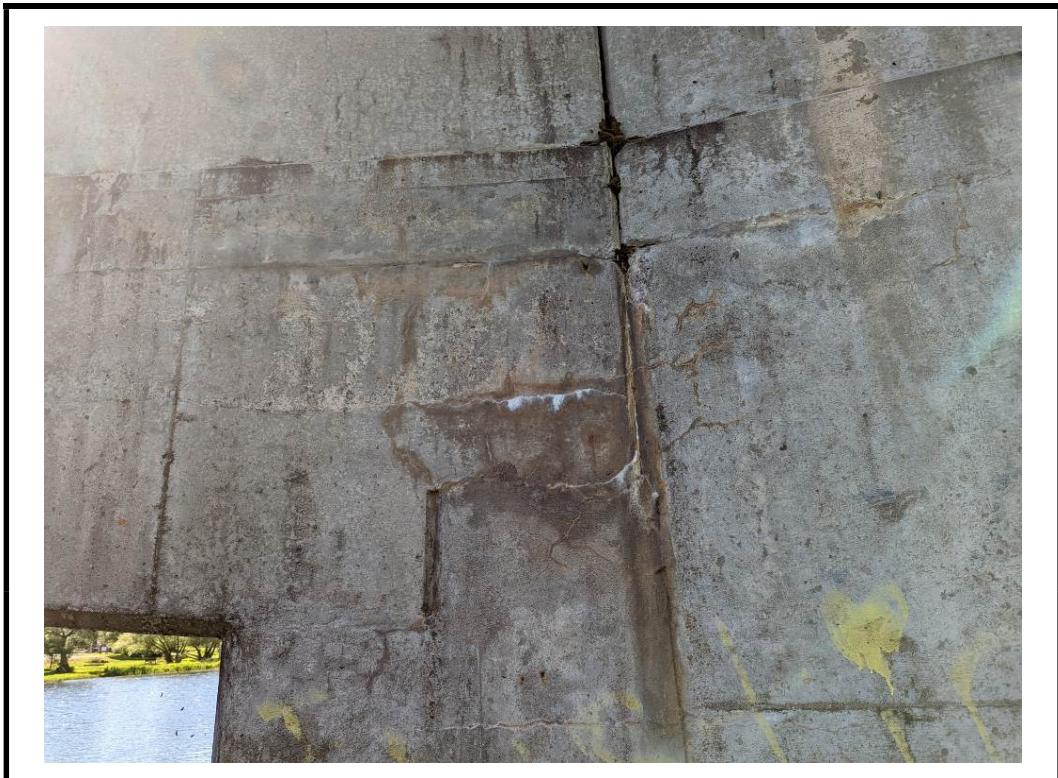
Photo 13 Narrow longitudinal and transverse cracks and damp stains on fascia.

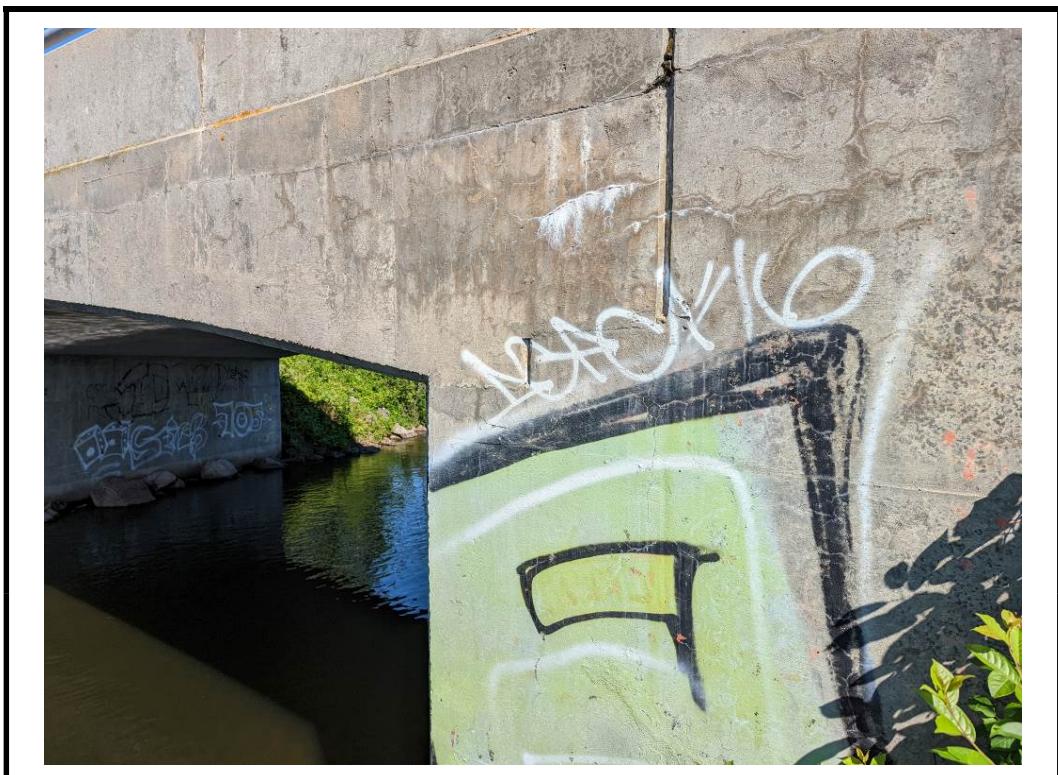
Photo 14 Narrow cracks, damp stains with efflorescence, & graffiti on southeast wingwall.

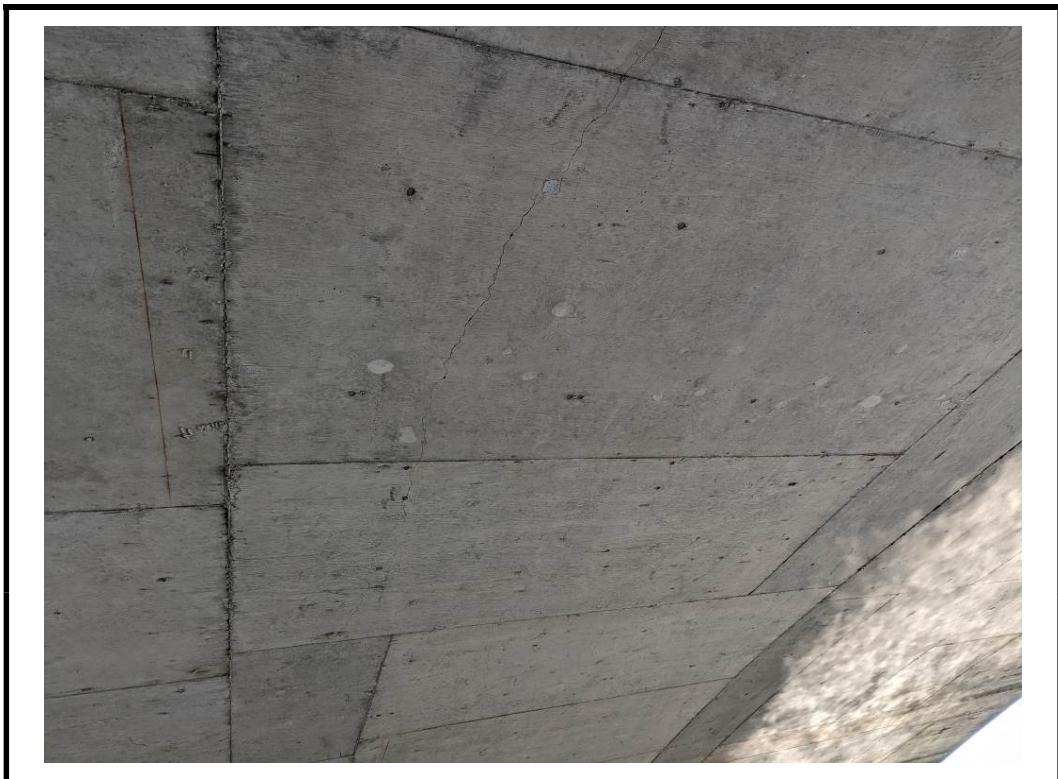
Photo 16 Narrow longitudinal cracks noted with origins at abutment wall

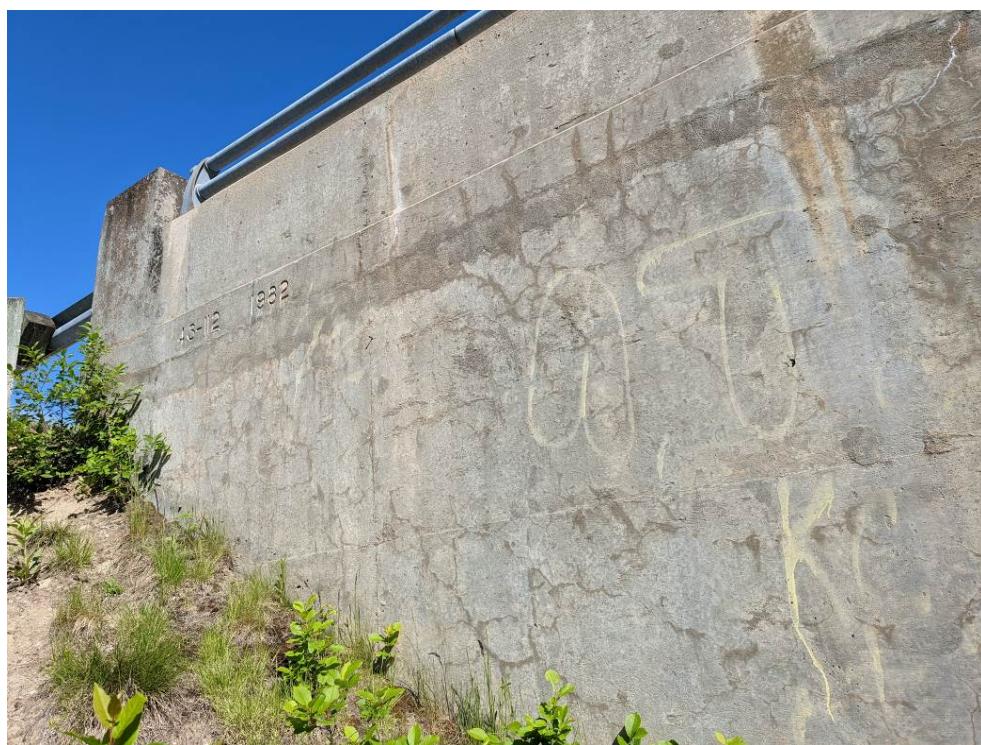
Photo 18 Typical southwest wingwall with graffiti and damp map cracks throughout

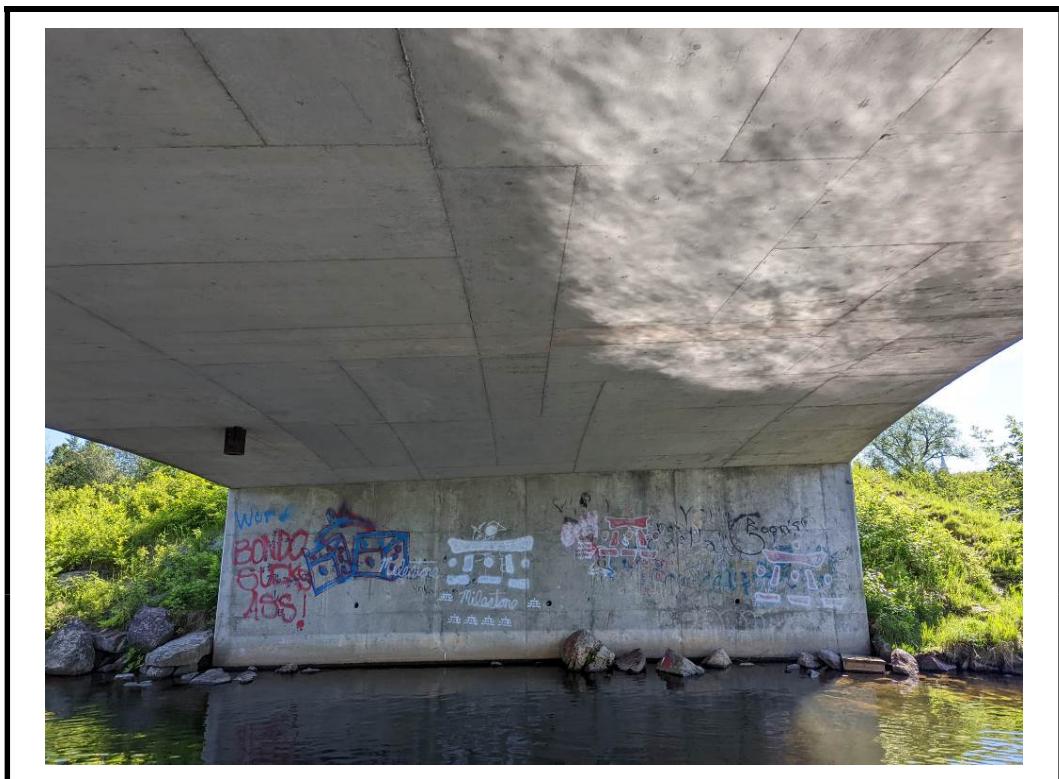
Photo 20 Narrow full length vertical cracks and graffiti noted on abutment walls (Typical)

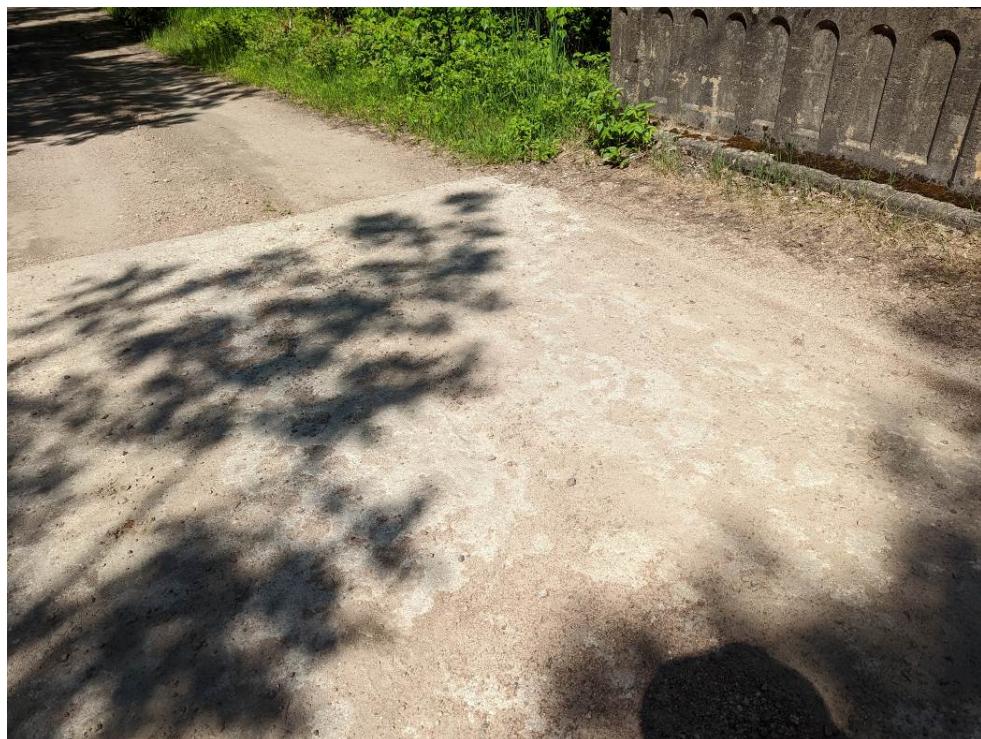
Photo 8 Moderate scaling, small spalls and dirt accumulation on exposed deck top.

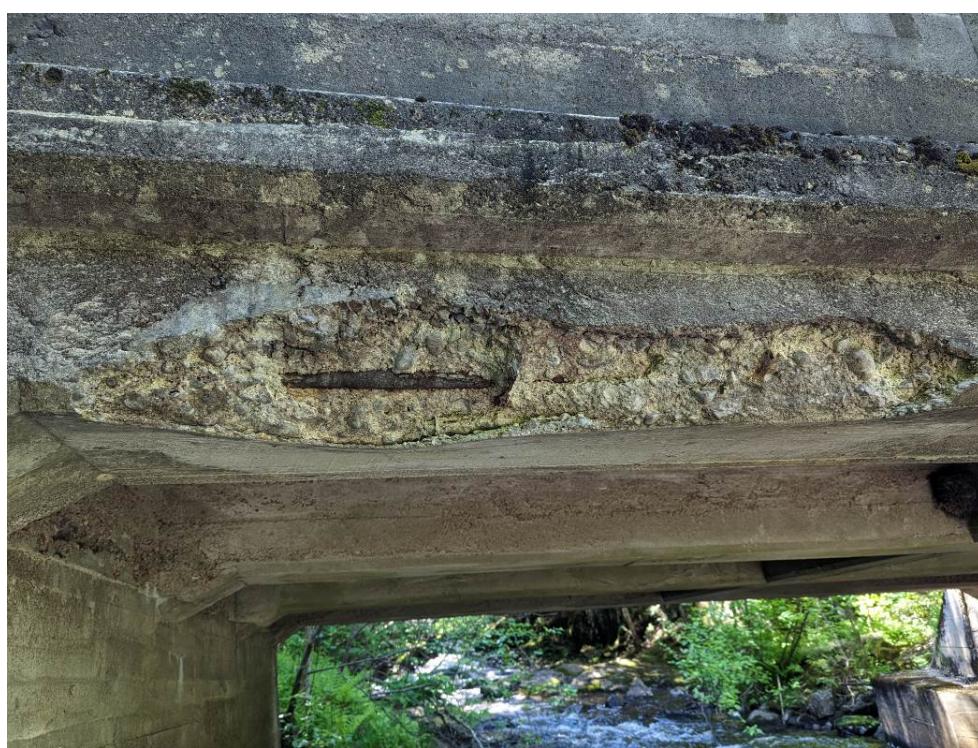
Photo 10 Large spall with exposed corroded reinforcing on north fascia.

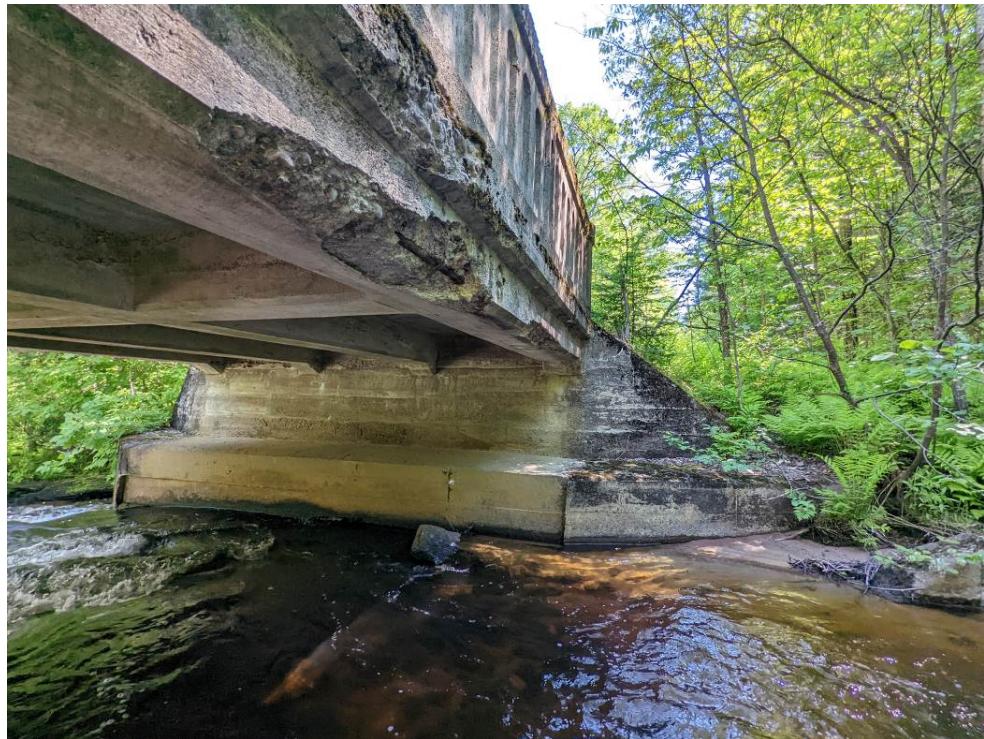
Photo 11 Spalls with exposed corroded reinforcement on face of exterior girder

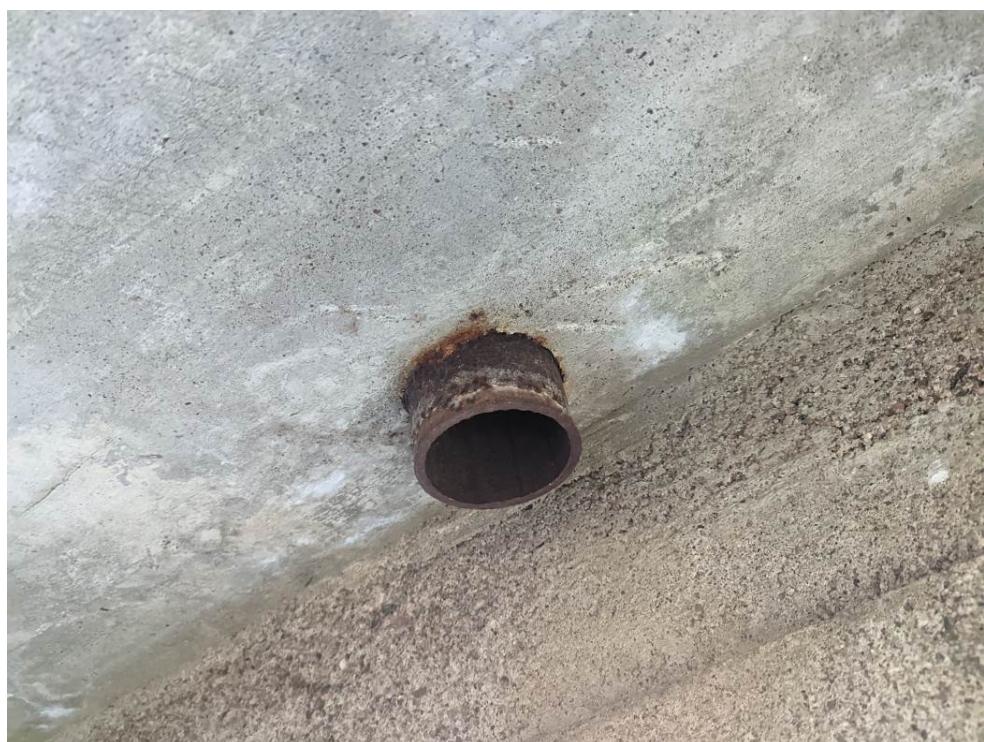
Photo 12 Corrosion and perforation noted at deck drain (Typical)

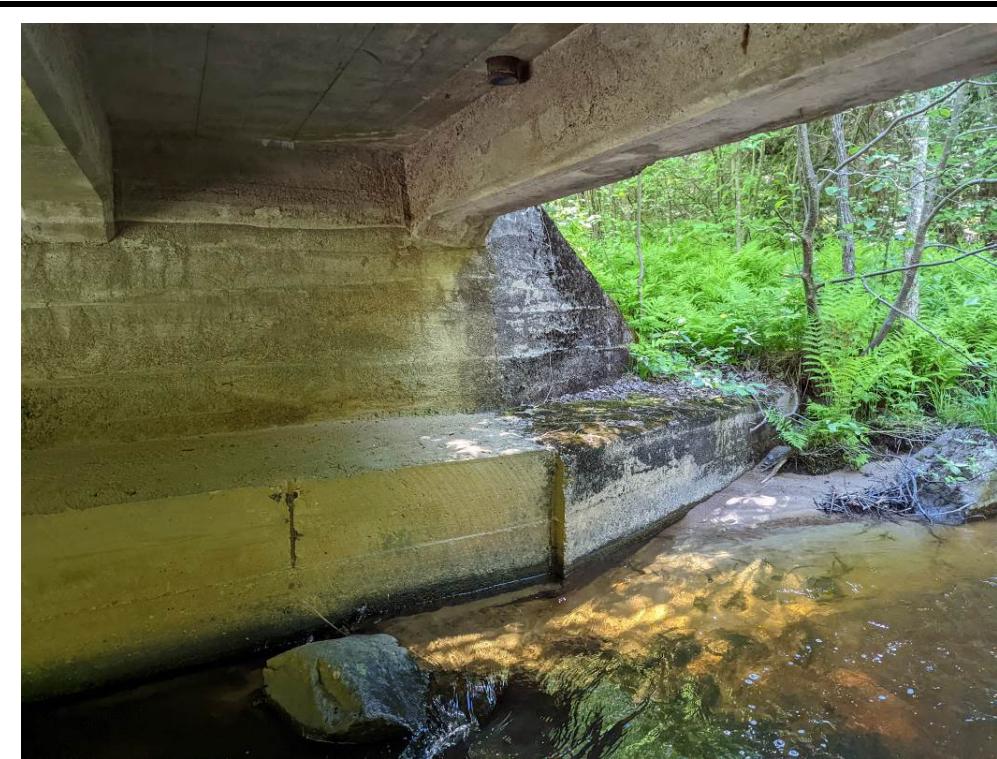
Photo 14 Spall with exposed corroded reinforcing steel on abutment wall

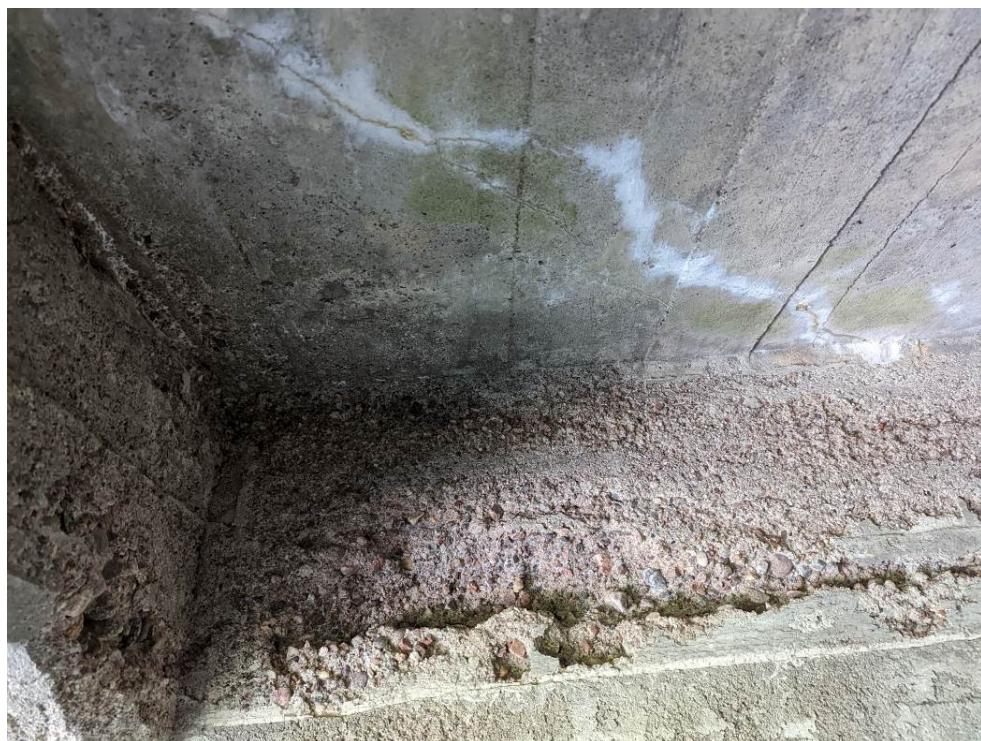
Photo 16 Severe scaling on ballast wall and cracks with efflorescence noted on deck soffit

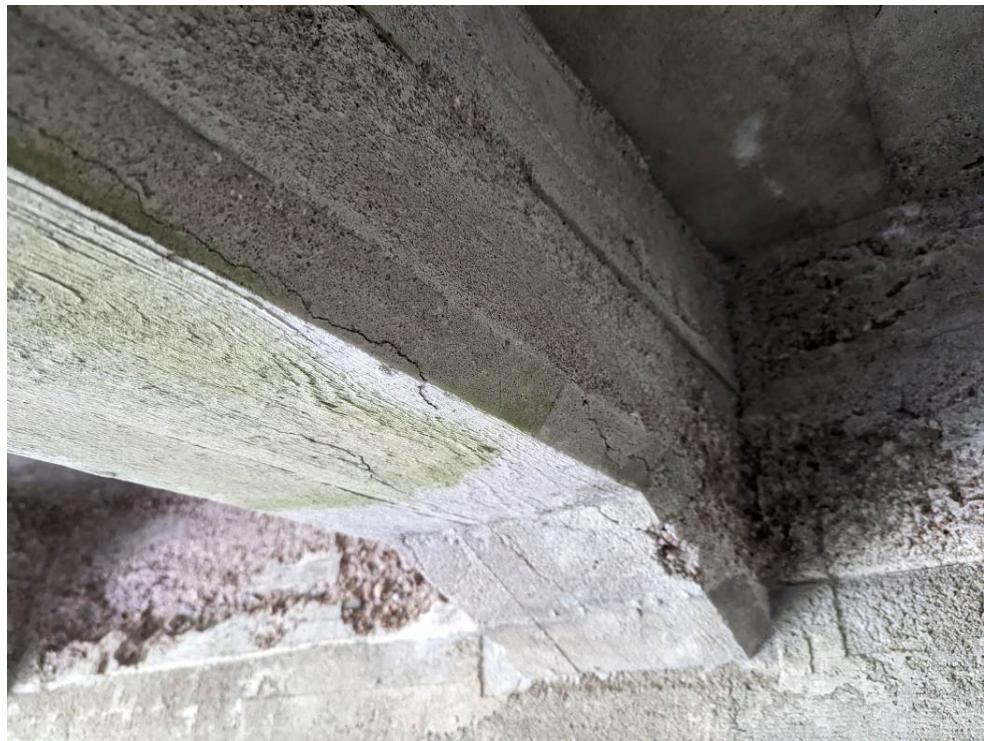
Photo 17 Spall and longitudinal cracks noted on girders

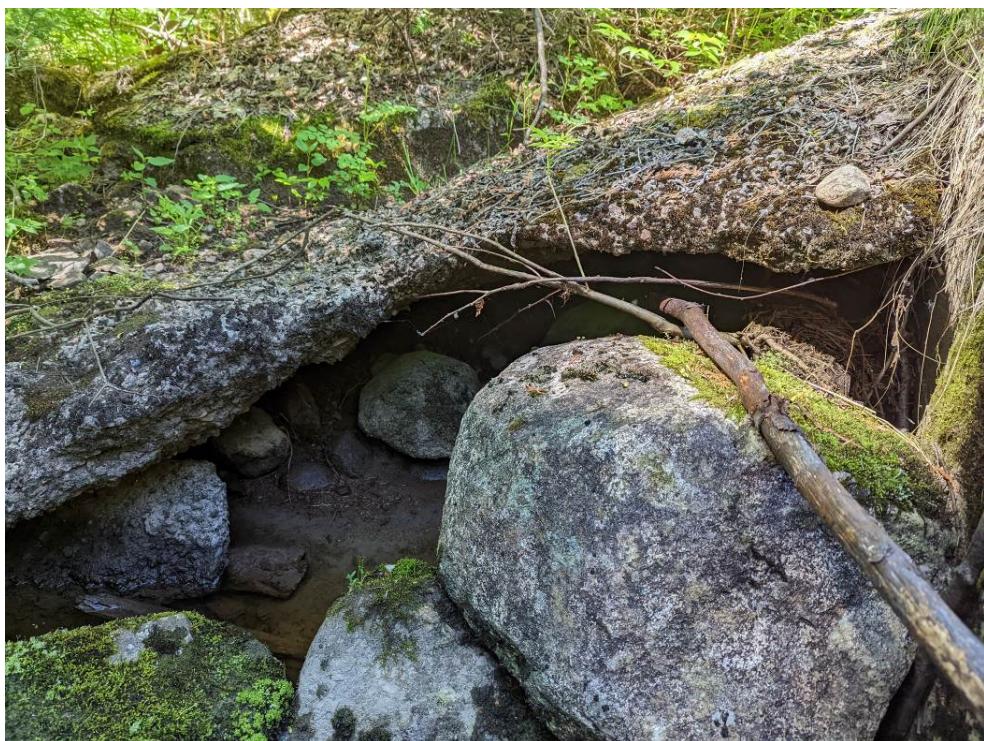
Photo 18 Concrete slope protection at southwest corner failed

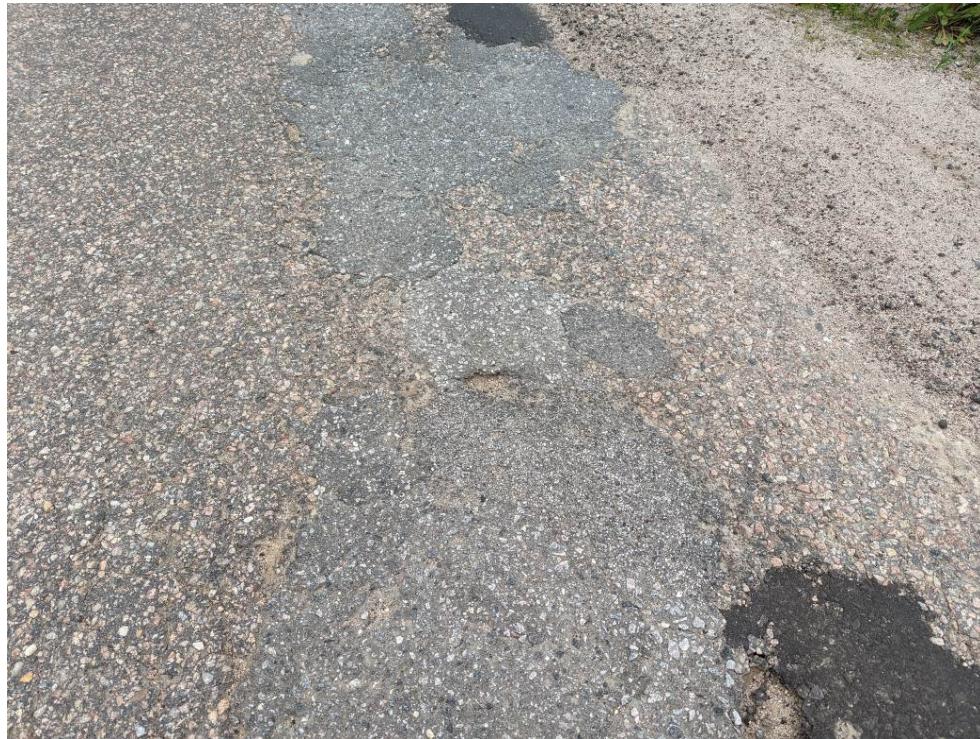
Photo 7 Asphalt patches and small pothole on west approach wearing surface

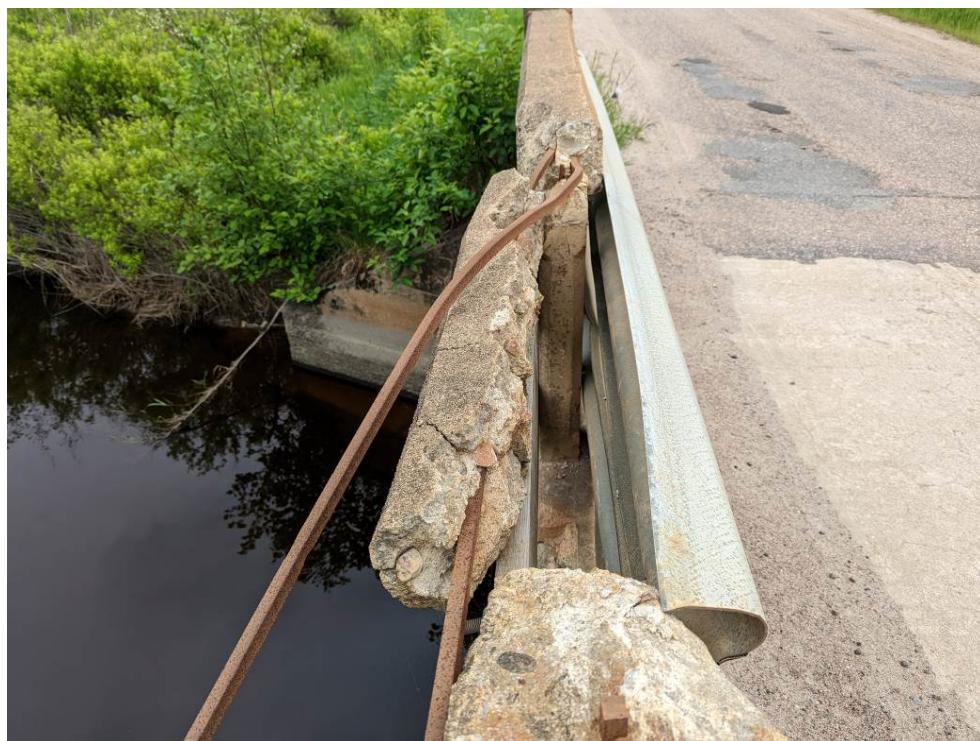
Photo 8 Exposed corroded reinforcement and steel beam on barrier

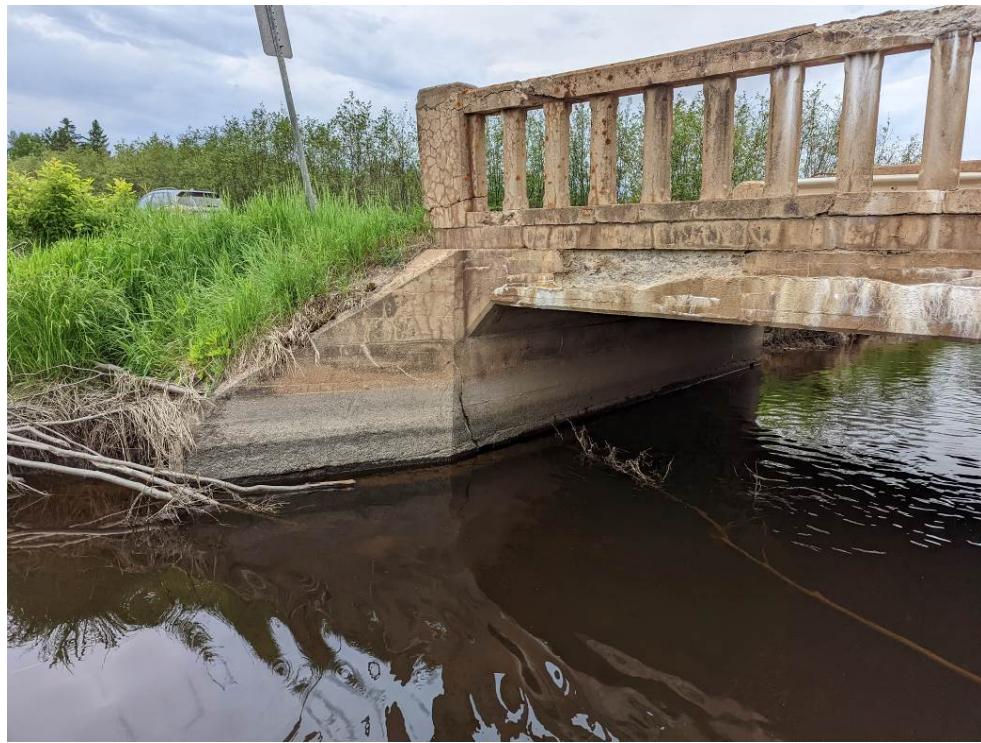
Photo 9 Severe spall and cracks with efflorescence noted on south fascia

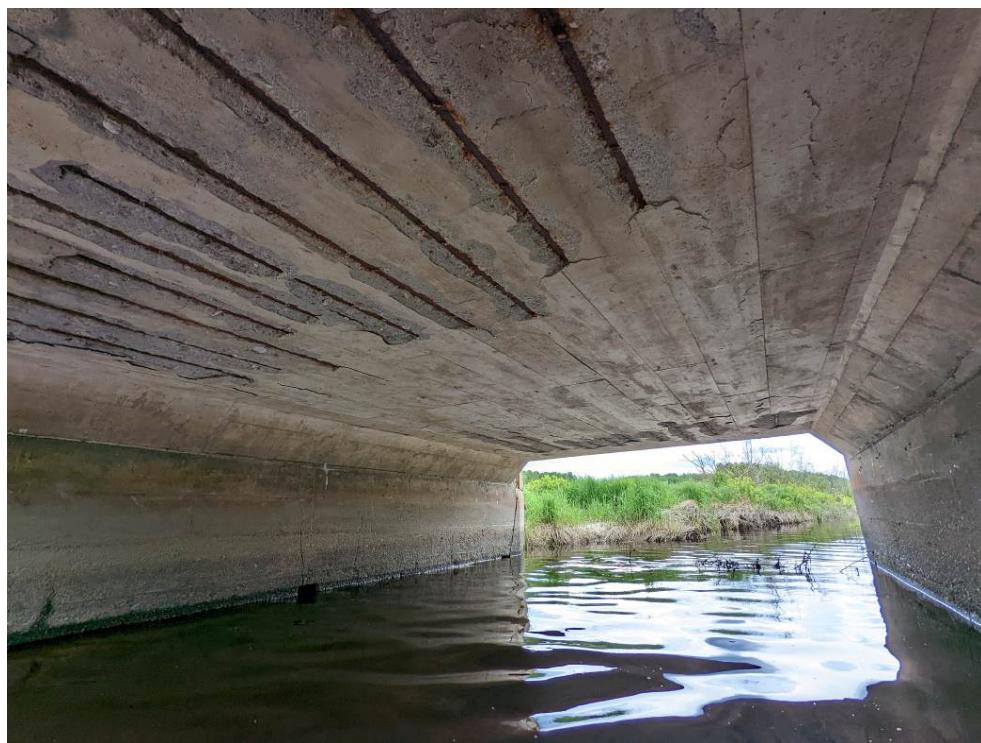
Photo 10 Spalls with exposed corroded reinforcement and severe delamination on soffit.

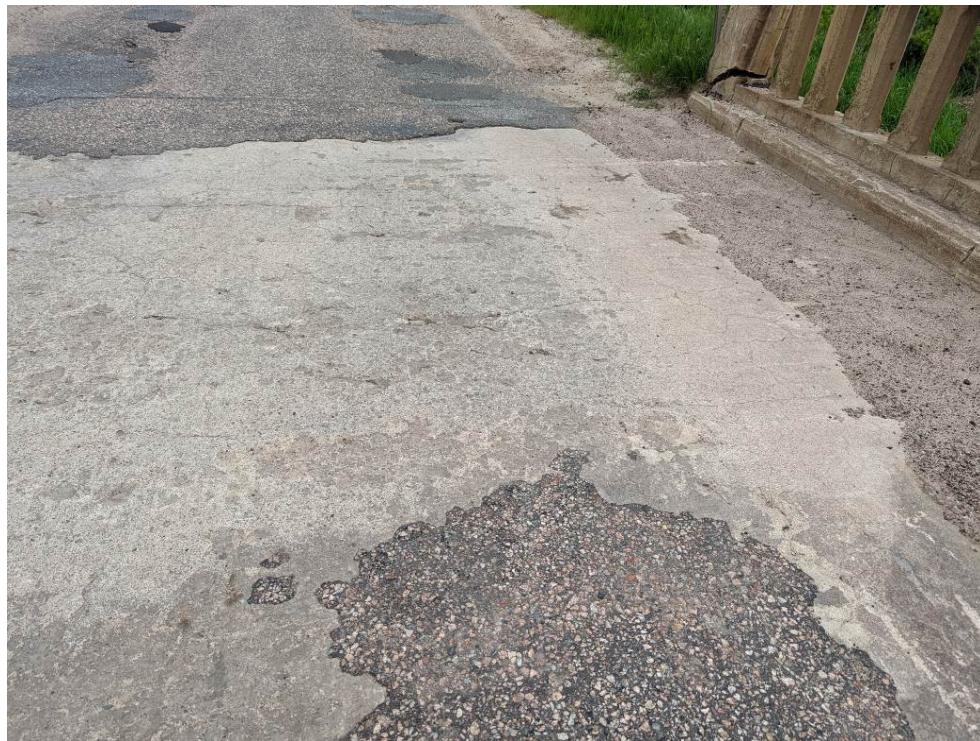
Photo 11 Minor scaling, medium spall and debris noted on deck top

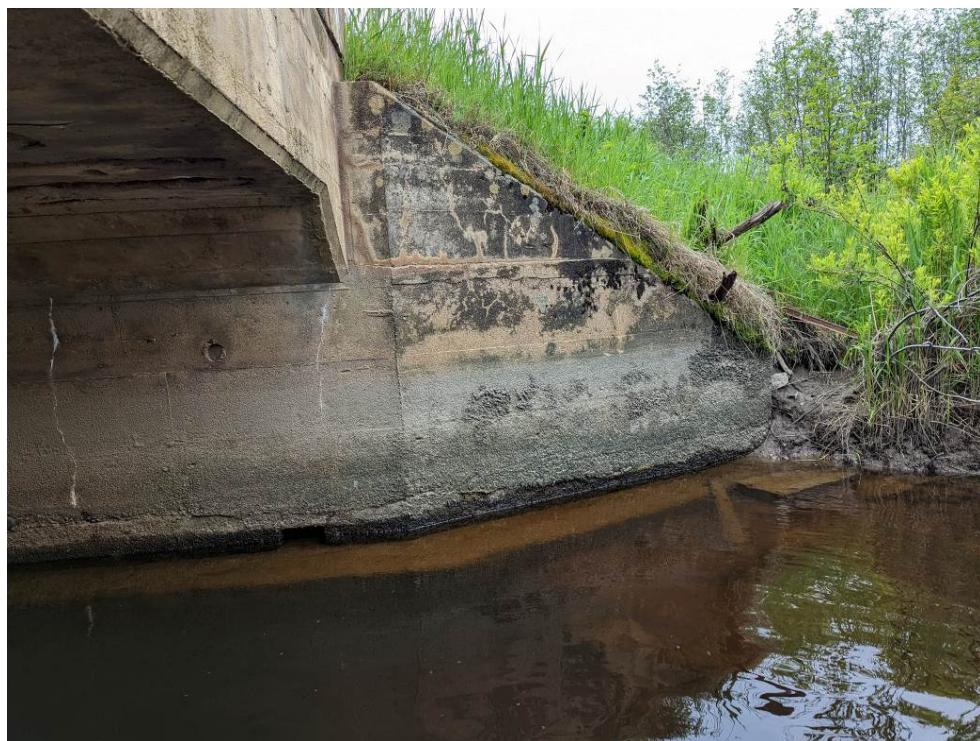
Photo 12 Narrow cracks with efflorescence noted on northwest wingwall.
