THE TOWNSHIP OF BONFIELD

BRIDGE MANAGEMENT STUDY REPORT (DRAFT)

6 BRIDGES / 10 CULVERTS

DECEMBER 2022

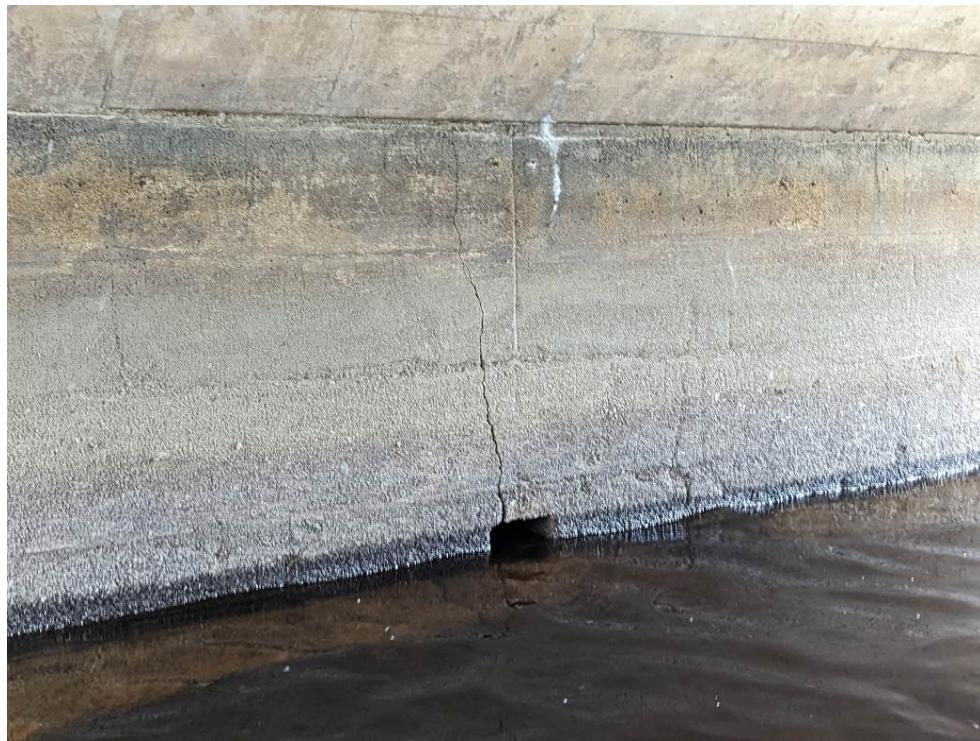
Photo 13 Medium crack with efflorescence observed on abutment wall

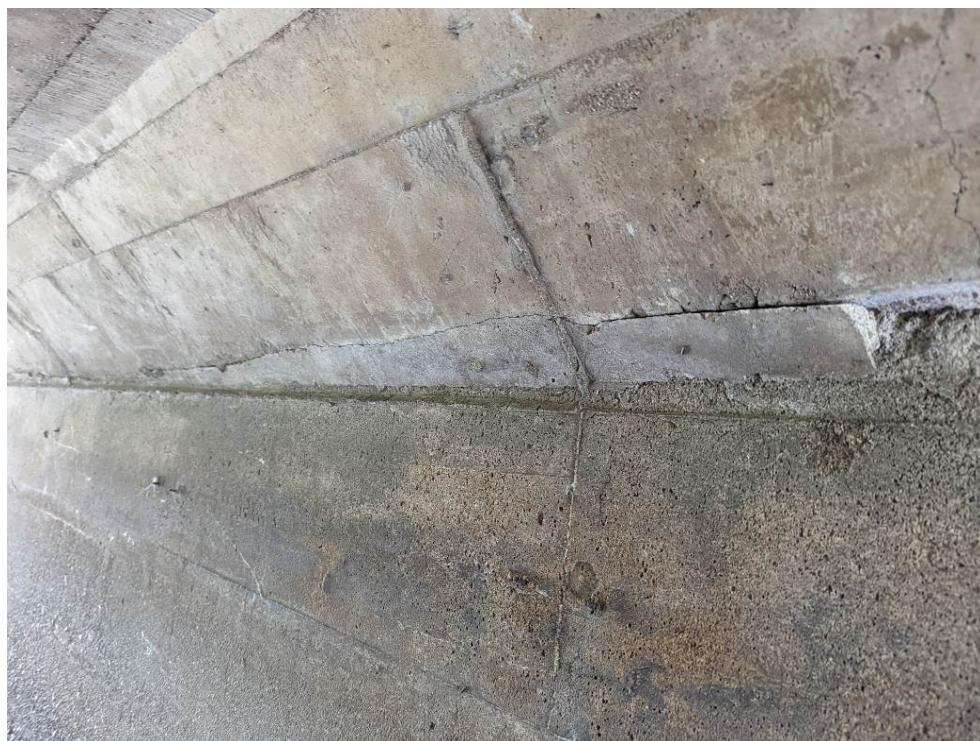
Photo 14 Small spall and longitudinal cracks noted at haunches

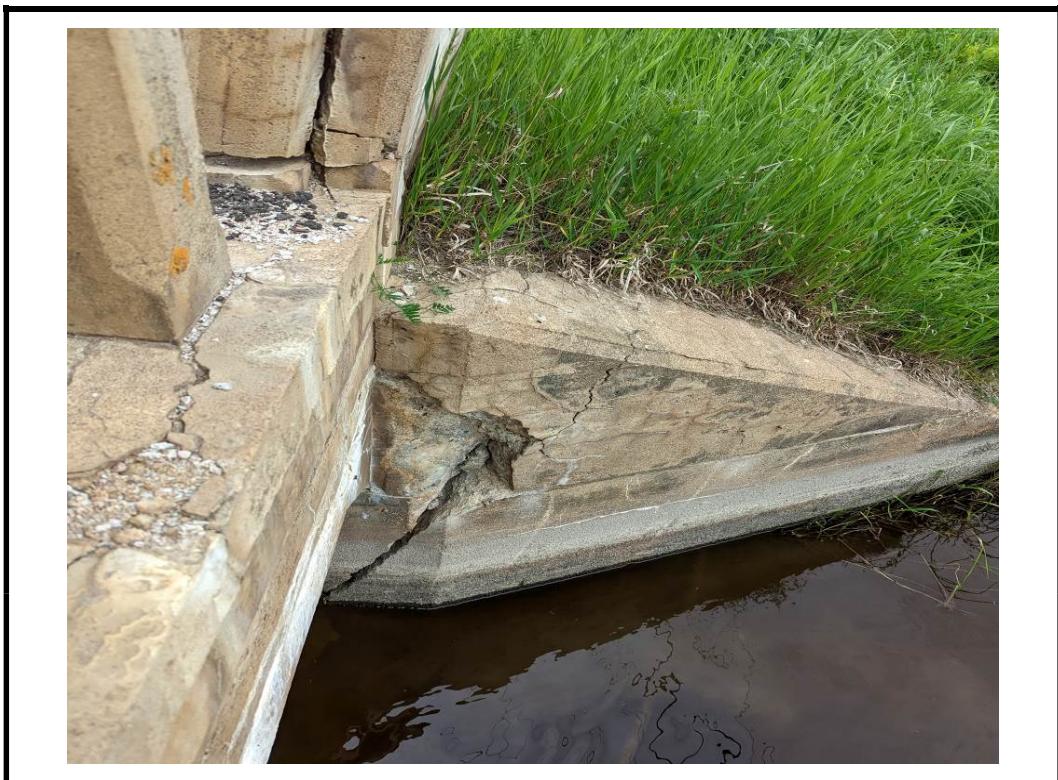
Photo 15 Large spall with crack noted on southeast wingwall

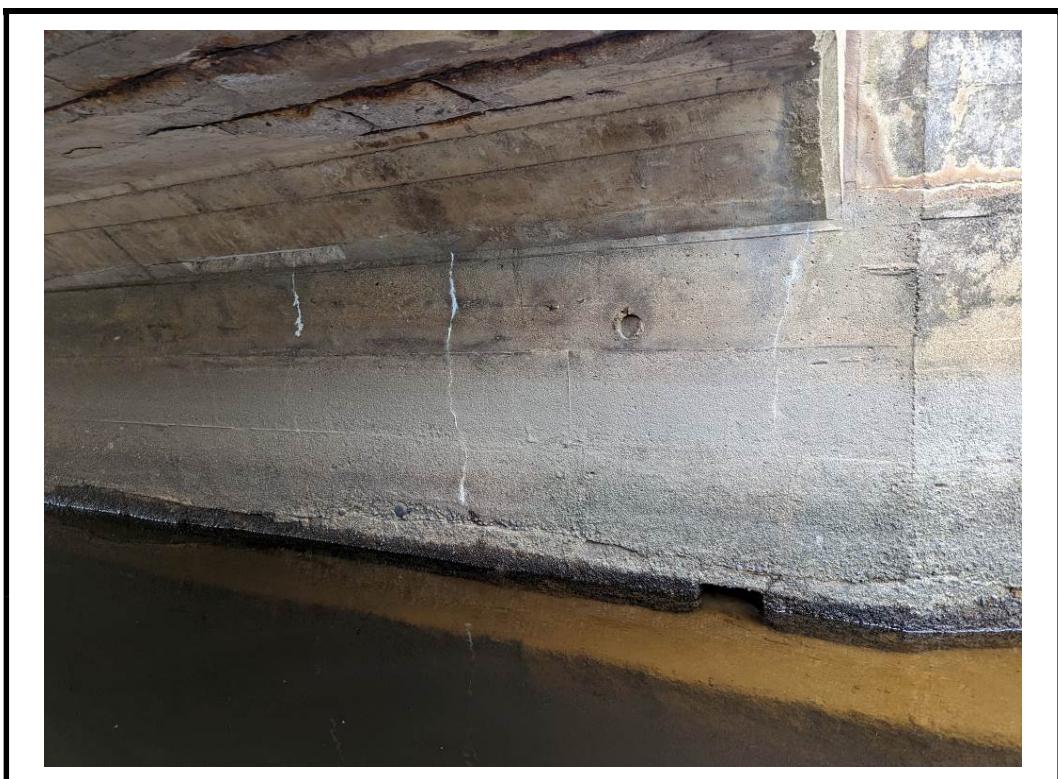
Photo 16 Moderate scaling, narrow cracks with efflorescence noted on west abutment wall

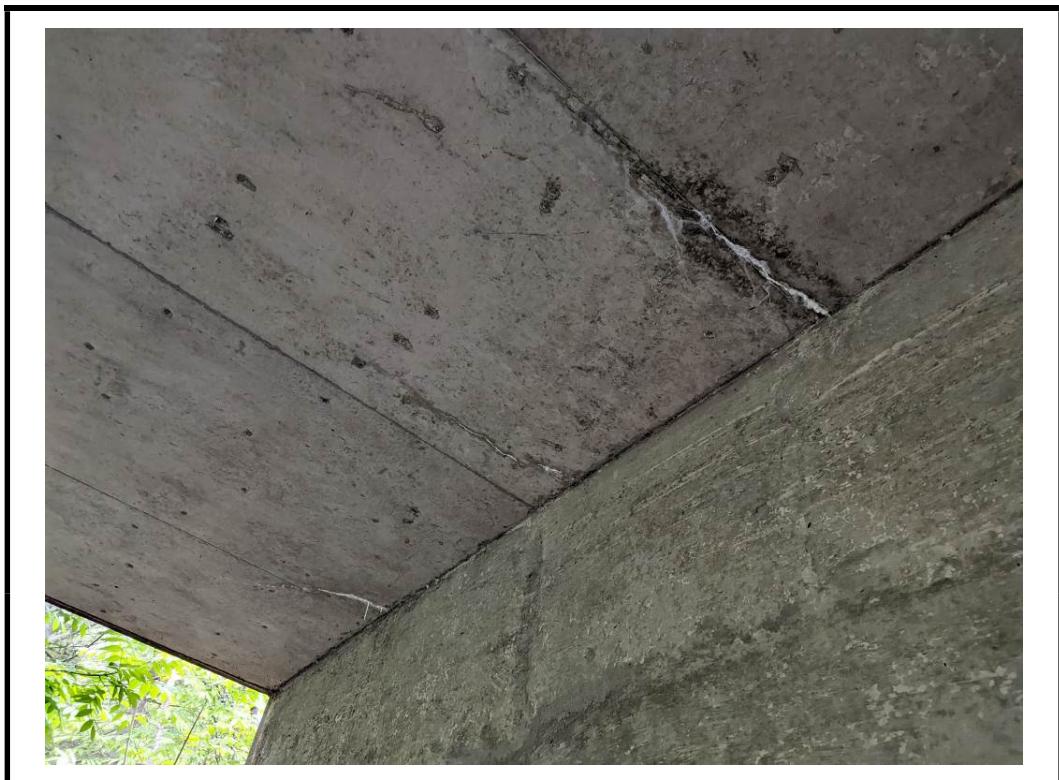
Photo 9 Narrow crack with efflorescence on north deck soffit

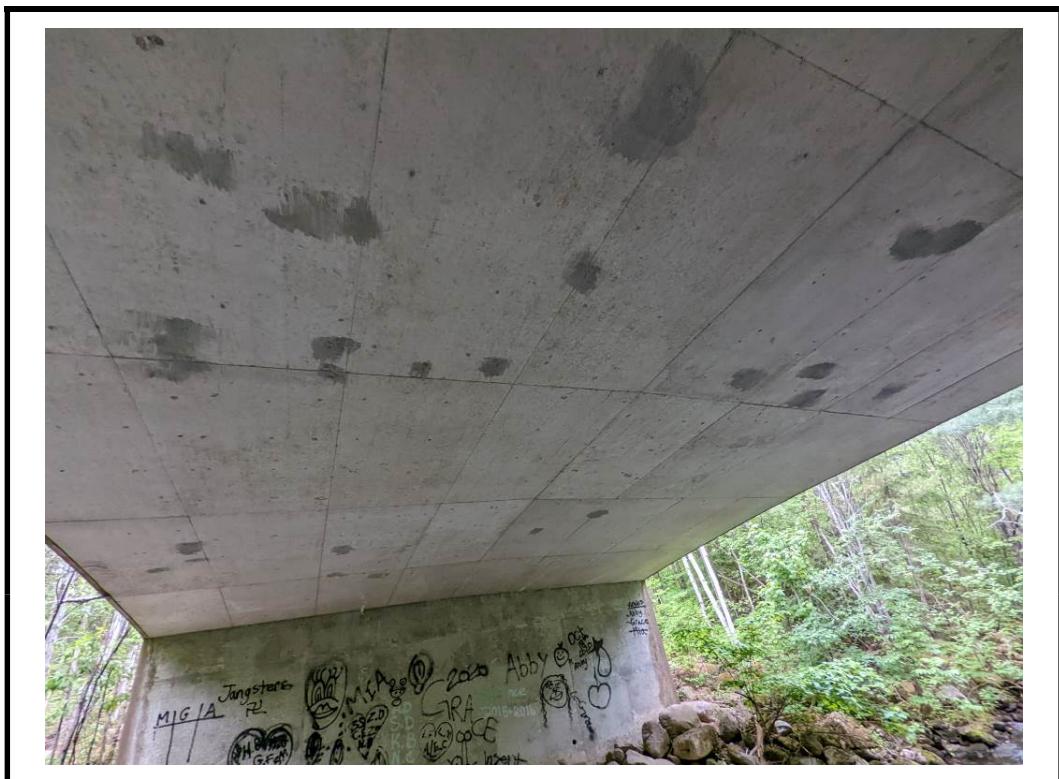
Photo 10 Typical deck soffit with previous concrete repairs

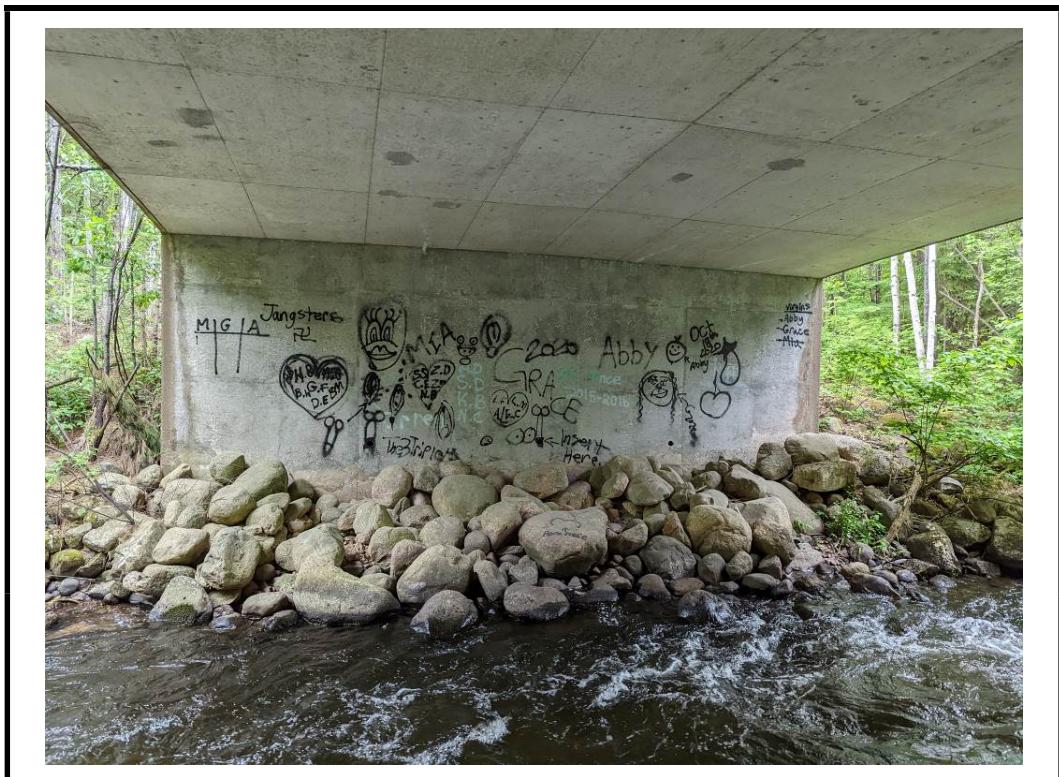
Photo 13 Graffiti on south abutment wall

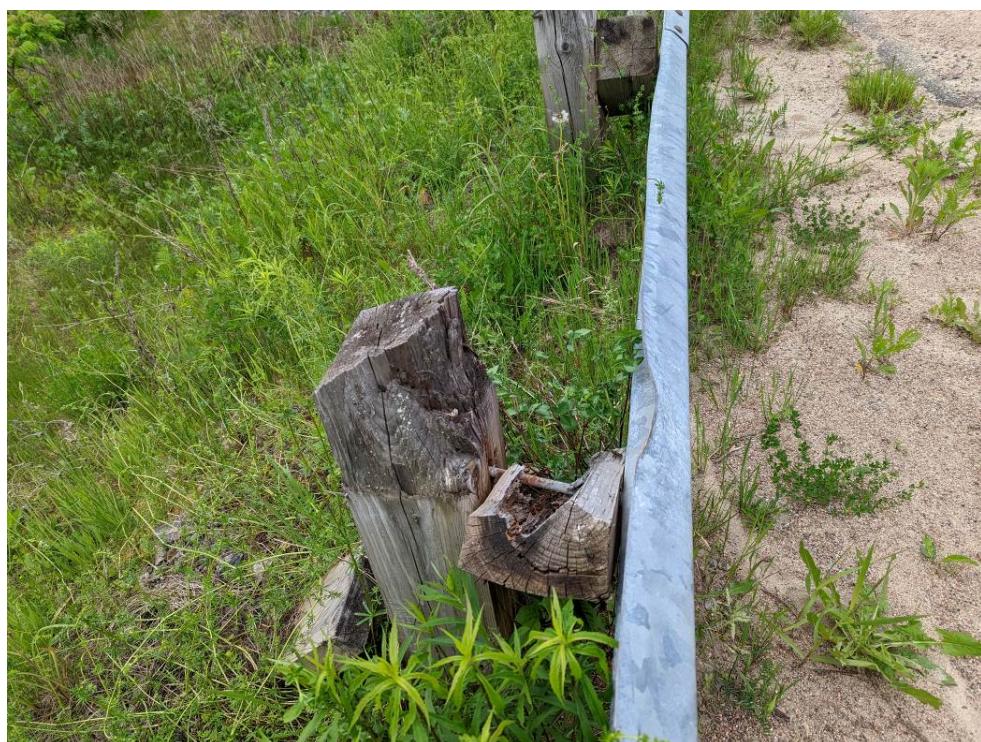
Photo 8 Checks and splits on barrier post with damaged and rotated spacer block

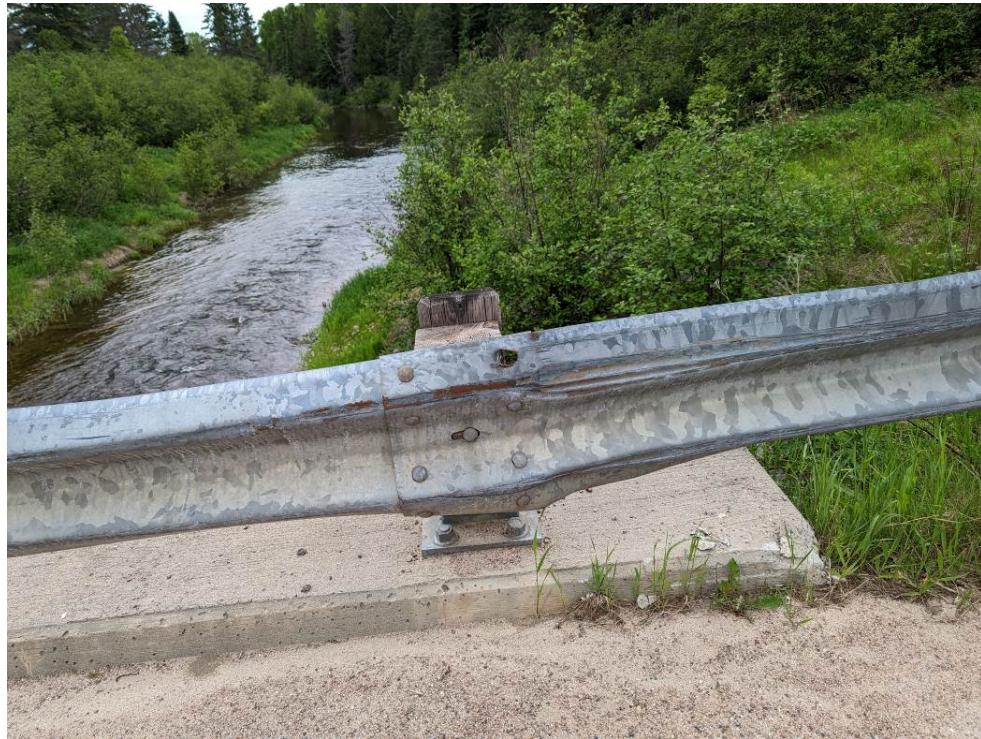
Photo 9 Vehicle damaged noted on deck barrier at southeast corner

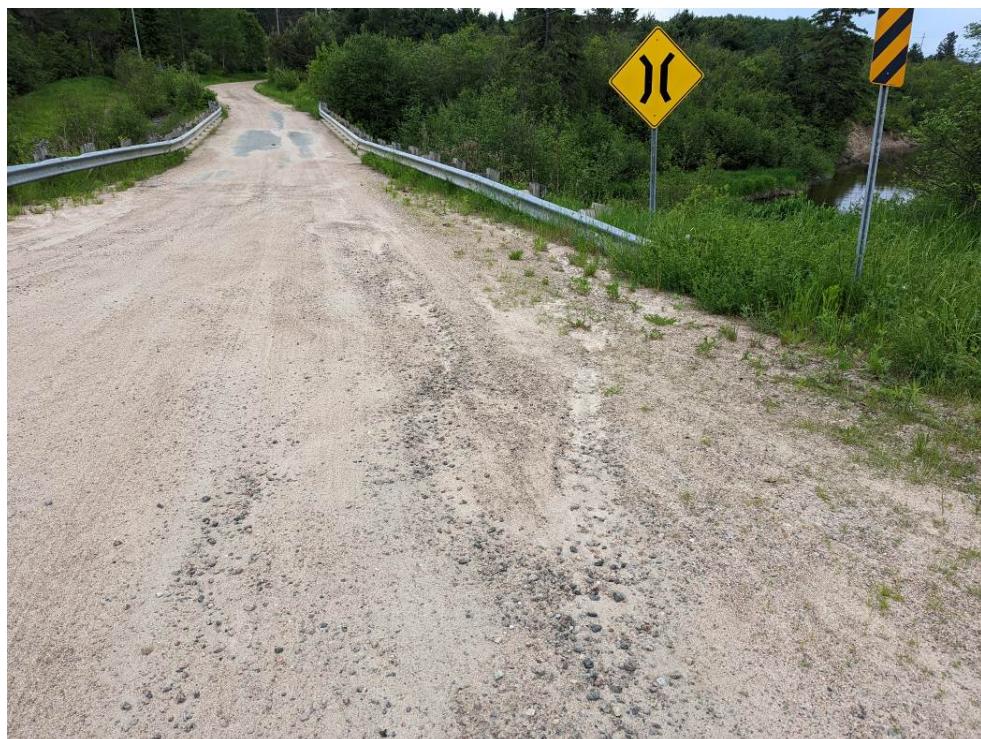
Photo 10 Washout noted in wearing surface at north approach

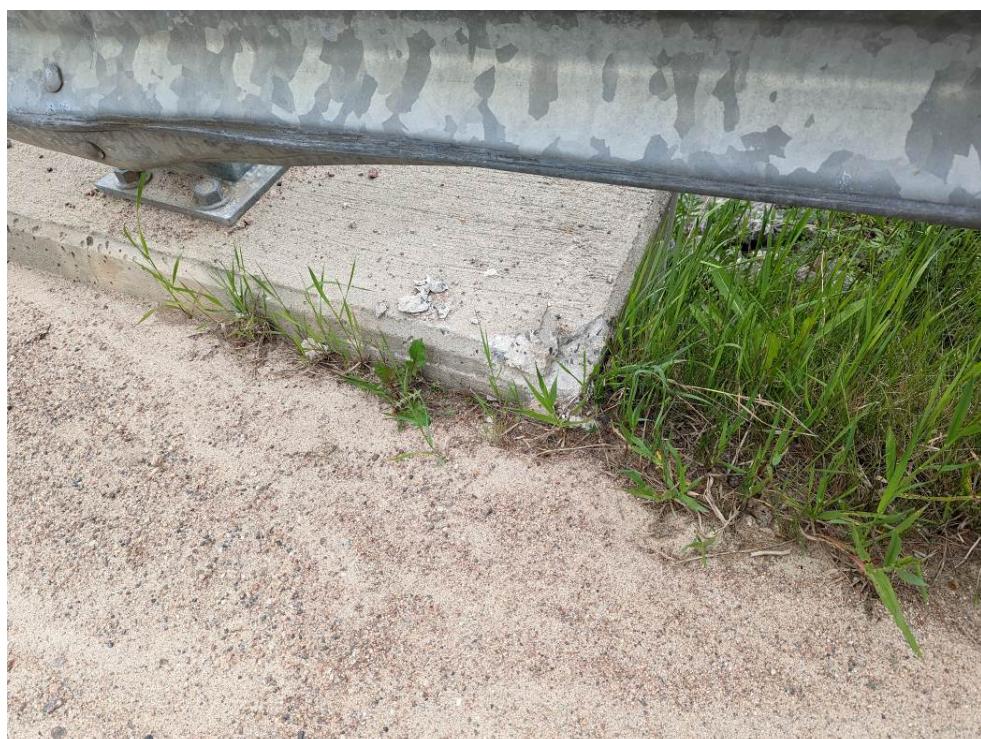
Photo 12 Small spall noted in curb at southeast corner

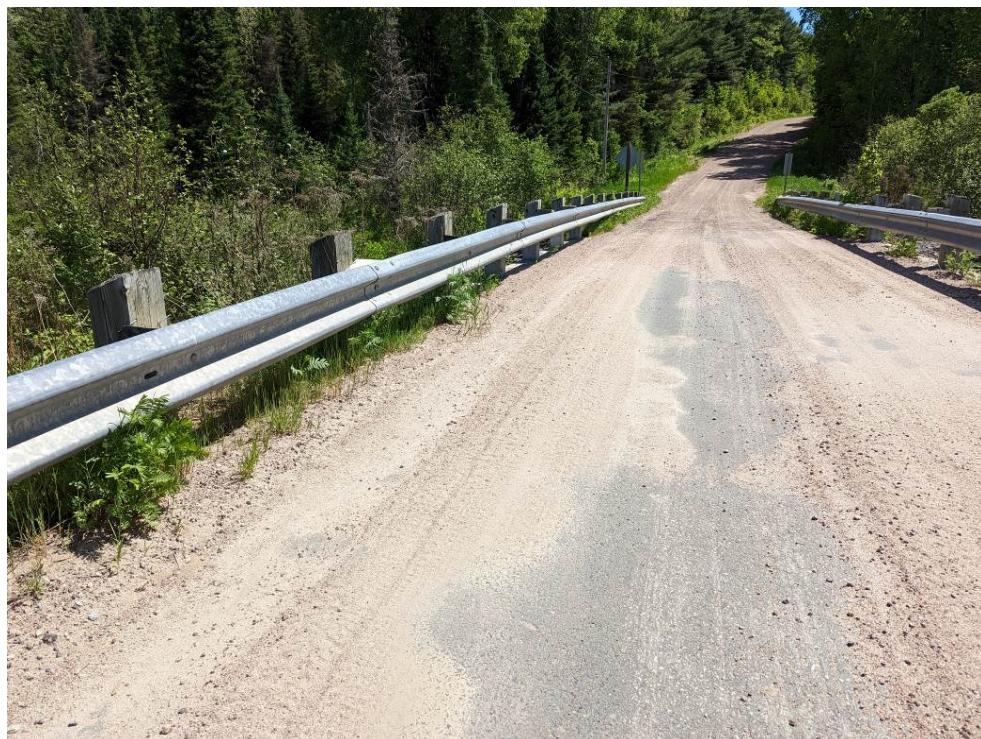
Photo 8 Longitudinal grooves on structure wearing surface

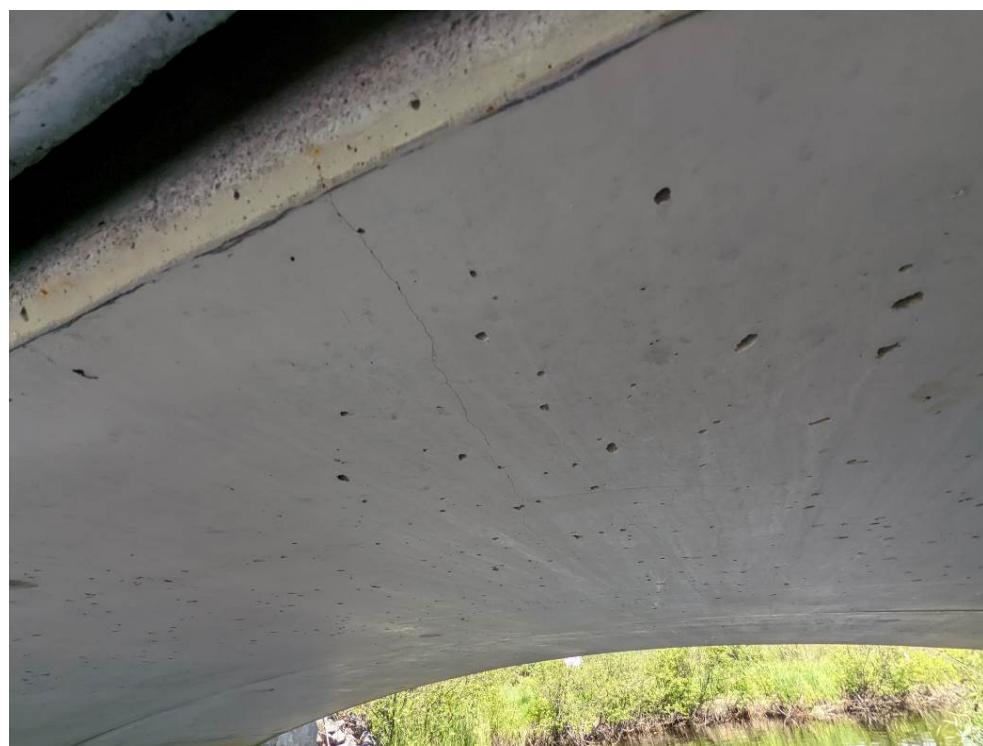
Photo 10 Narrow transverse crack noted in centre of soffit at south end

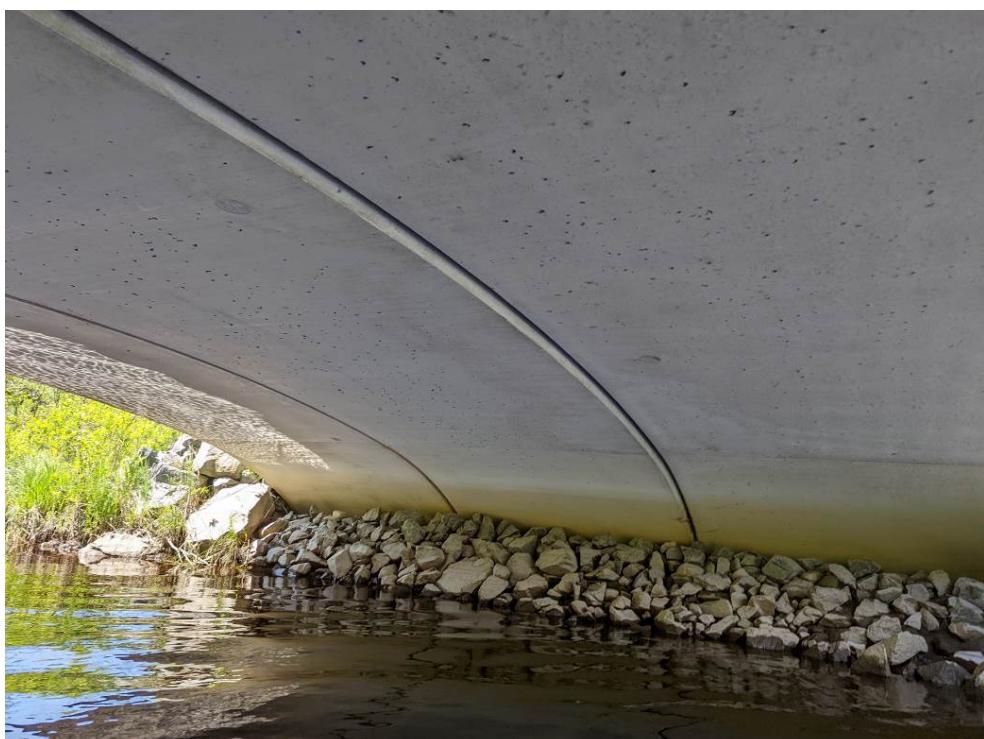
Photo 12 Bug holes noted throughout barrel soffit

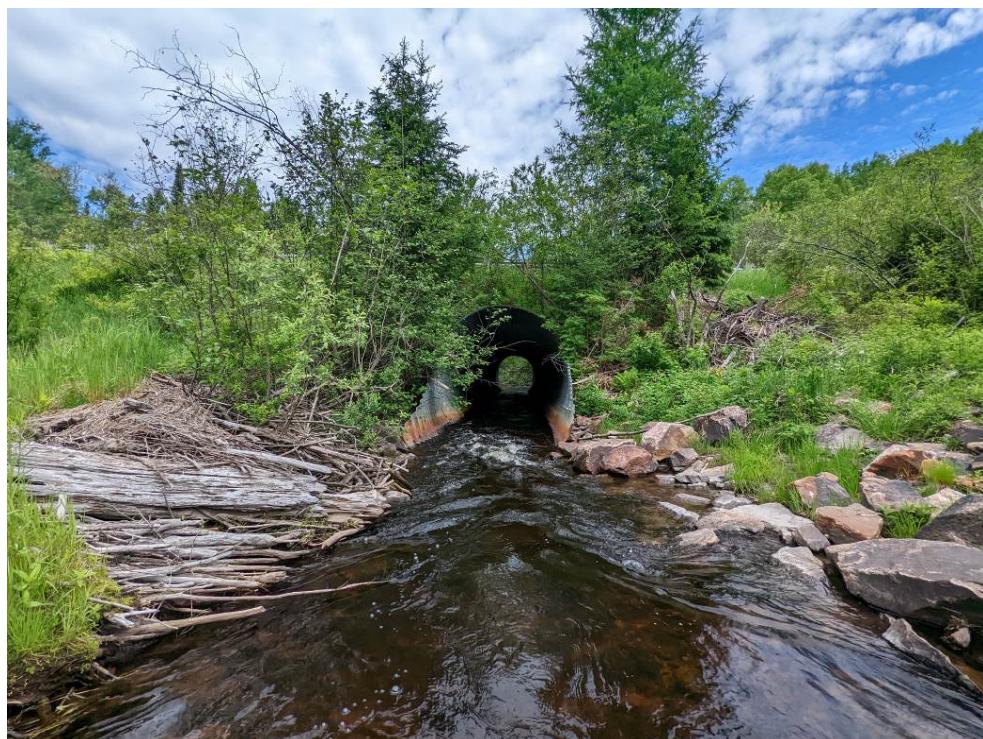
Photo 10 Accumulation of branches noted at south end of culvert.

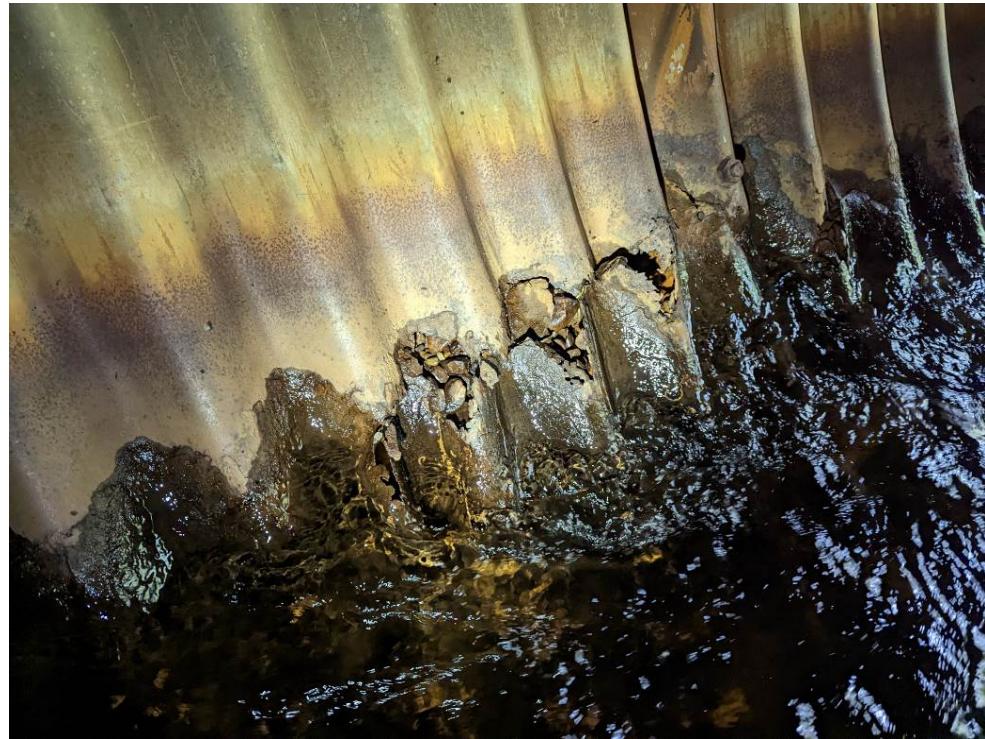
Photo 11 Localized perforation at bottom of barrel, near north end of barrel

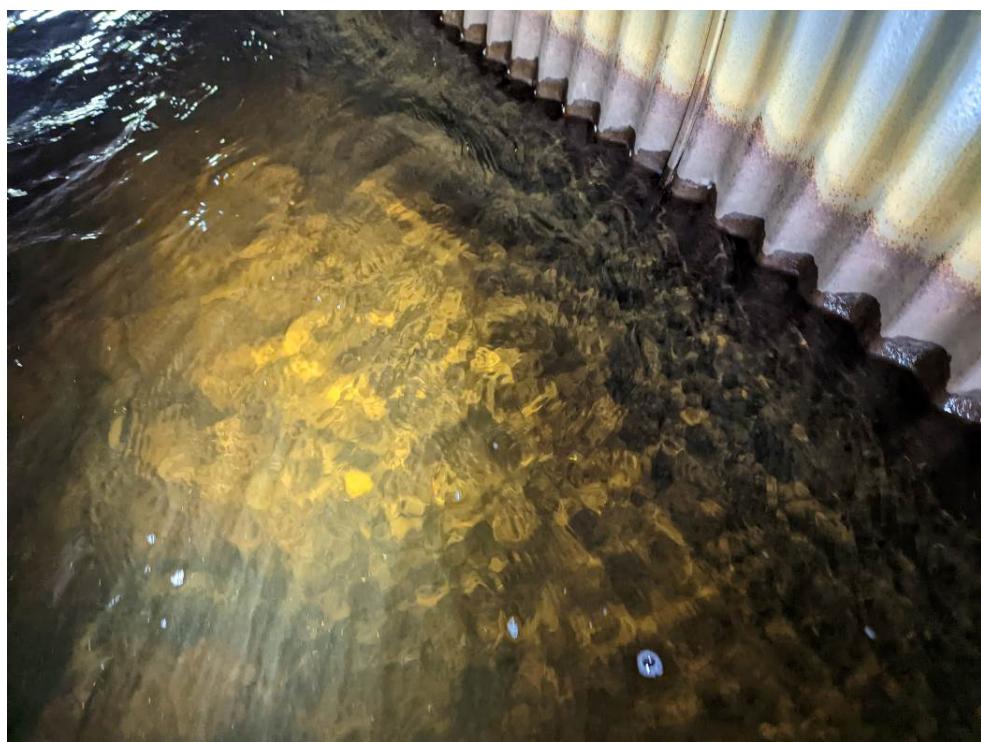
Photo 8 Light to moderate corrosion noted below waterline

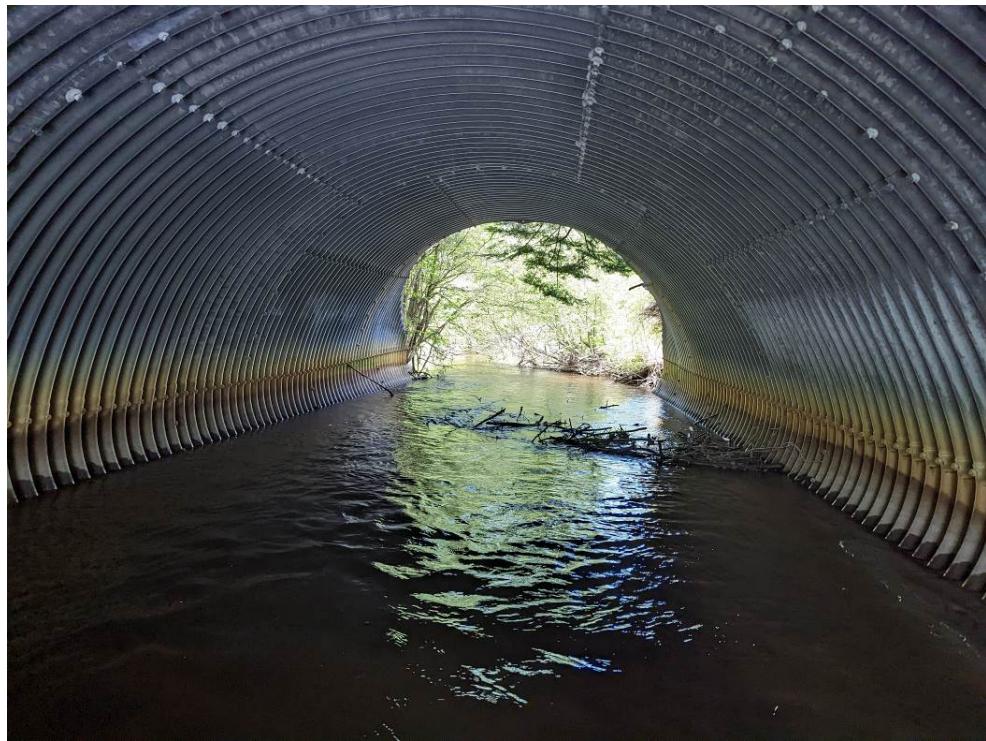
Photo 7 Debris noted in middle of barrel obstructing stream flow

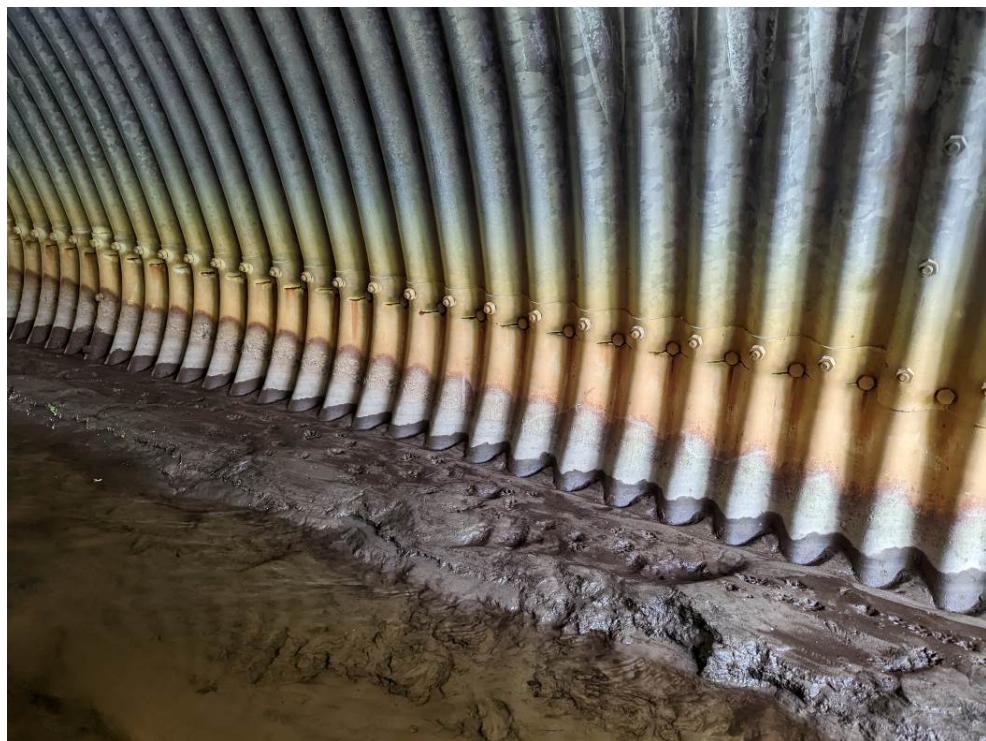
Photo 8 Light to localized moderate corrosion noted at and below waterline

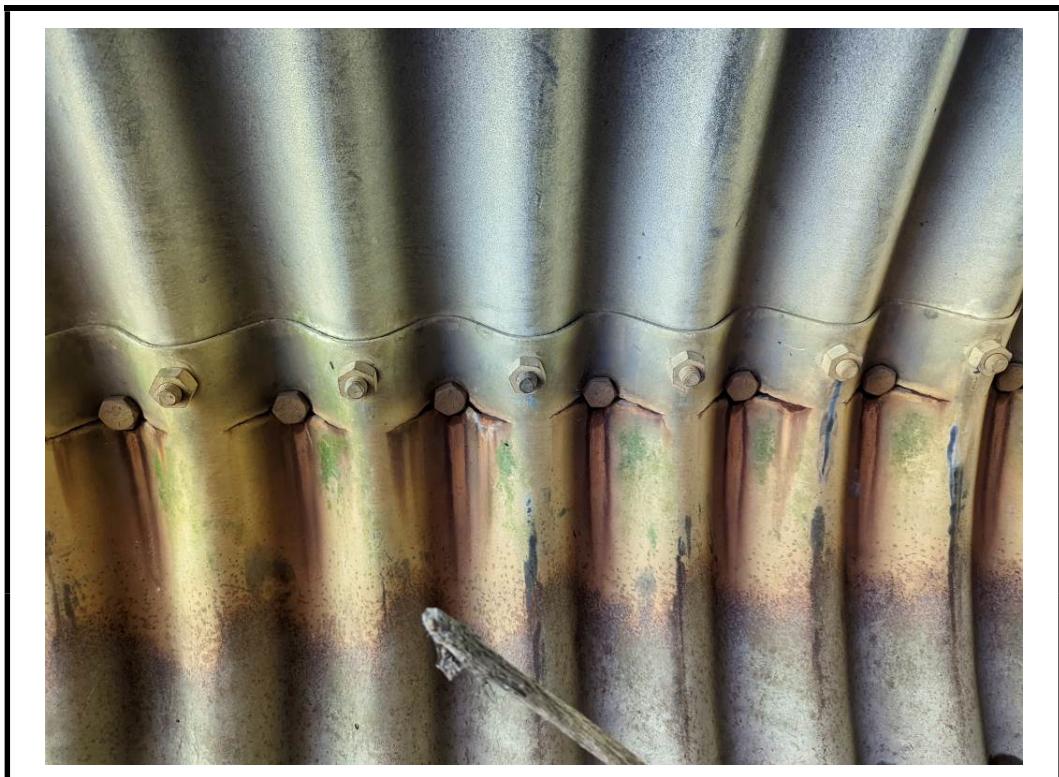
Photo 9 Medium cracking noted along bolt line

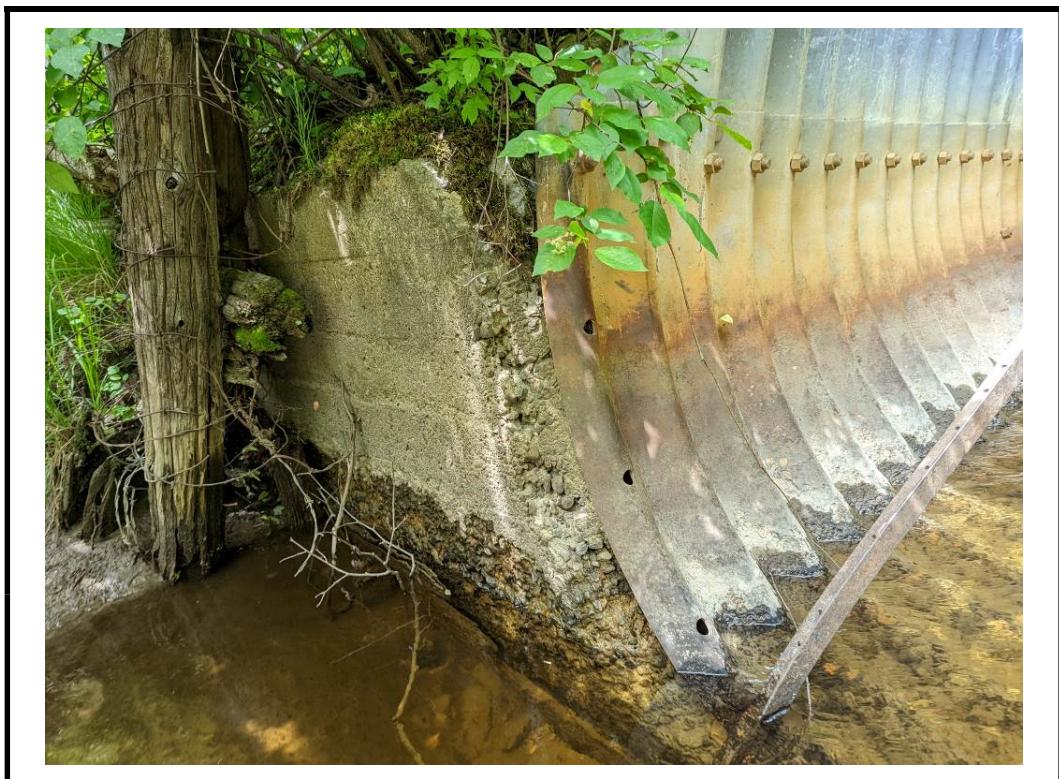
Photo 10 Light to moderate scaling noted on concrete inlet at south end

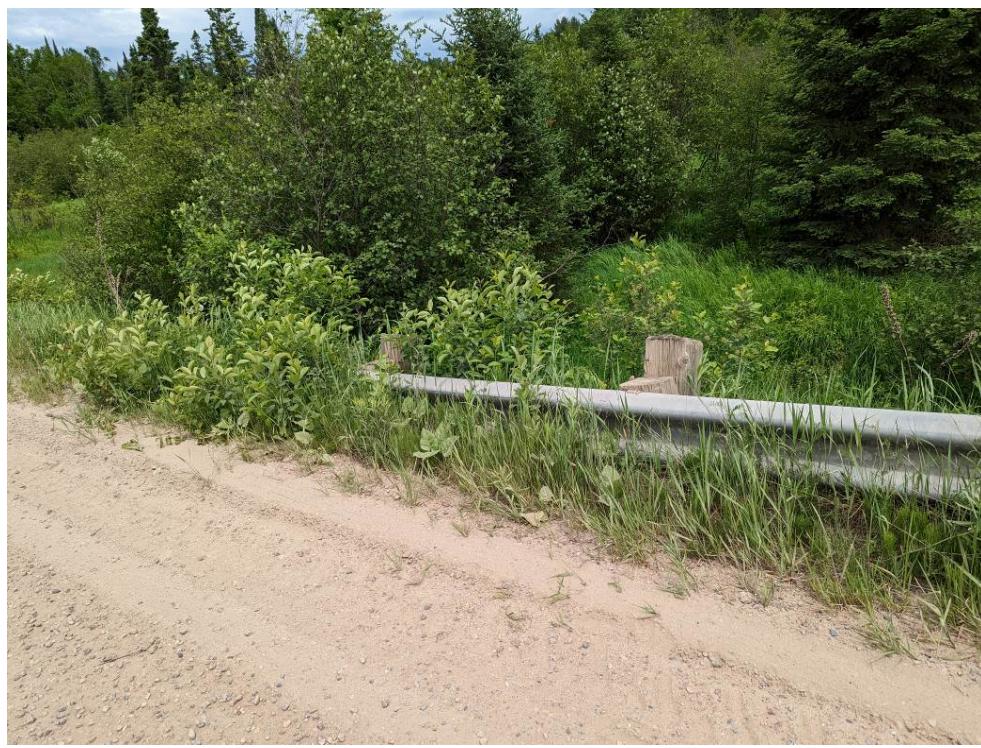
Photo 8 Substandard buried end treatment at approach barrier

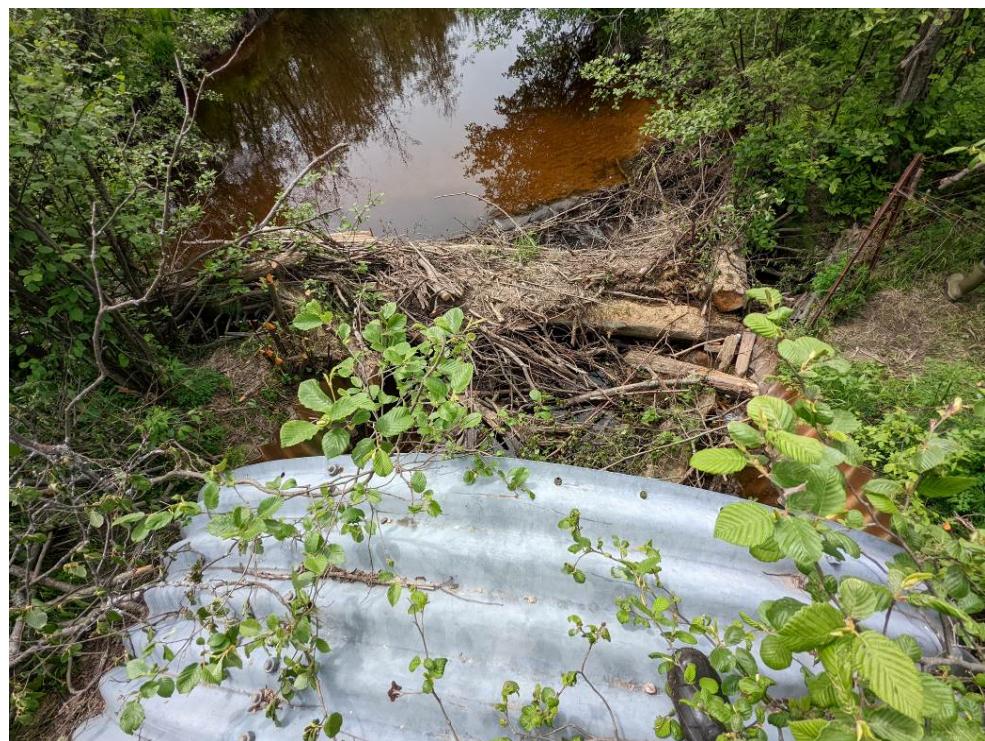
Photo 10 Obstruction at west end of north culvert.

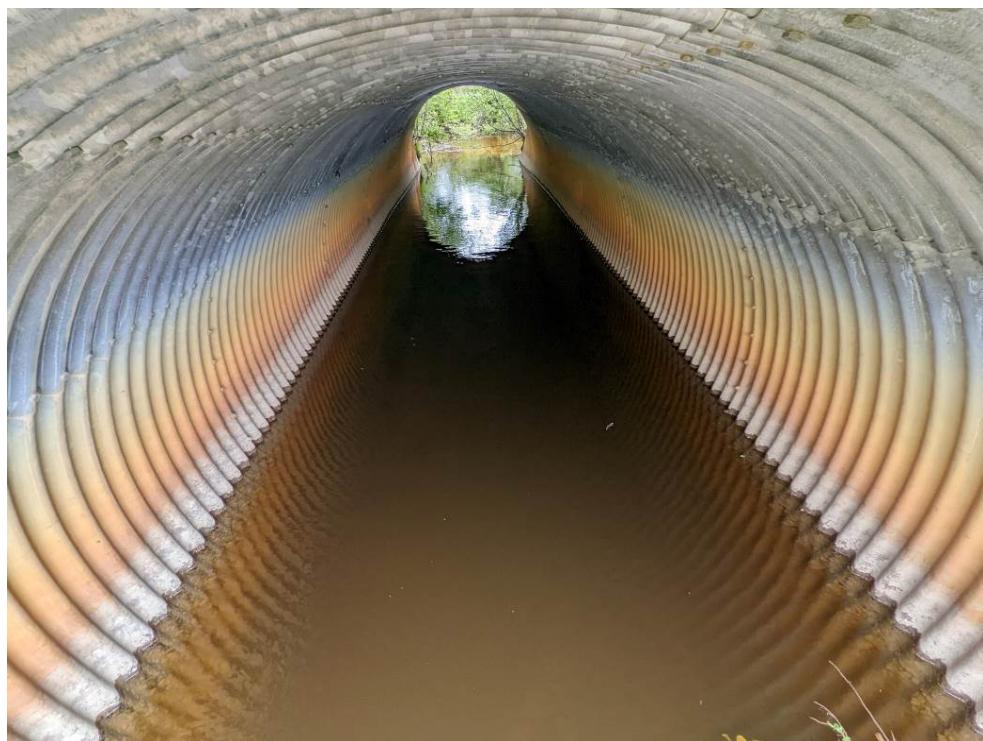
Photo 12 Light corrosion noted at waterline in north culvert barrel (Typical)

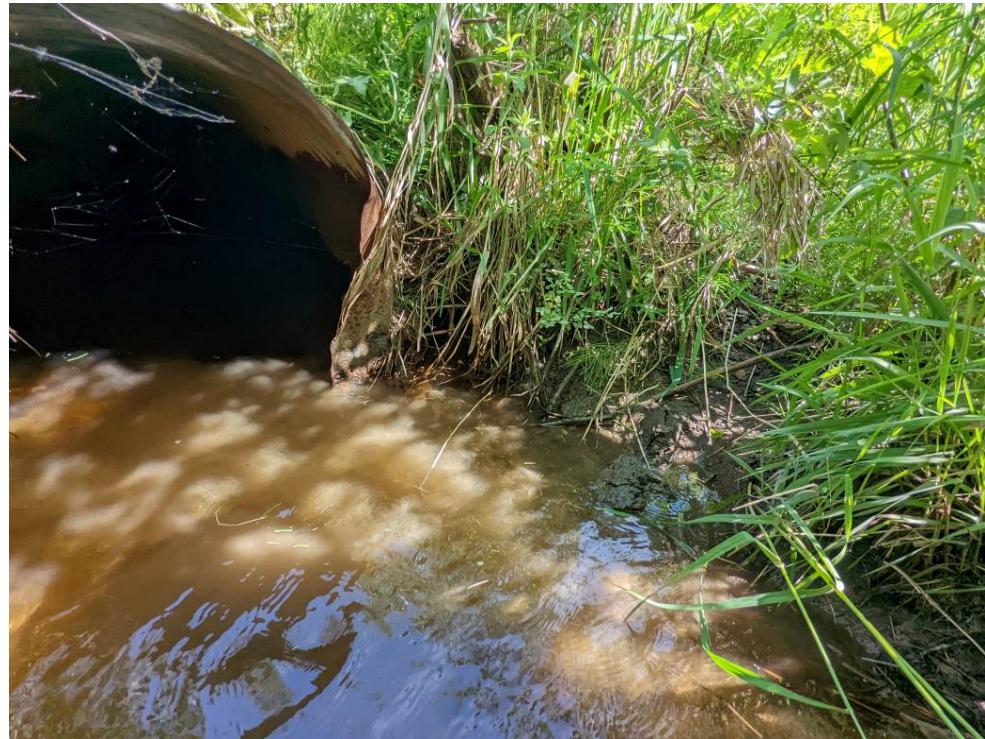
Photo 9 Dents noted at south end of barrel

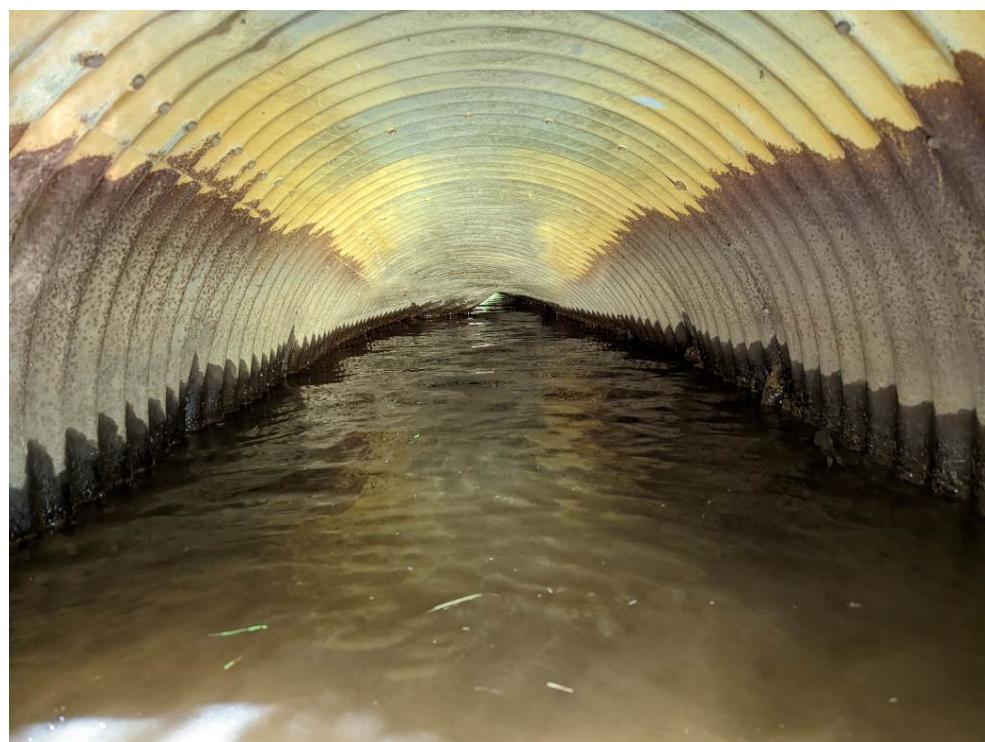
Photo 10 Apparent deformation noted inside barrel

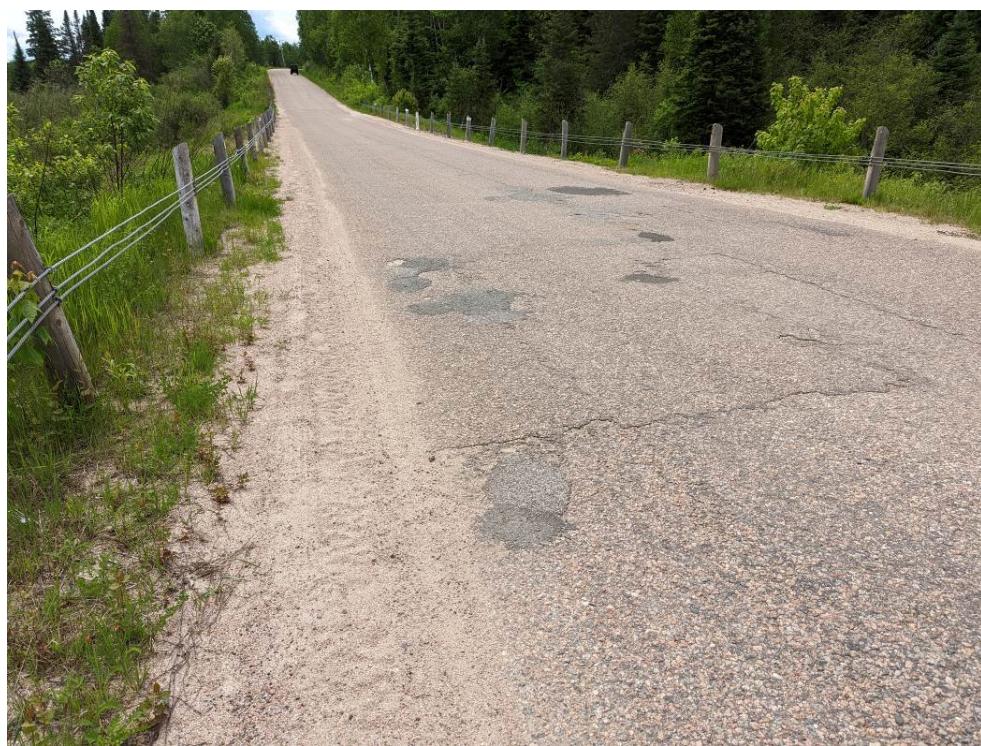
Photo 8 Moderate ravelling, patched potholes noted in east approach wearing surface

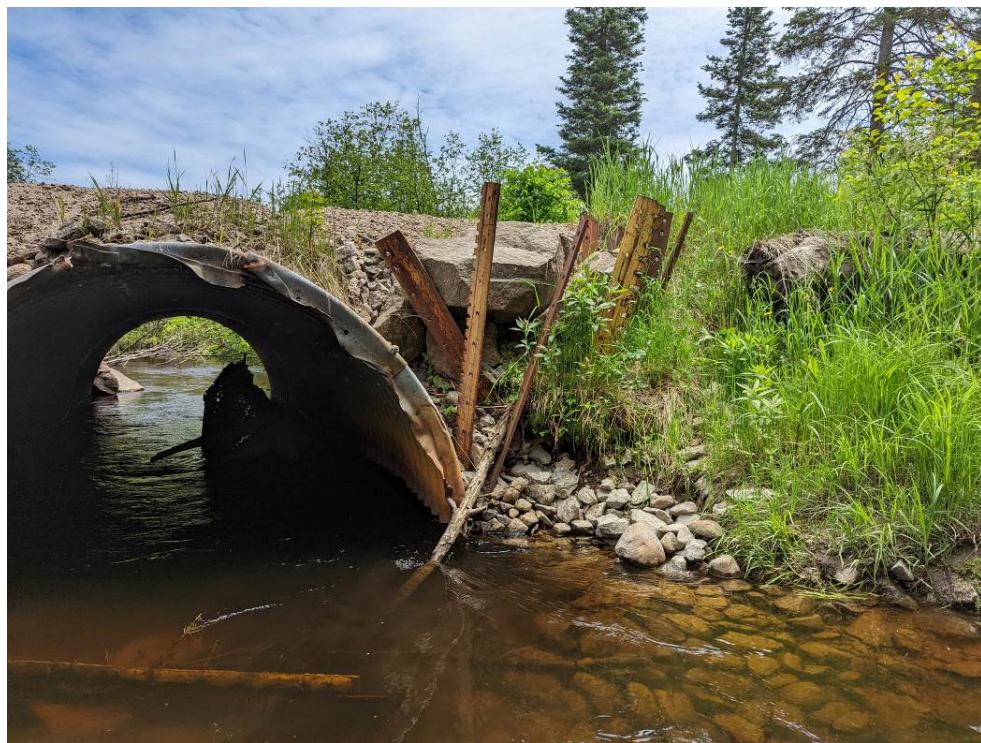
Photo 8 Dents noted at west end of barrel

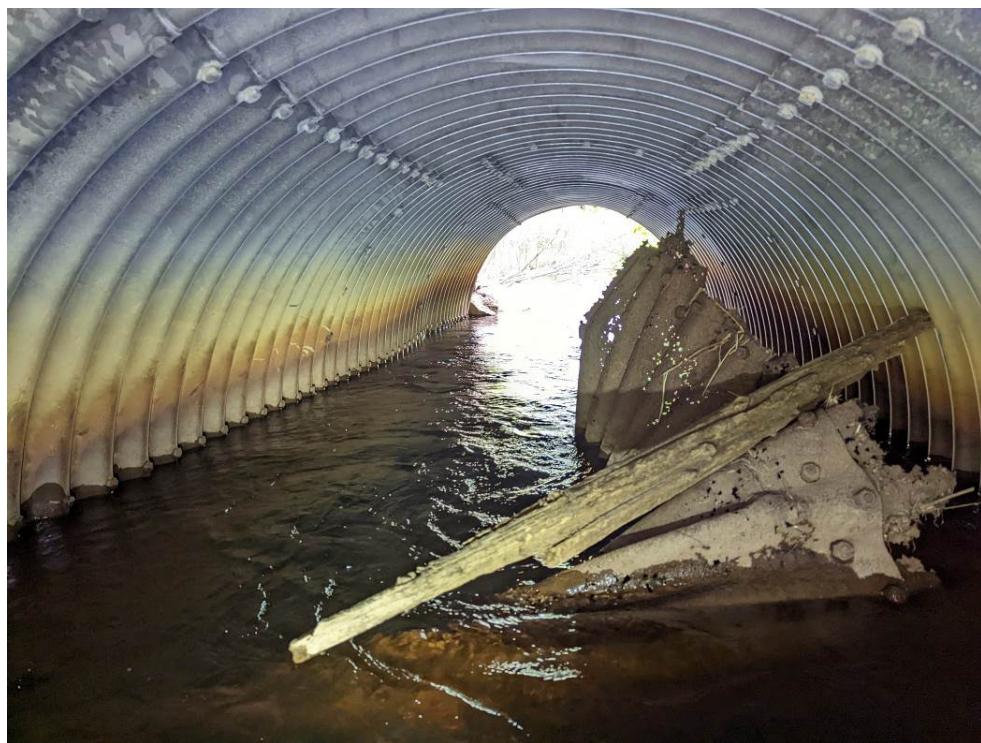
Photo 10 Efflorescence noted at seams and along boltline

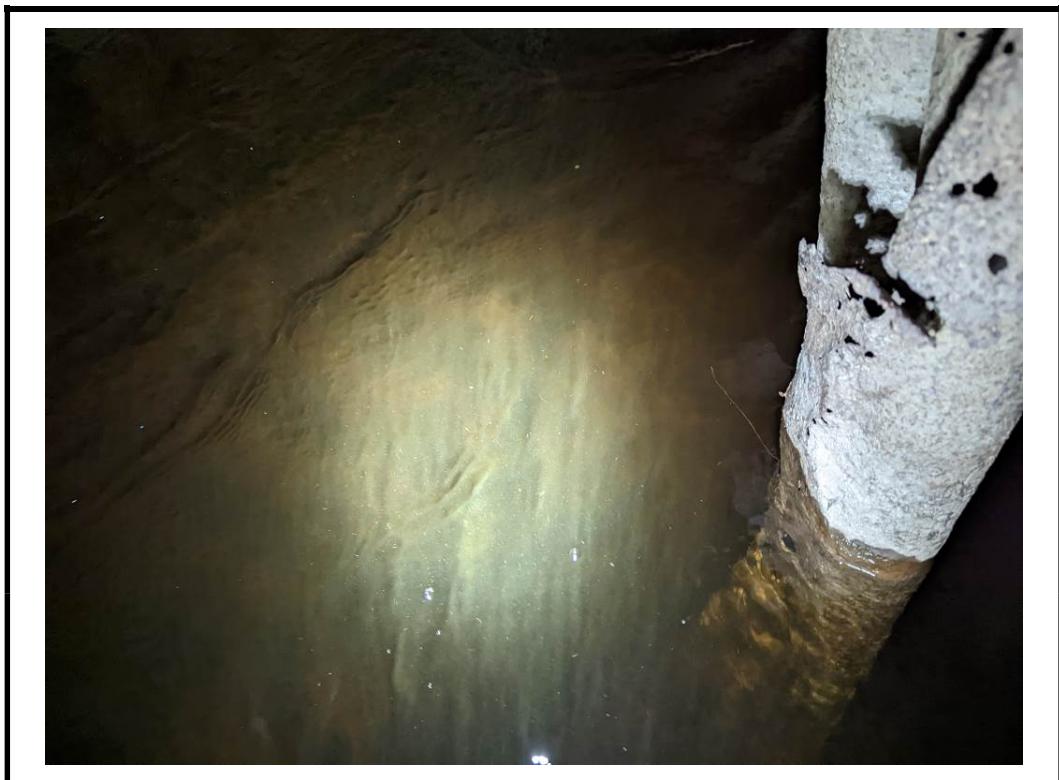
Photo 11 Severe perforation noted at and below waterline
