THE TOWNSHIP OF BONFIELD

BRIDGE MANAGEMENT STUDY REPORT (DRAFT)

6 BRIDGES / 10 CULVERTS

DECEMBER 2022

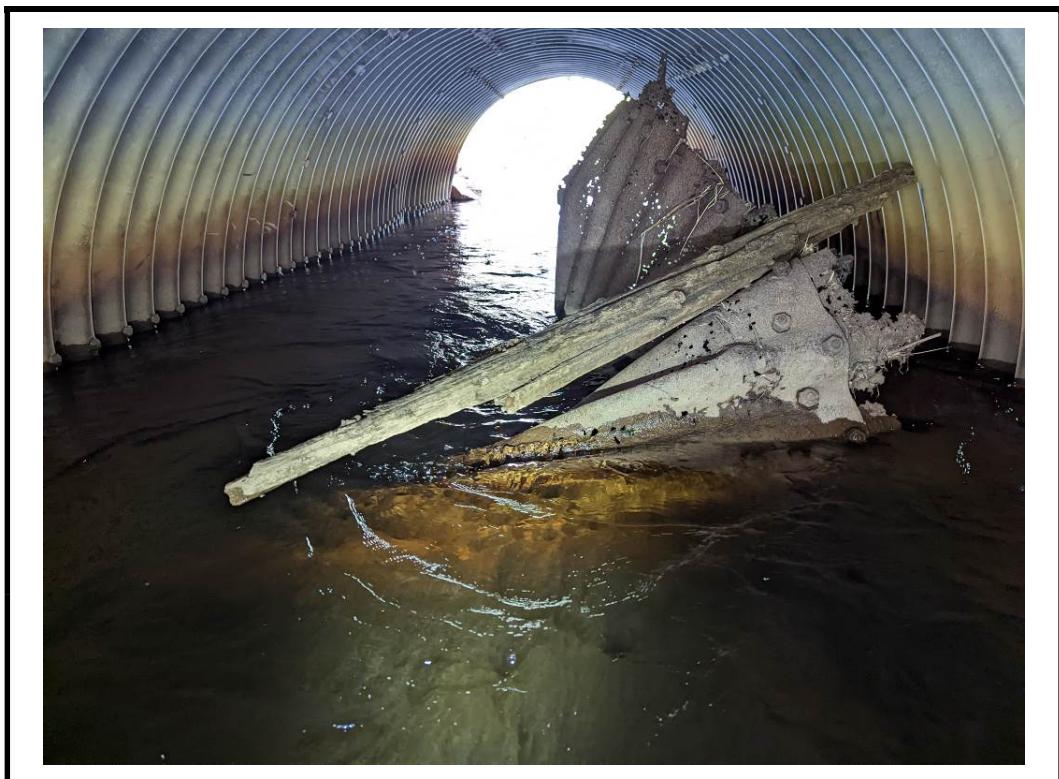
Photo 12 Damaged section of CSP in barrel, does not appear to be from this structure

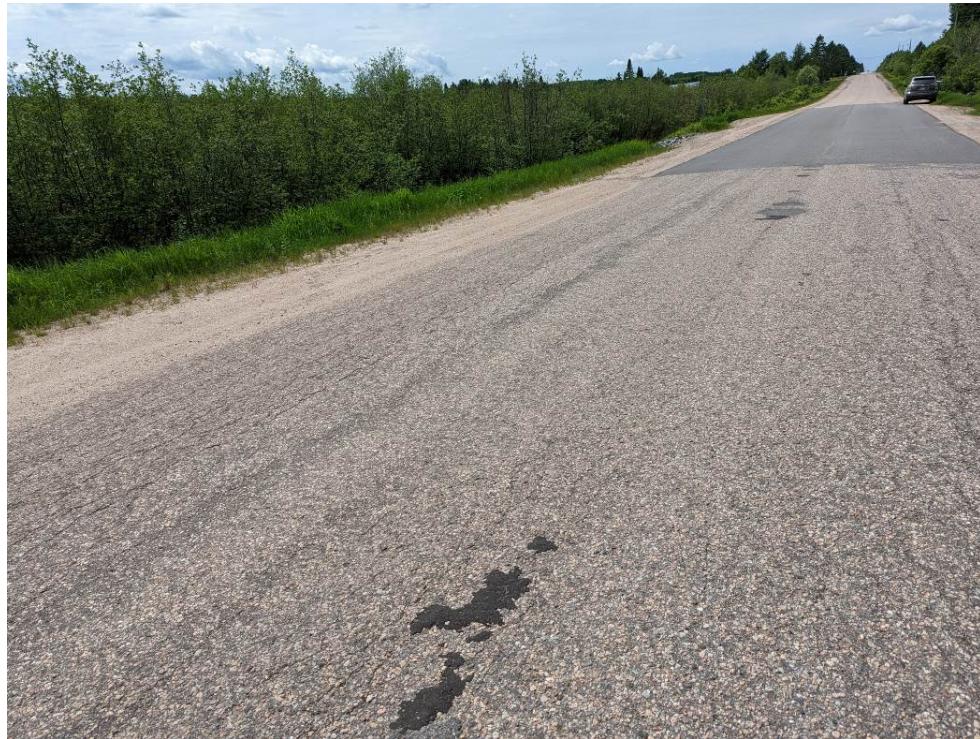
Photo 7 Medium to wide longitudinal cracks and patches noted at east approach

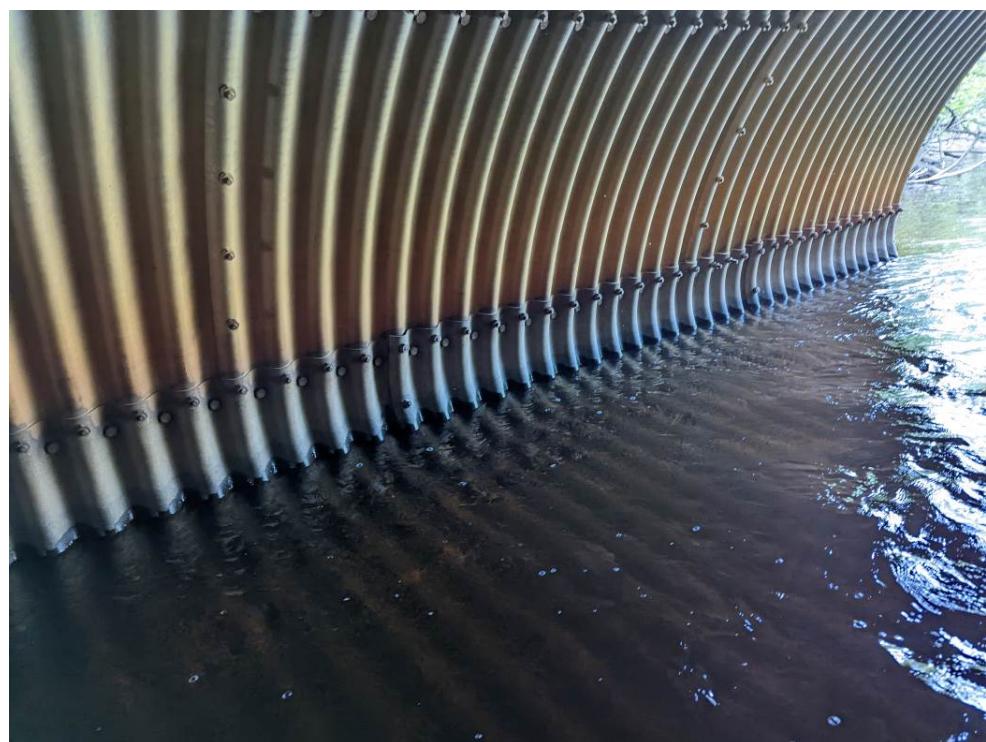
Photo 8 Light to moderate corrosion noted at waterline

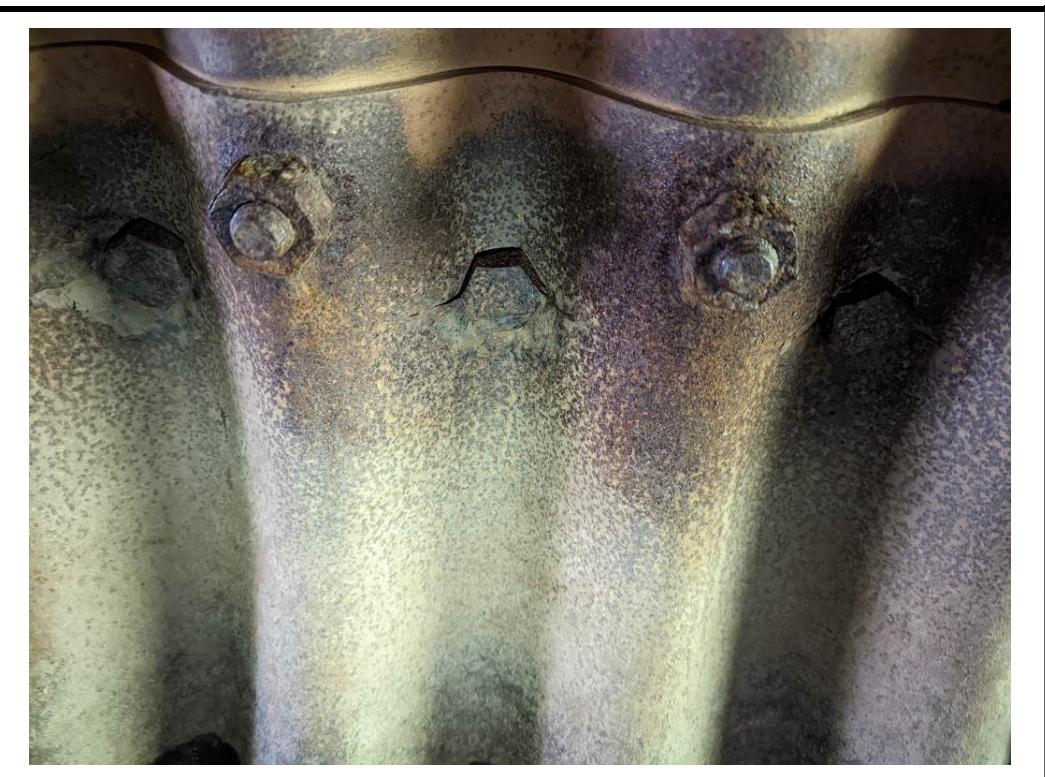
Photo 9 Cracks at bolt line at the west side of structure
