BONFIELD WASTE DISPOSAL SITE
Physical Address: LOT:10, CONCESSION:5,
GEOTOWNSHIP:BONFIELD,
BON, ON

INSPECTION REPORT

System Number: A530702
Entity: CORPORATION OF THE
TOWNSHIP OF BONFIELD
Inspection Start Date: October 15, 2025
Site Inspection Date: January 14, 2026
Inspection End Date: January 21, 2026
Inspected By: Christopher Horne
Badge #: 1811

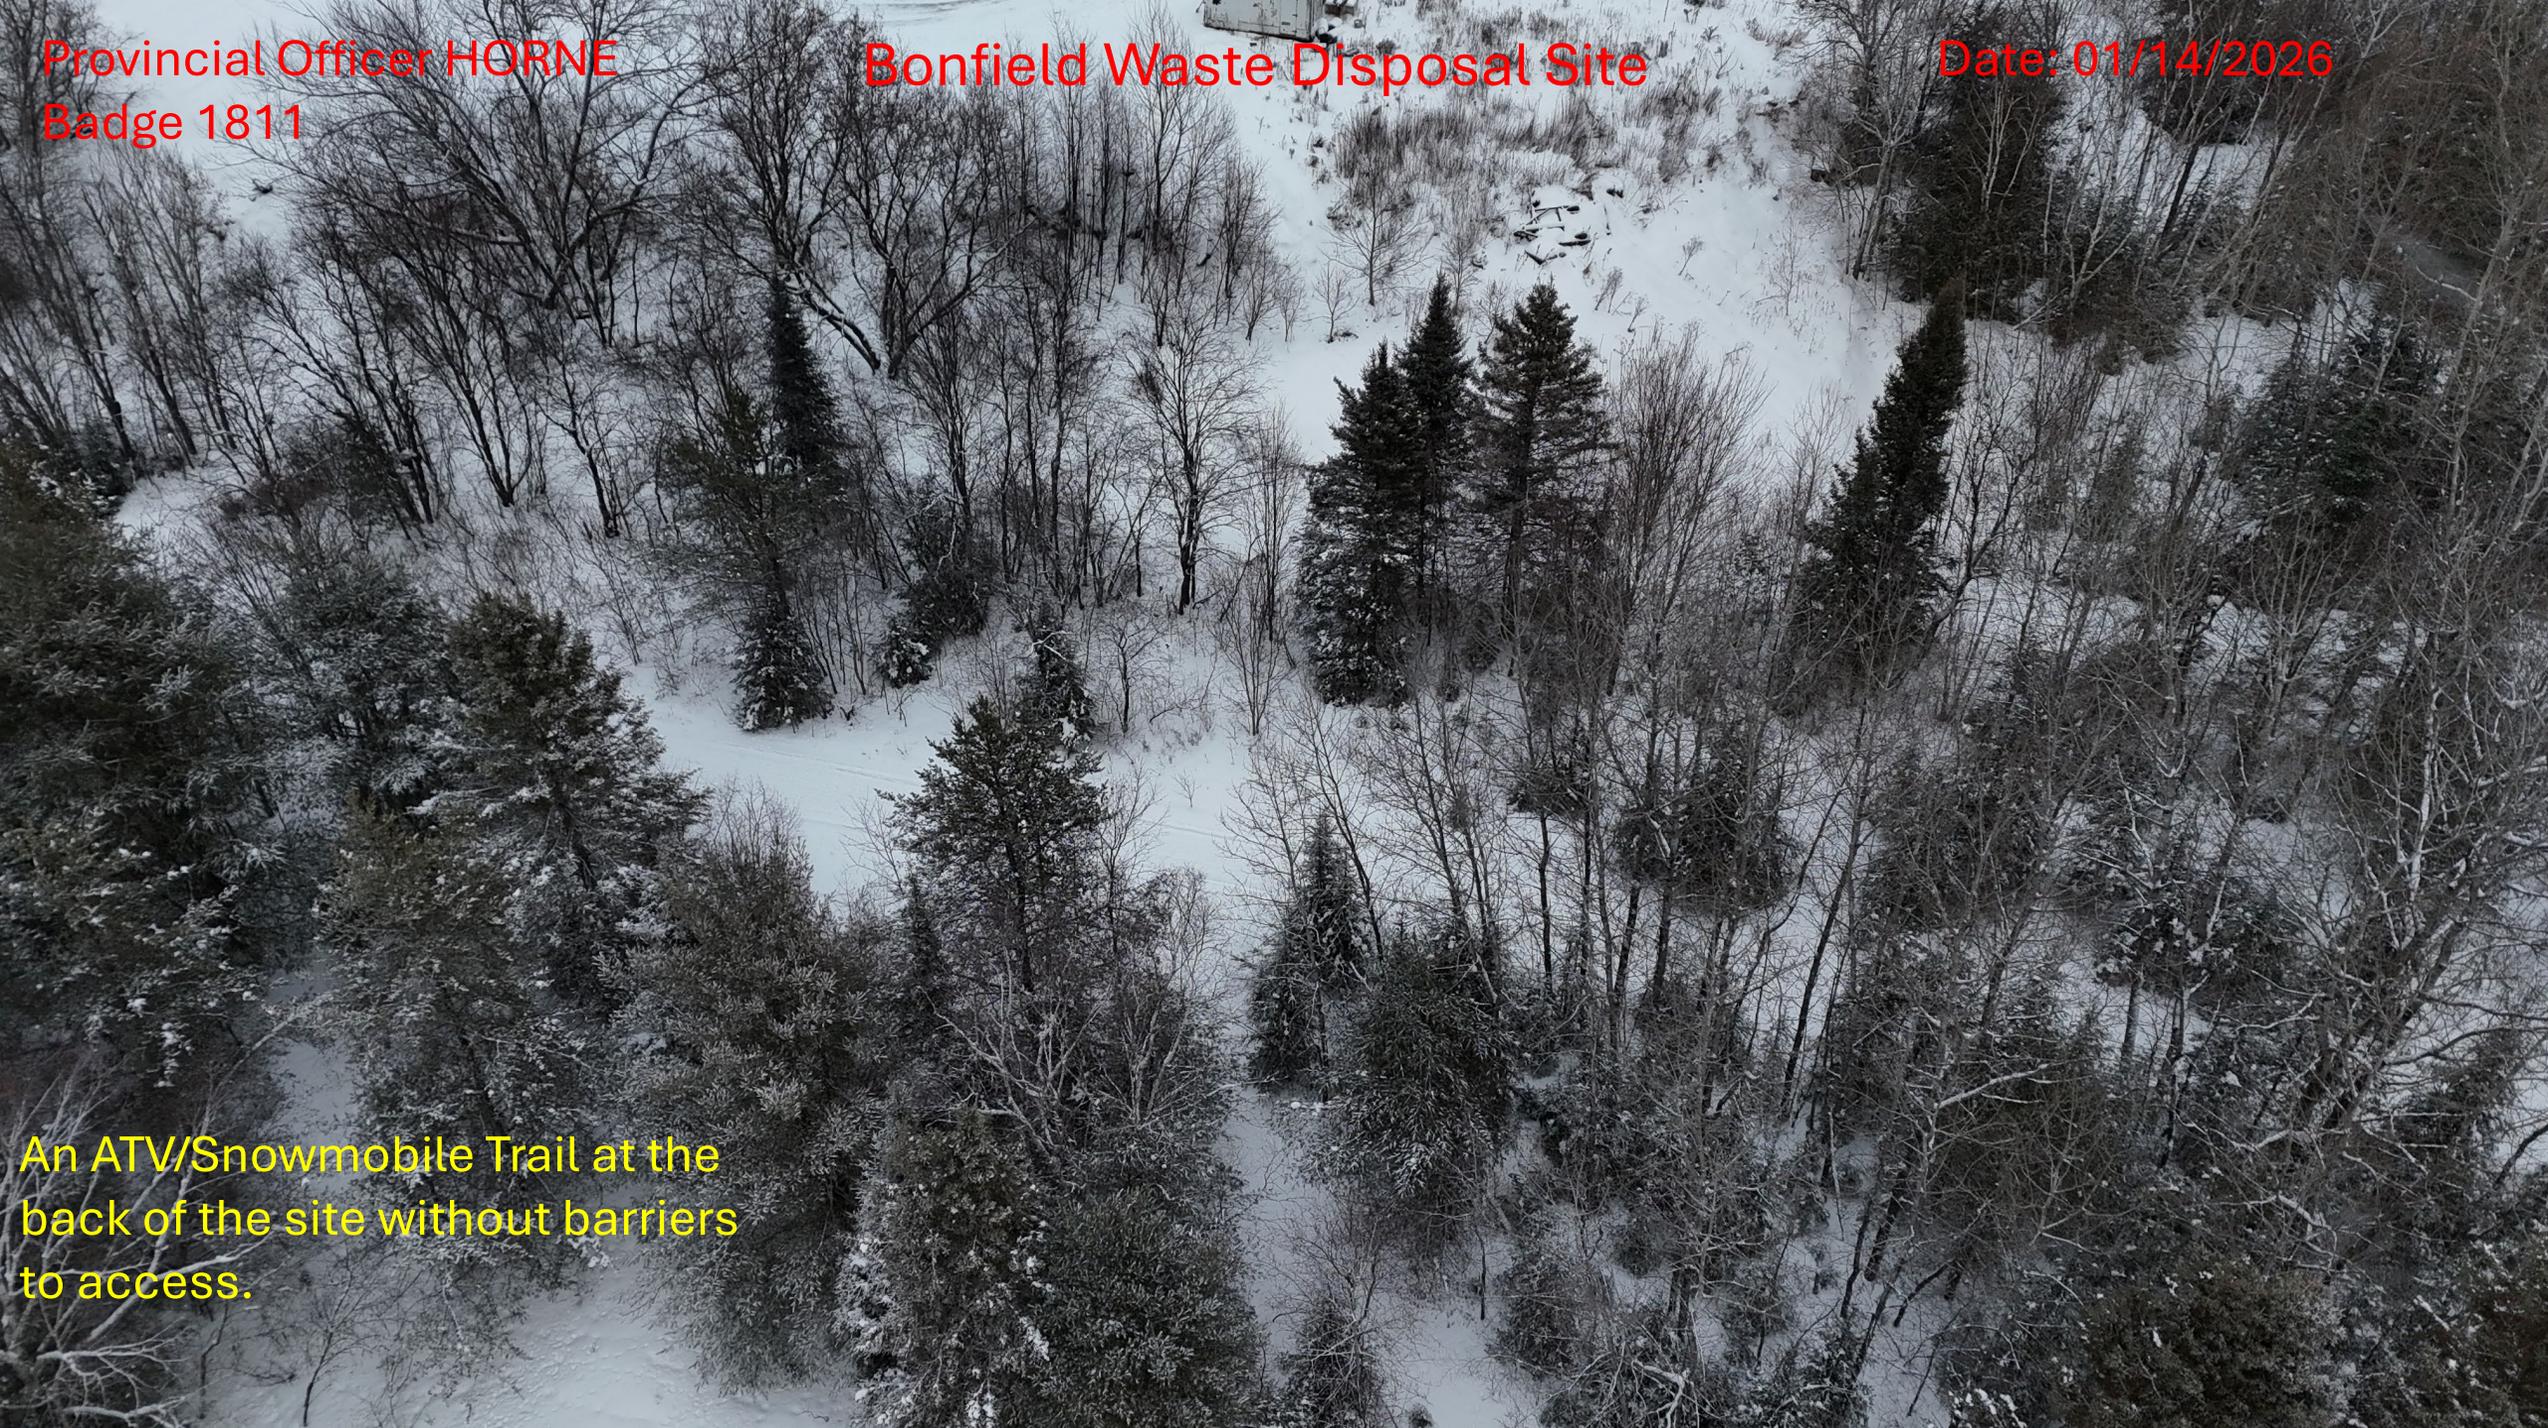
An ATV/Snowmobile Trail at the
back of the site without barriers
to access.

Question ID	OOL 22	Question Type	Legislative
Legislative Requirement(s): EPA 27 (1); EPA R.R.O. 1990, Reg. 347 11 (16);			
Question: Is site access restricted by use of a gate, fence, or physical barrier when the site is not operating?			
Compliance Response(s)/Corrective Action(s)/Observation(s): A gate is used at the front entrance. Other areas can be accessed by people using ATV's or snowmobiles and the municipality has used cameras to stop being from accessing the site. Under Section 11 of Ontario Regulation 347 Standards for Waste Disposal Sites paragraph 16 states the following : " The waste disposal area shall be enclosed to prevent entry by unauthorized persons and access to the property shall be by roadway closed by a gate capable of being locked" Based on the observation in the field, some areas could require fencing to stop authorized access ACTION ITEM #3) By August 31st 2026 provide email conformation to the undersigned officer that fencing or another perimeter control has been installed at the site to restrict access.
