THE TOWNSHIP OF BONFIELD

BRIDGE MANAGEMENT STUDY REPORT (DRAFT)

6 BRIDGES / 10 CULVERTS

DECEMBER 2022

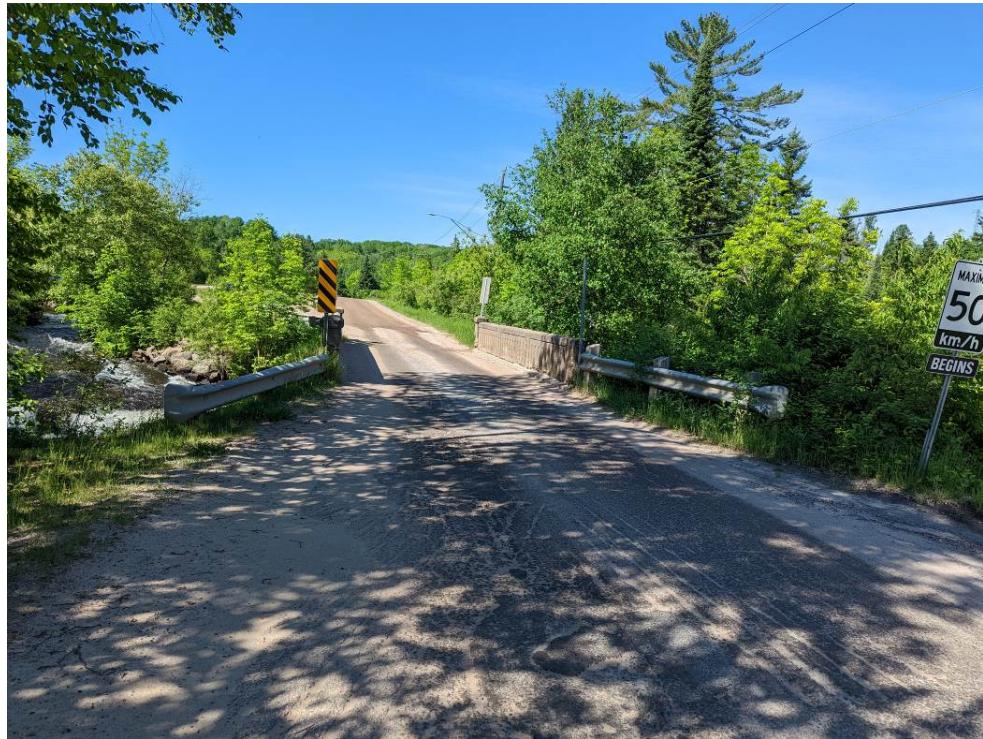
Photo 1 Structure from east approach

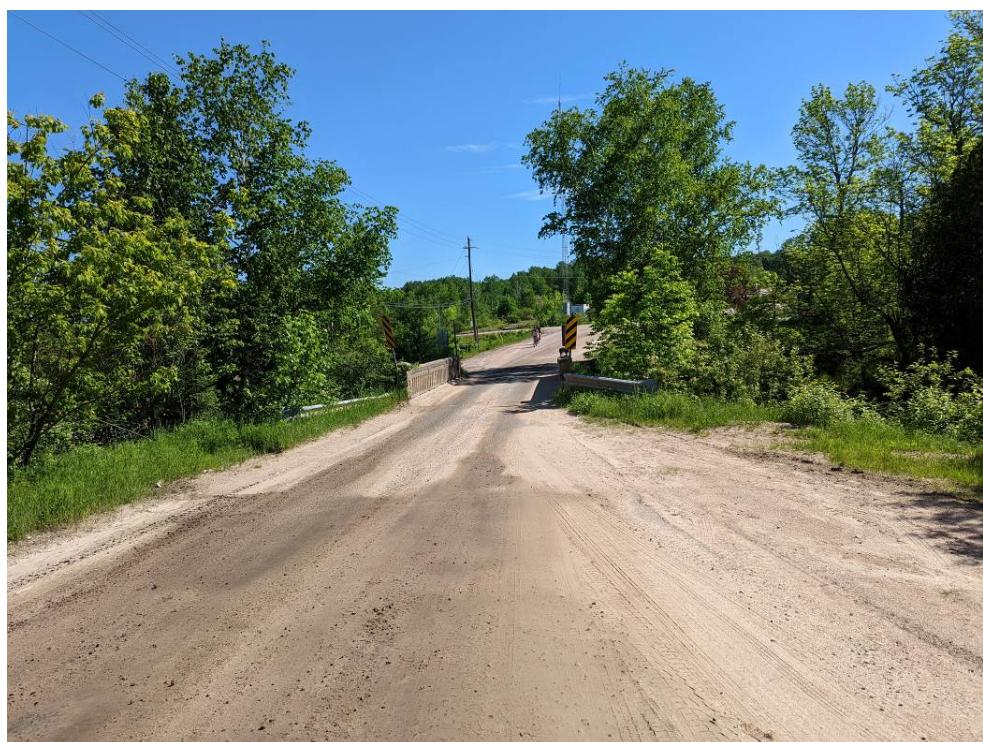
Photo 2 Structure from west approach

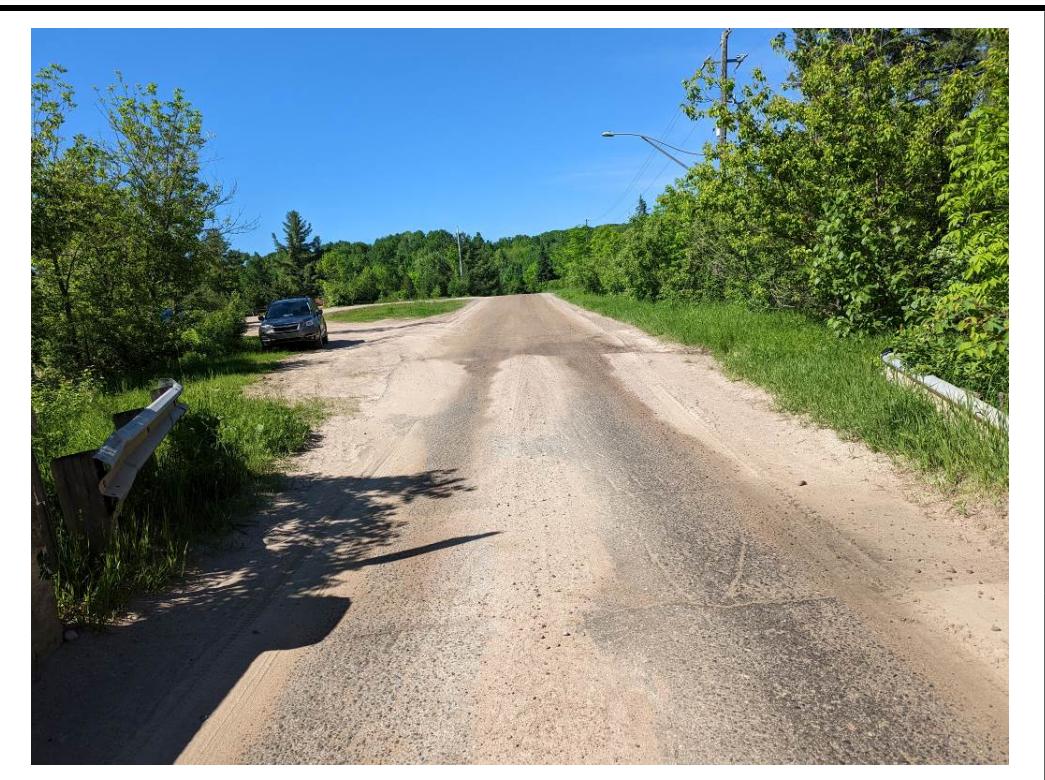
Photo 3 East approach from centre of structure

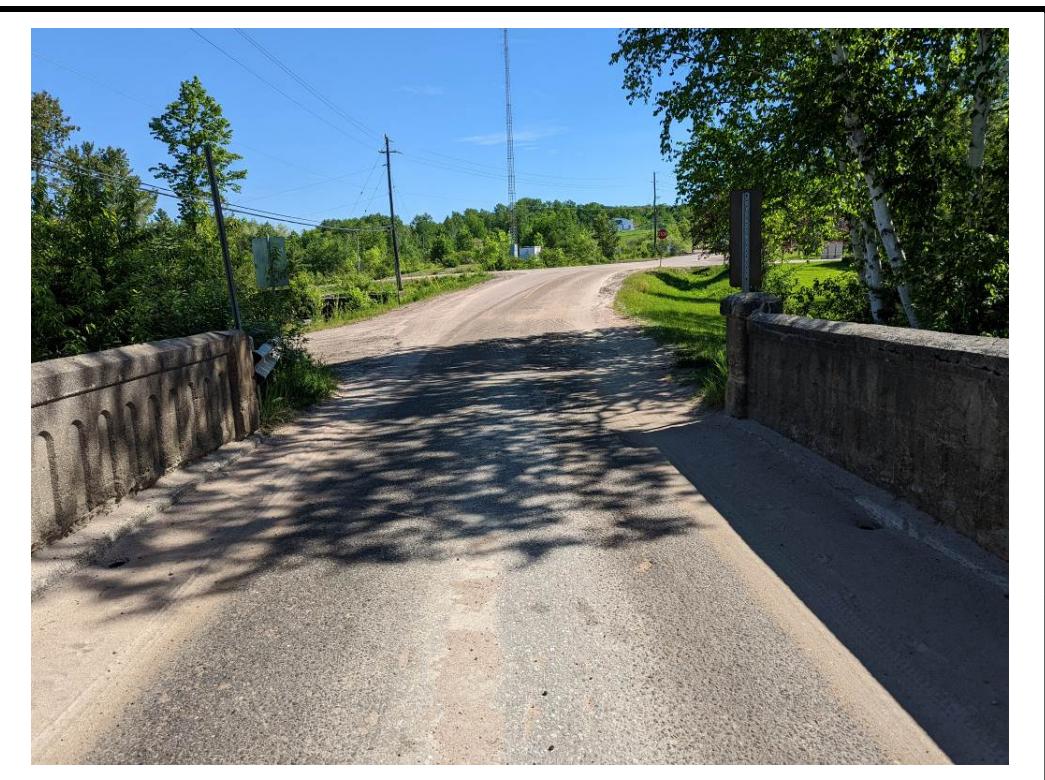
Photo 4 West approach from centre of structure

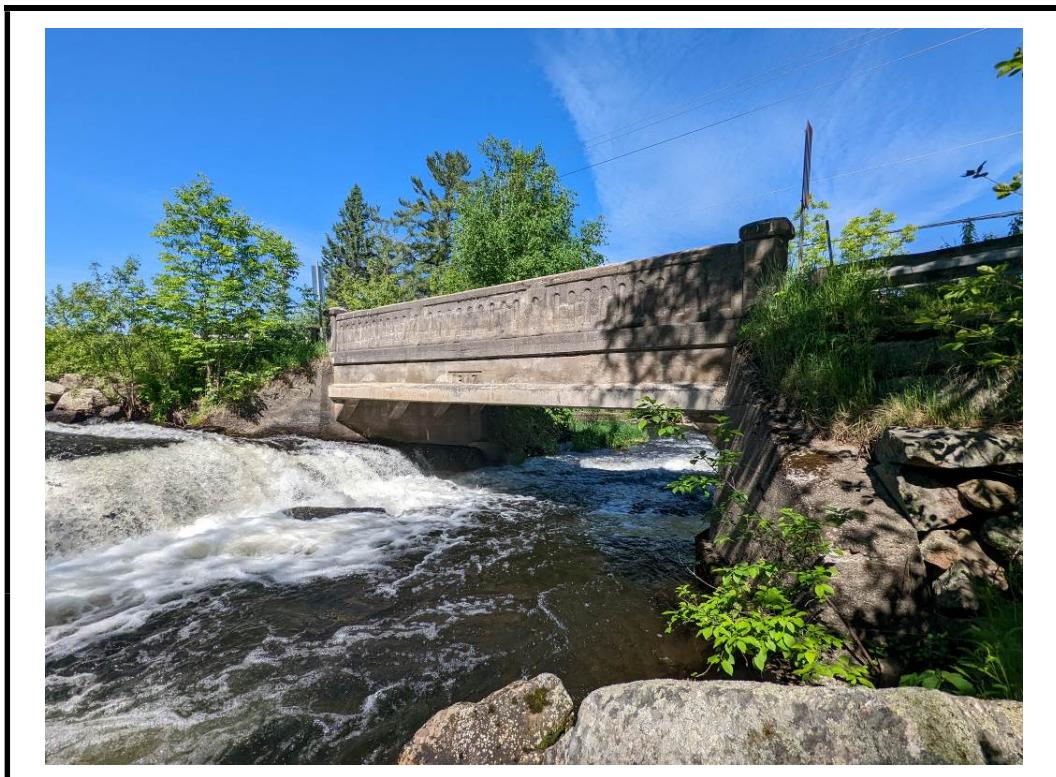
Photo 5 North elevation

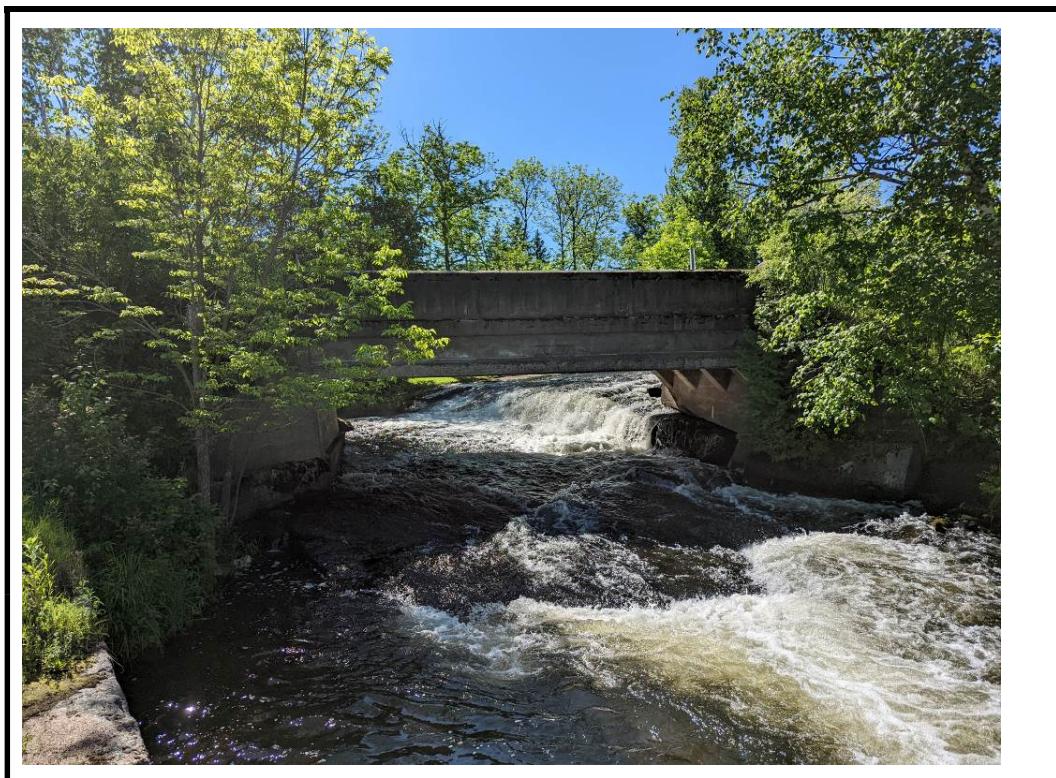
Photo 6 South elevation

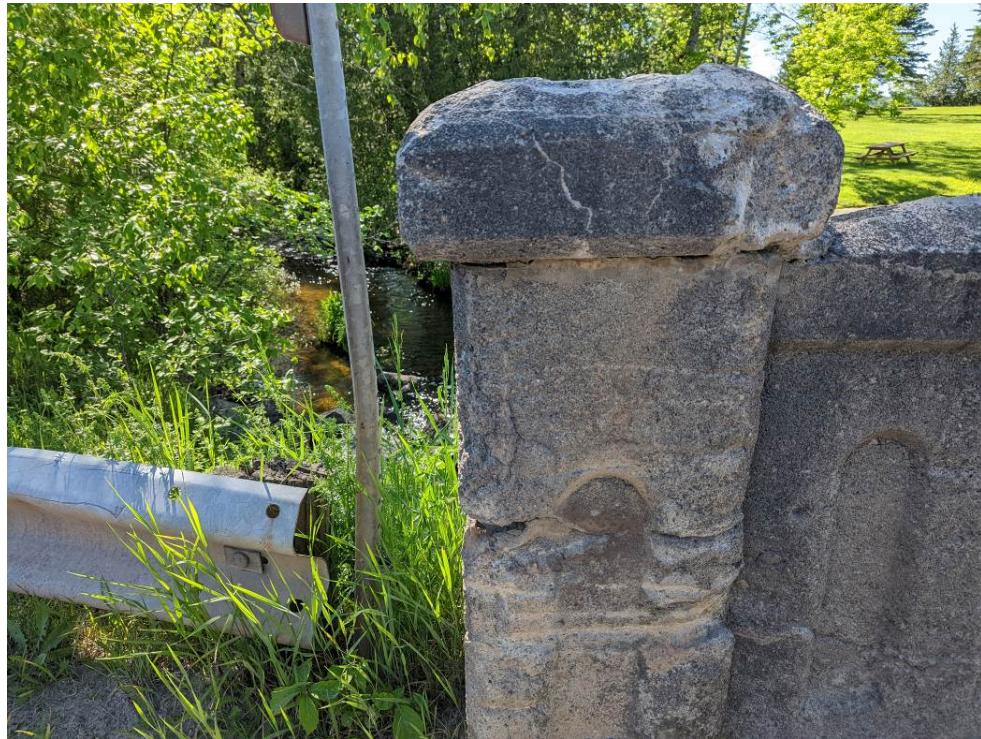
Photo 9 Substandard connection at northwest approach barrier (Typical)

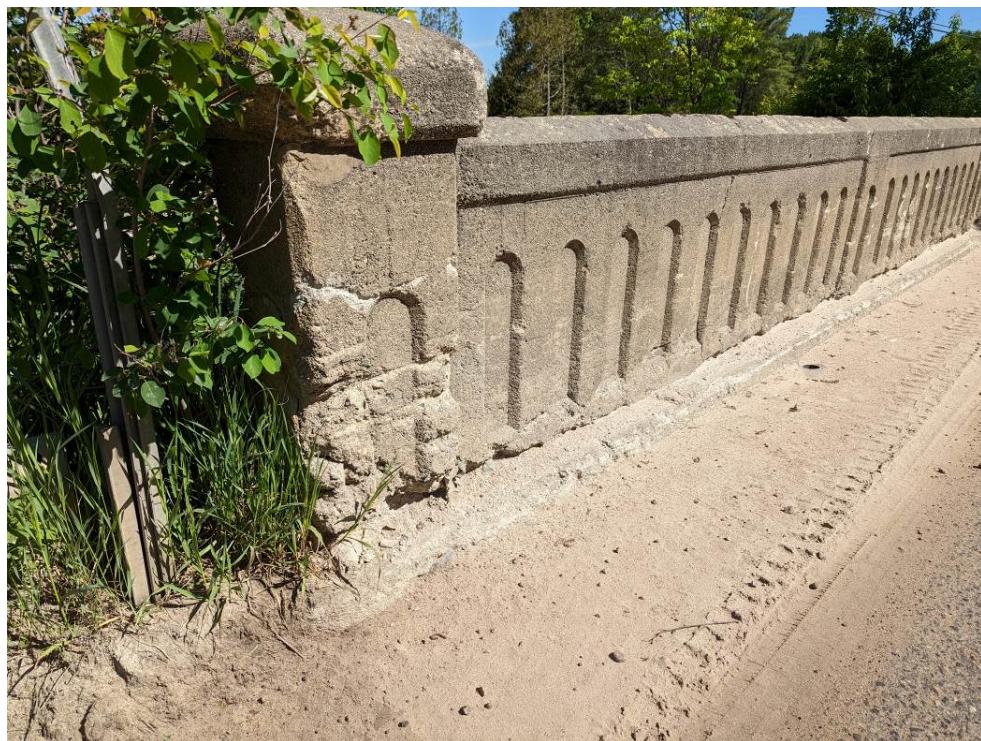
Photo 10 Moderate to severe scaling along base of north parapet wall

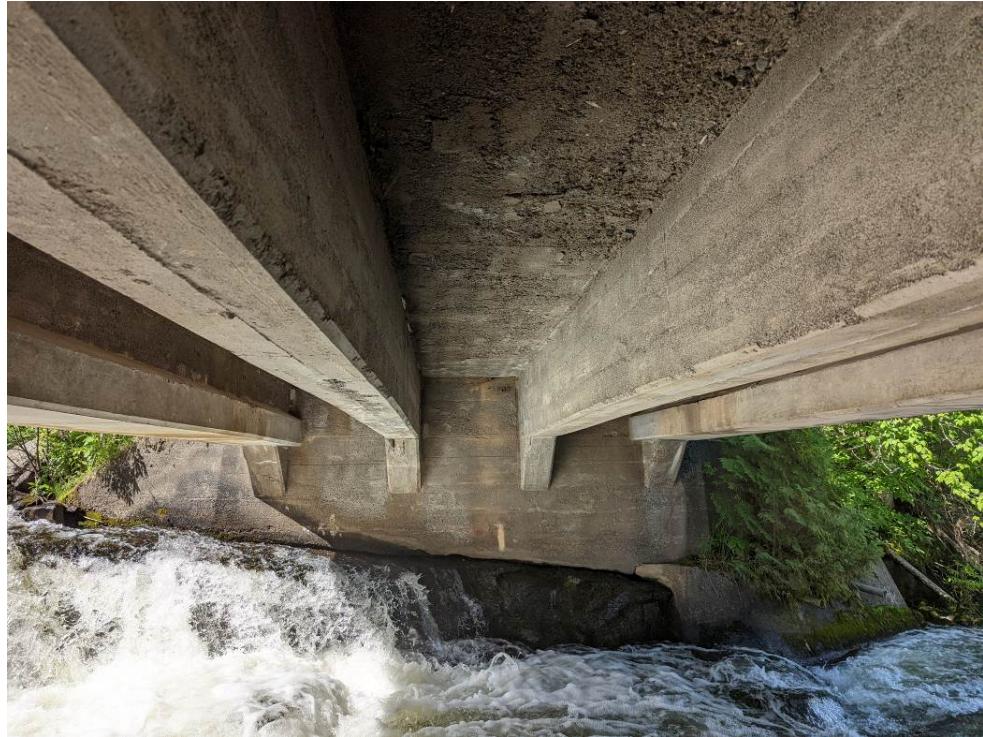
Photo 15 West underside of Structure

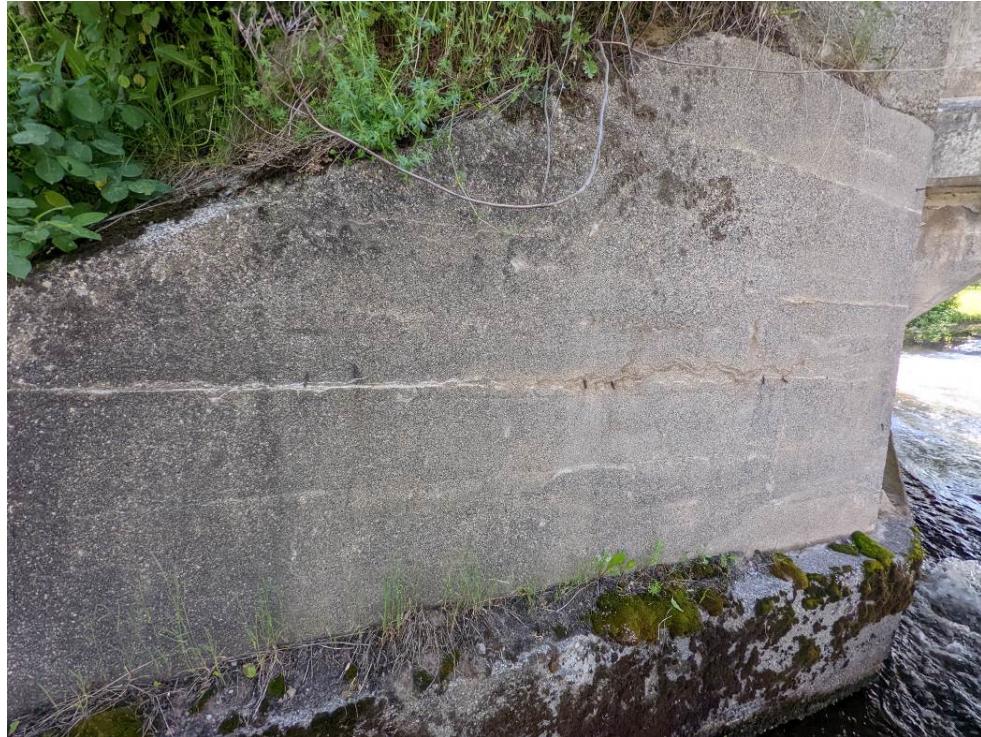
Photo 17 Narrow longitudinal and transverse cracks, damp stains and moos grown at wingwalls (Typical)

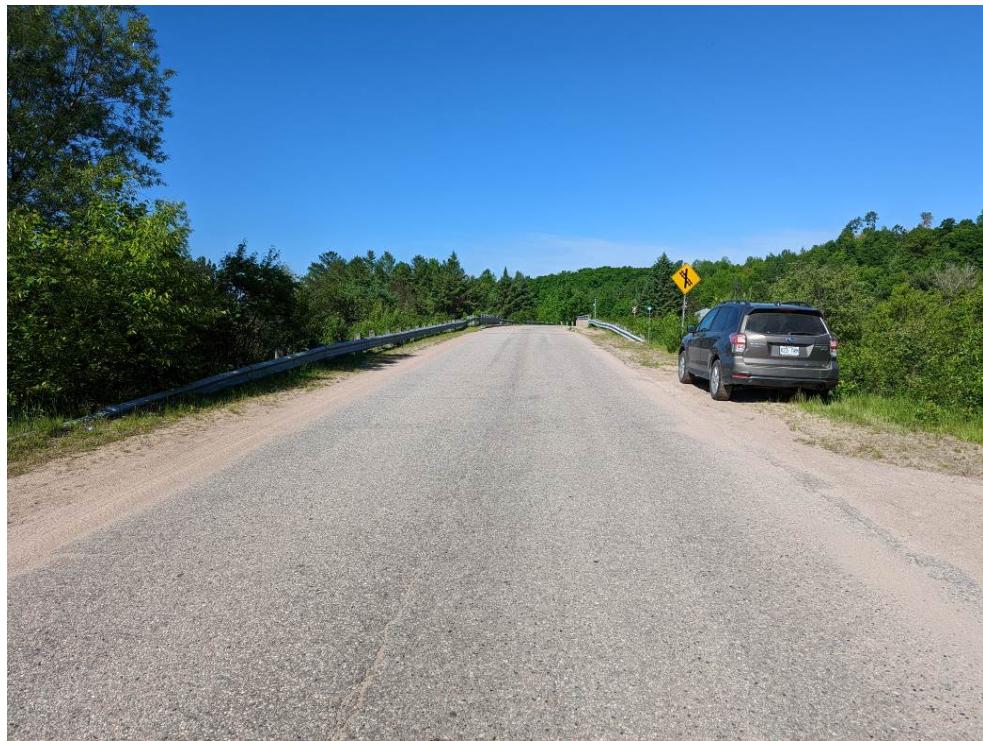
Photo 1 Structure from east approach

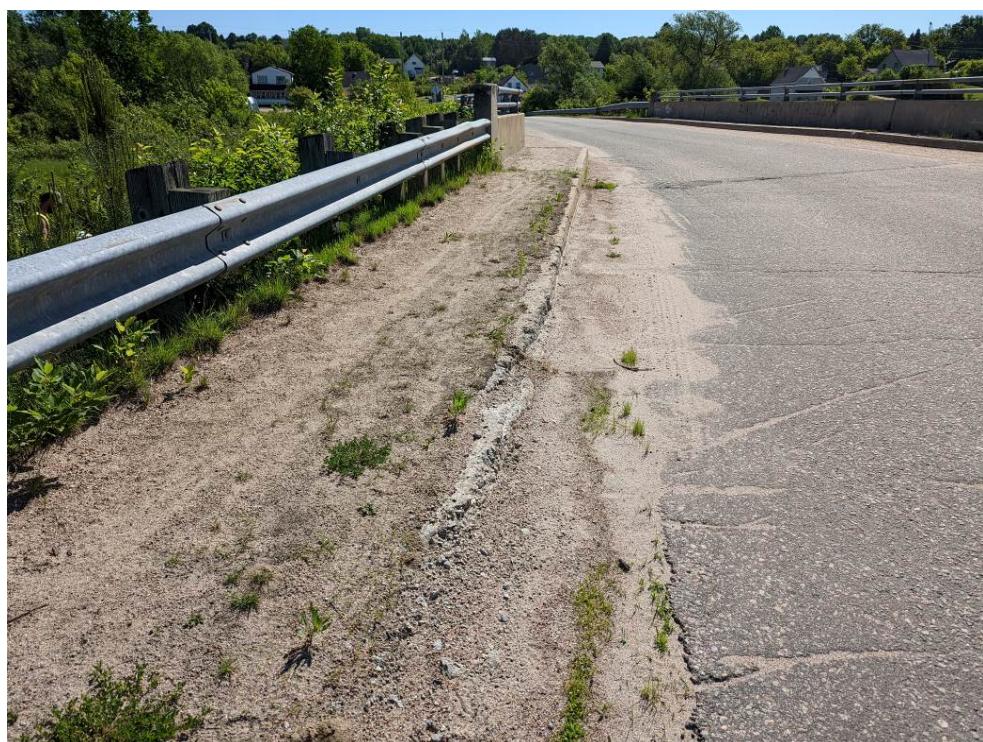
Photo 2 Structure from west approach

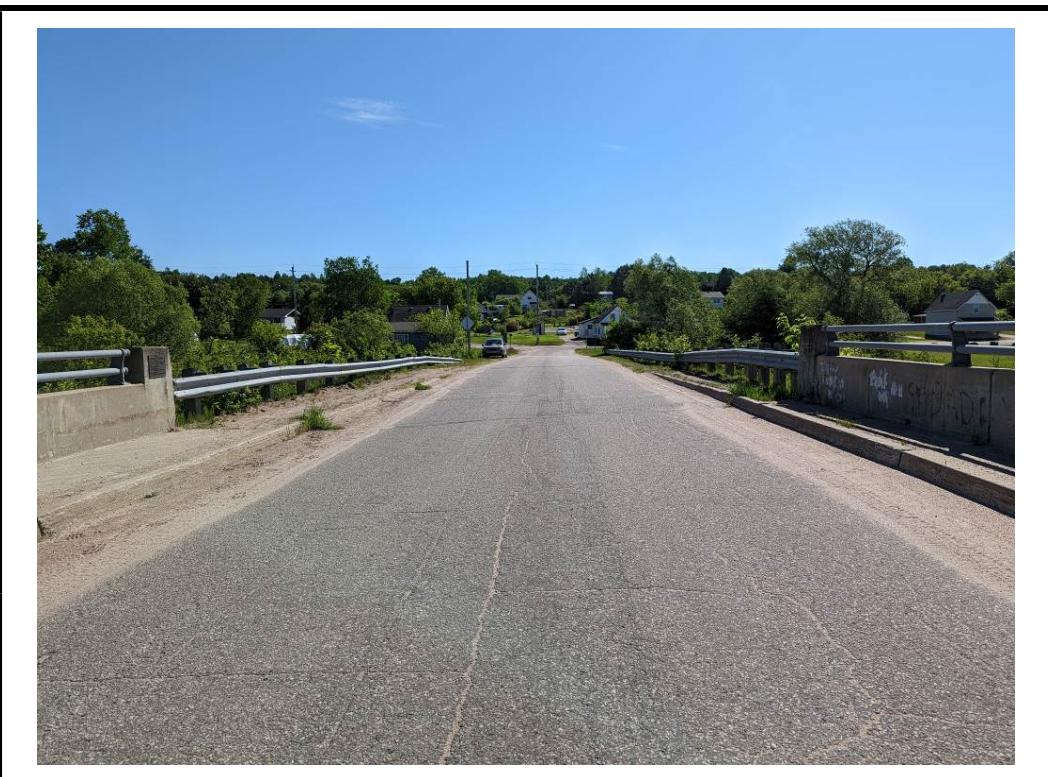
Photo 3 East approach from centre of structure

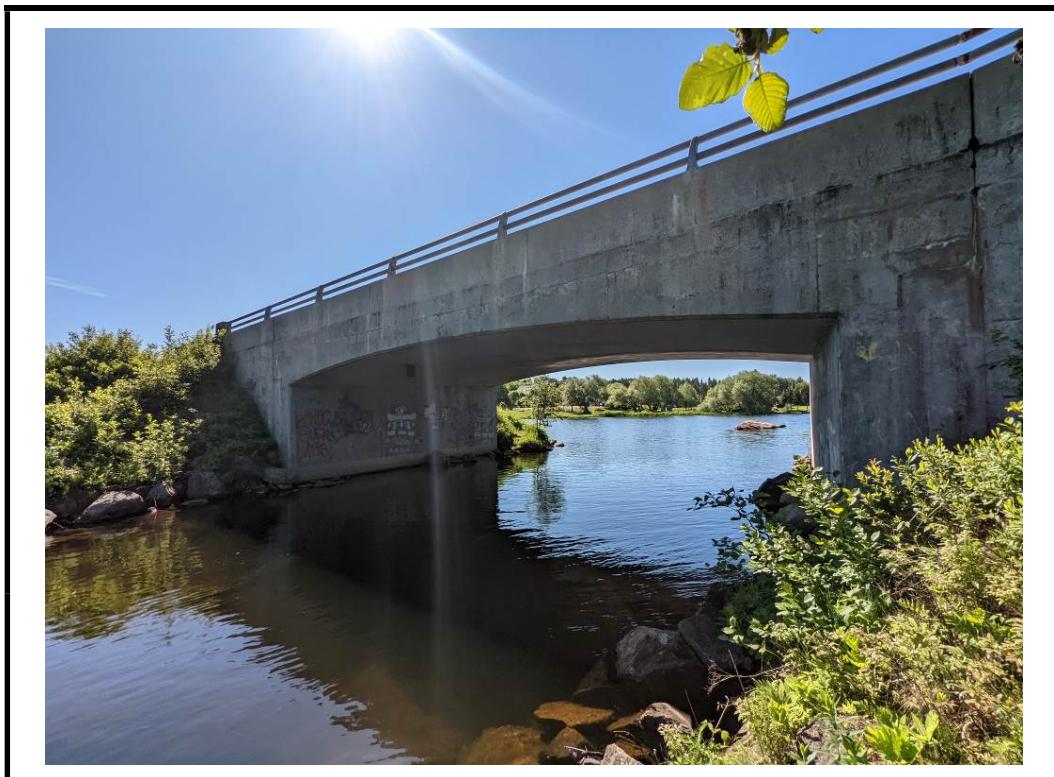
Photo 5 North elevation

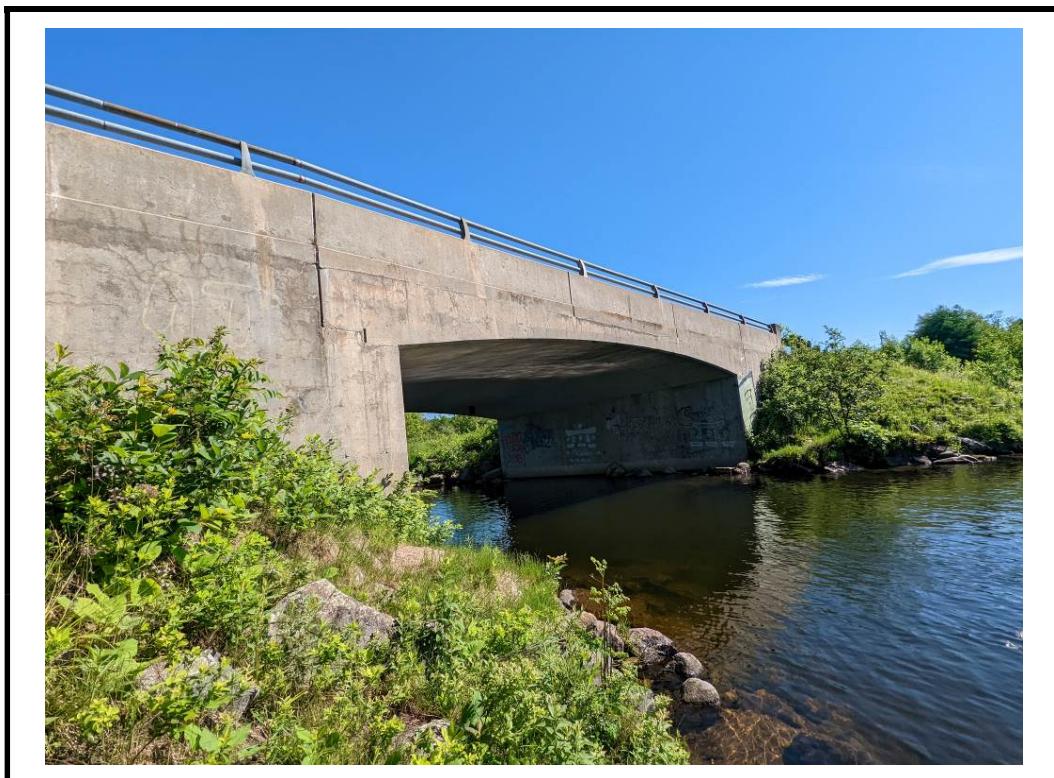
Photo 6 South elevation

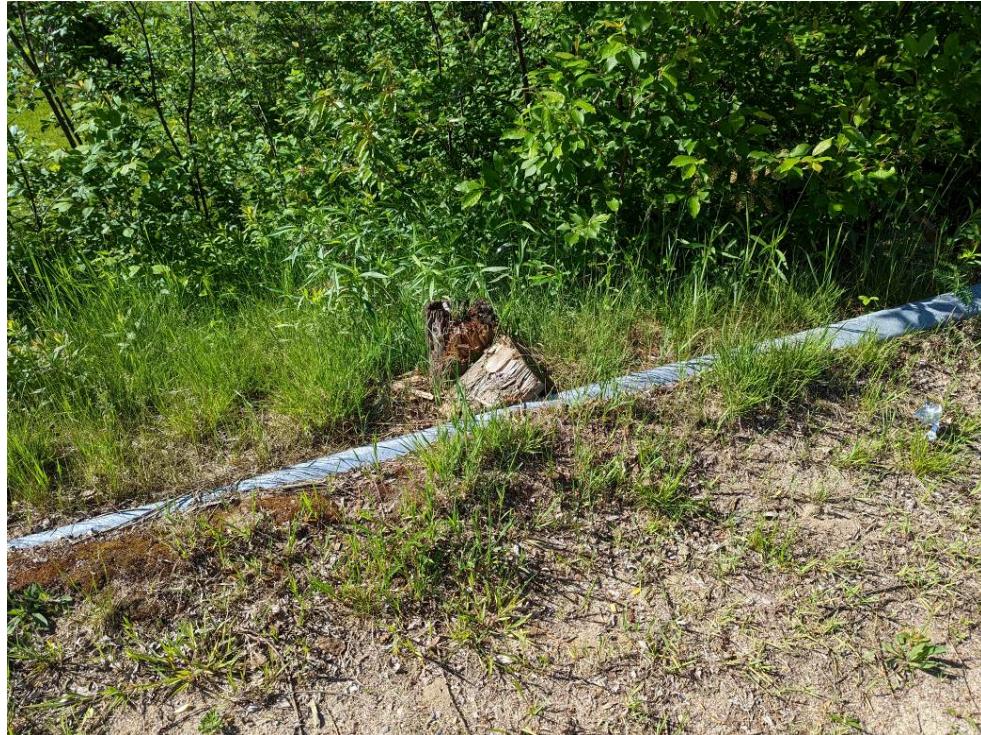
Photo 7 Typical buried end treatment and rotted post at southeast corner

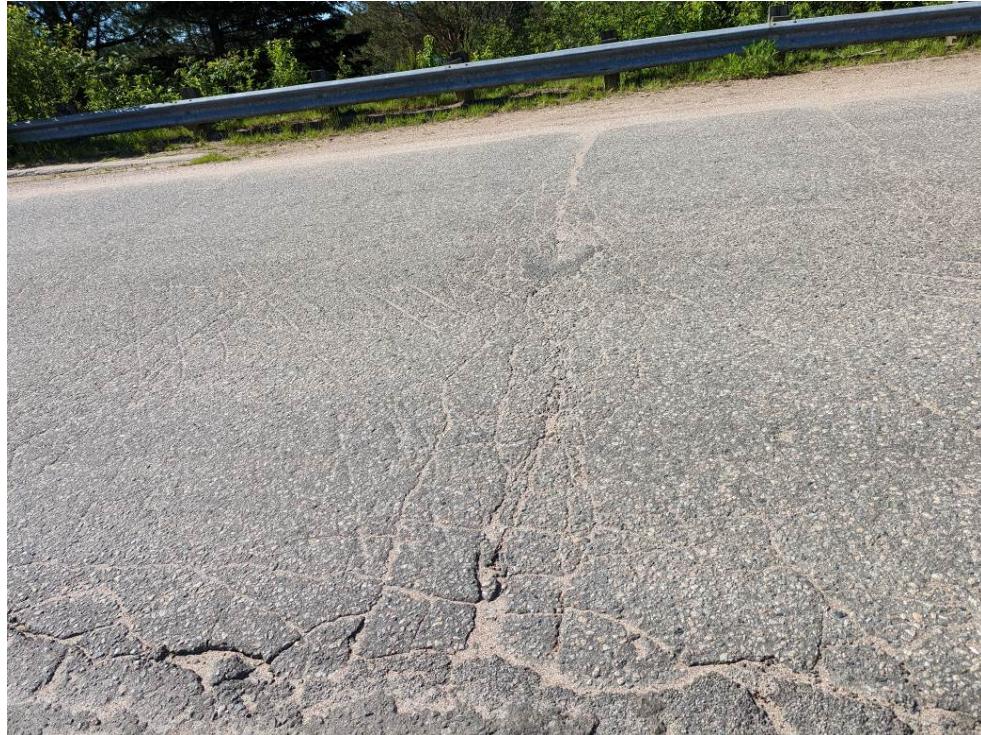
Photo 9 Medium transverse cracks with potholes in west approach

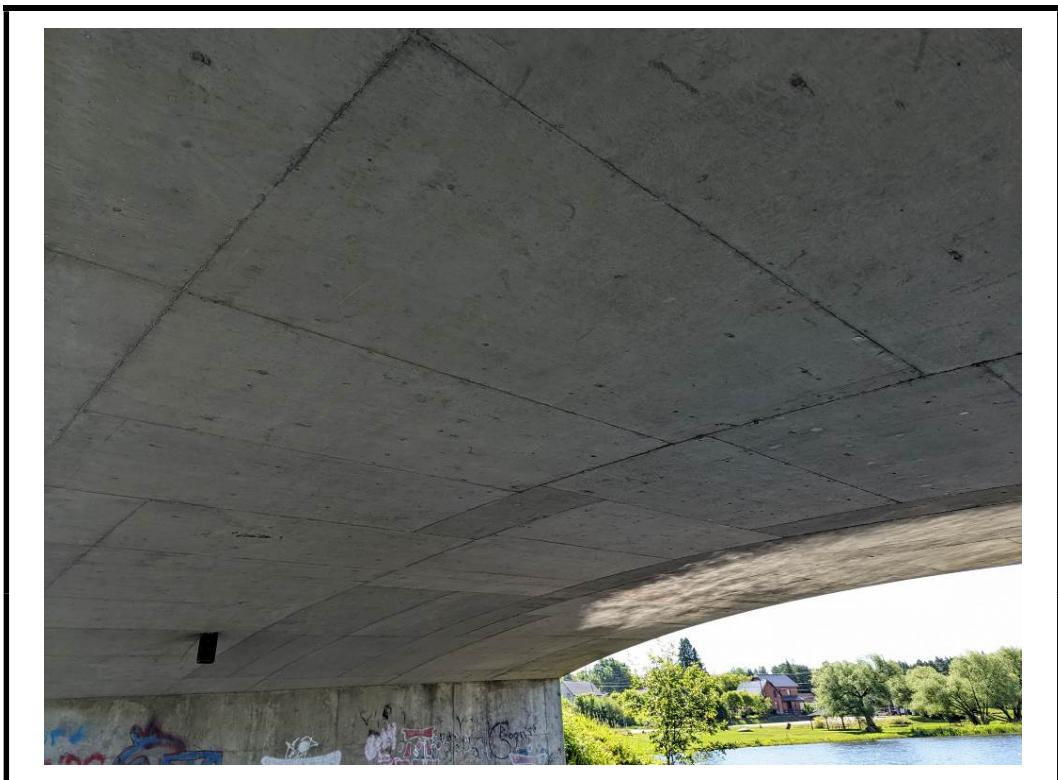
Photo 15 Typical deck soffit

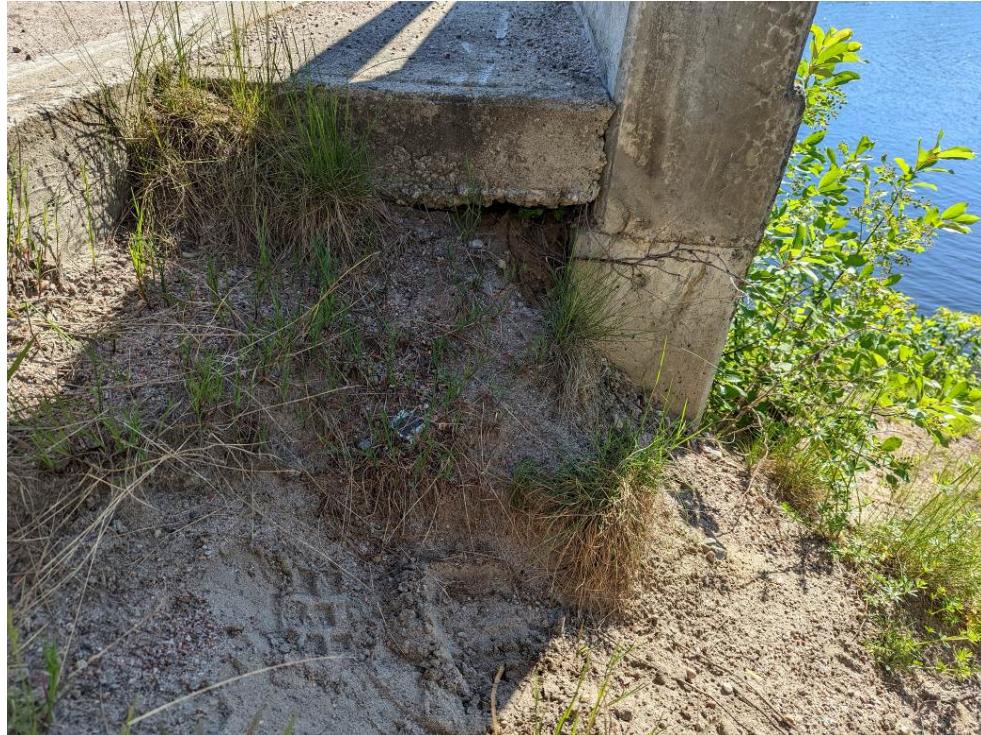
Photo 17 Minor washout noted at southwest corner near deck end

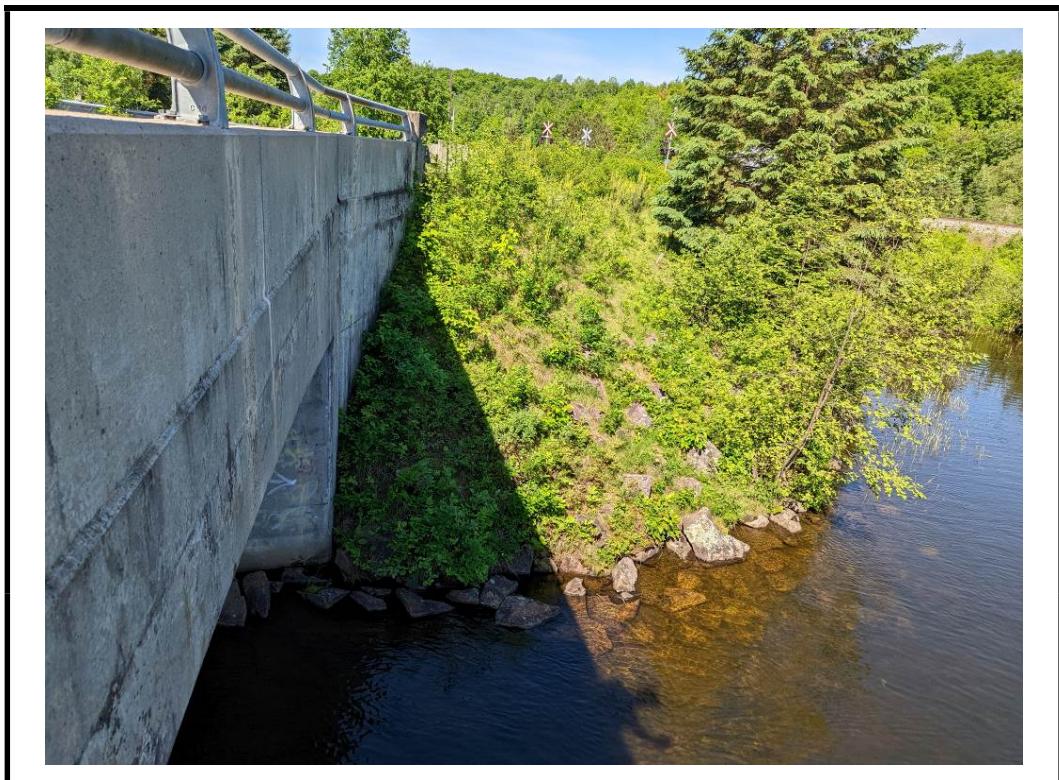
Photo 19 Typical northwest embankment with rock protection at base

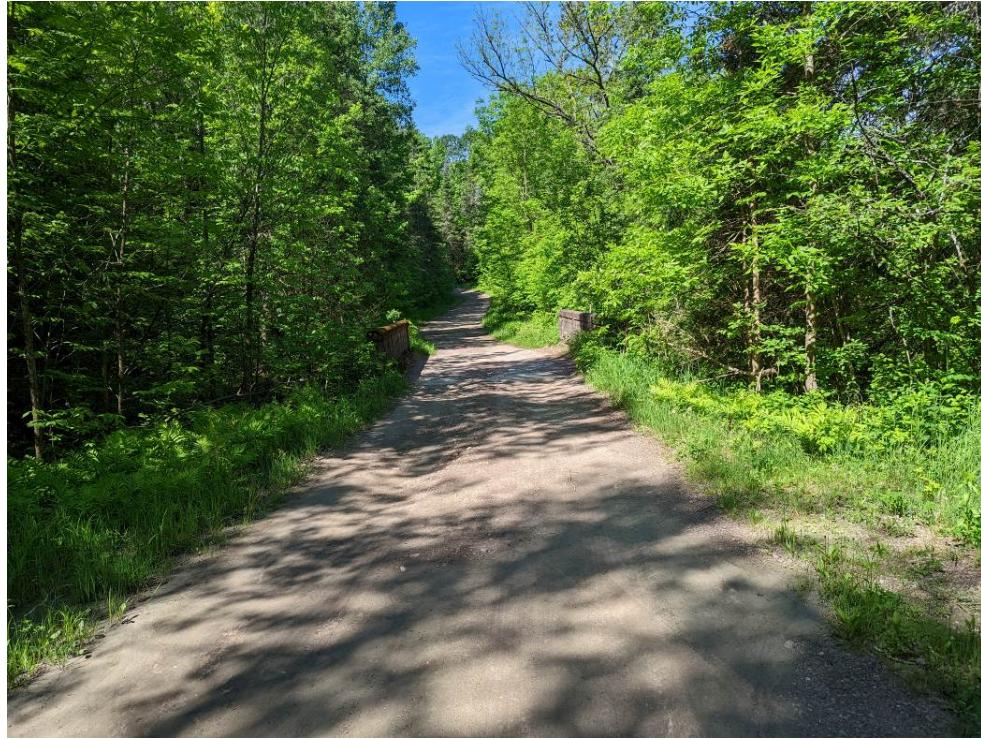
Photo 1 Structure from east approach

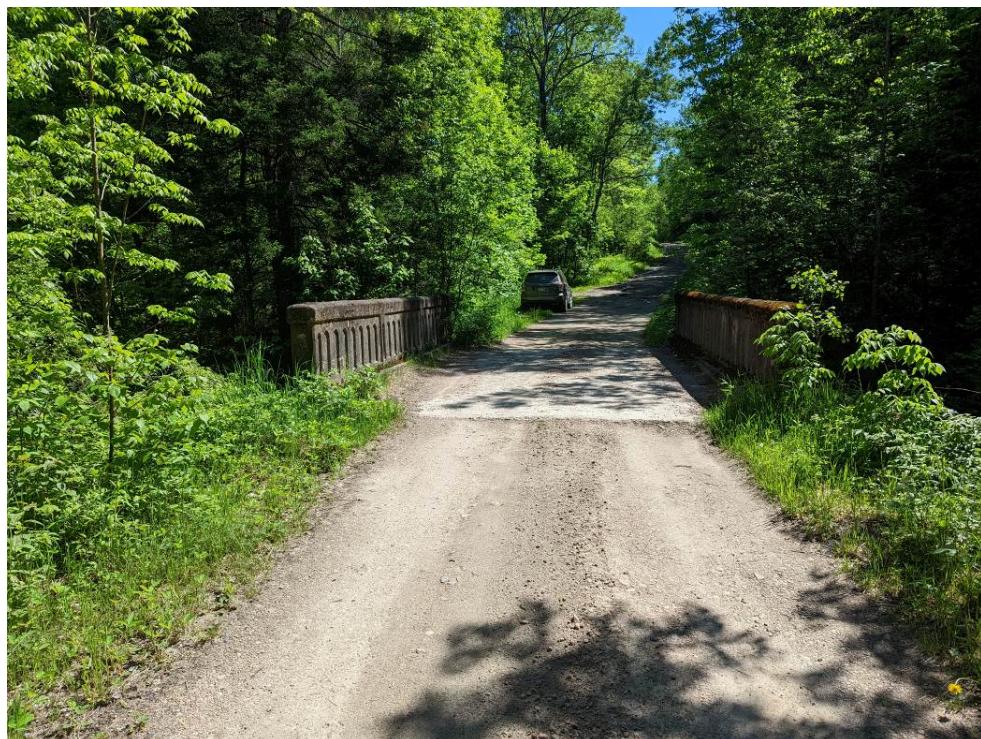
Photo 2 Structure from west approach

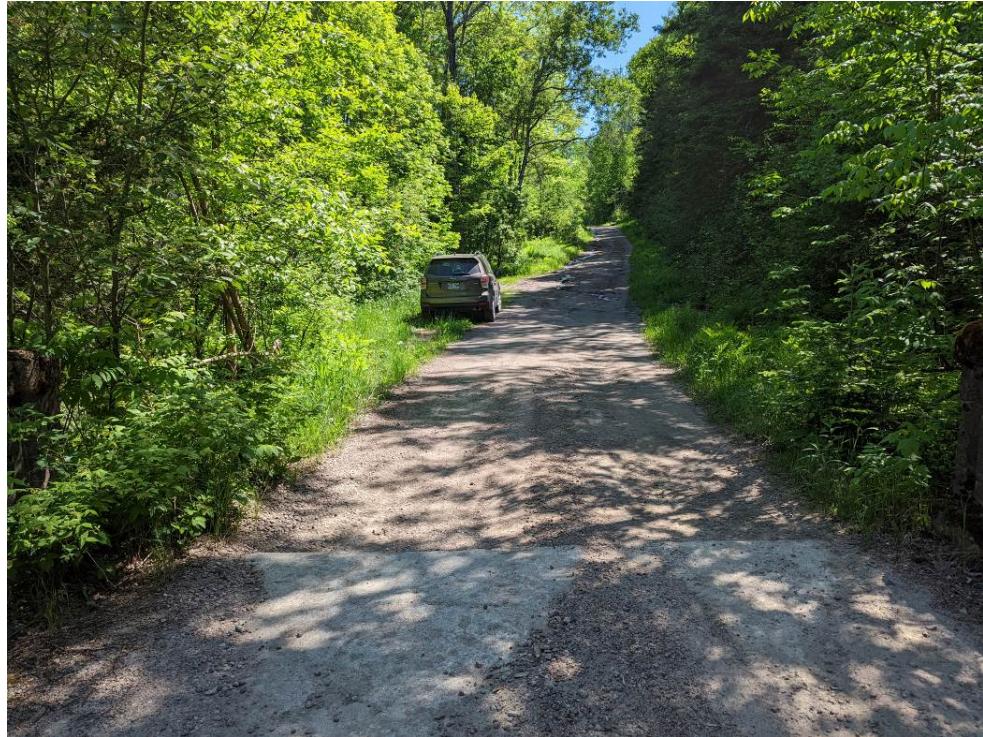
Photo 3 East approach from centre of structure

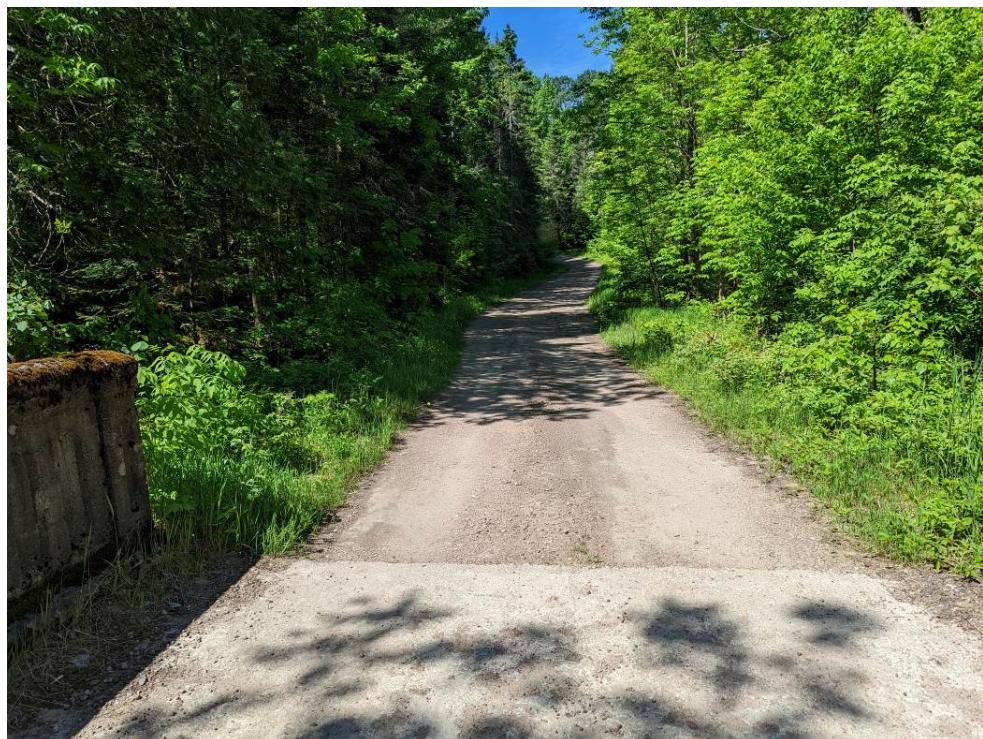
Photo 4 West approach from centre of structure

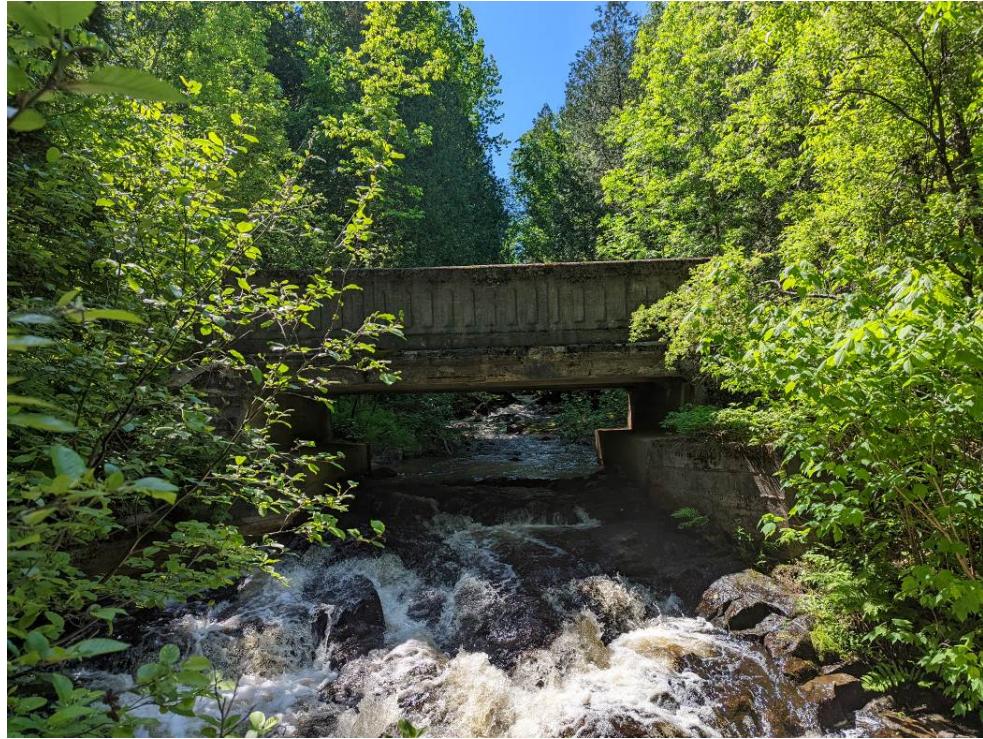
Photo 5 North elevation

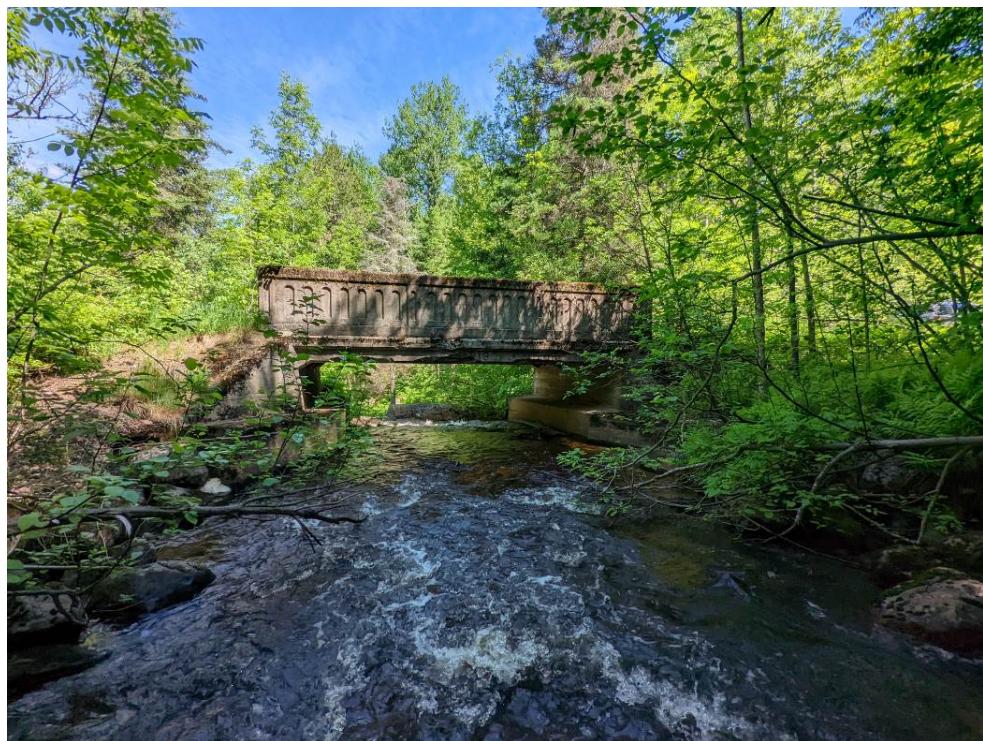
Photo 6 South elevation

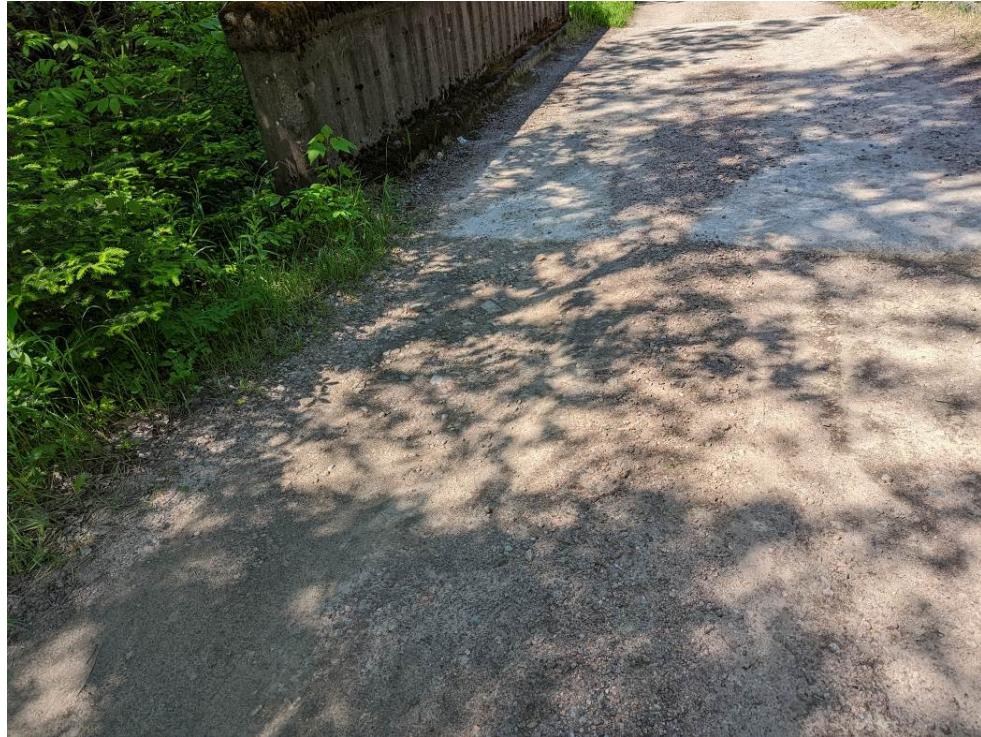
Photo 7 Large potholes on east approach.

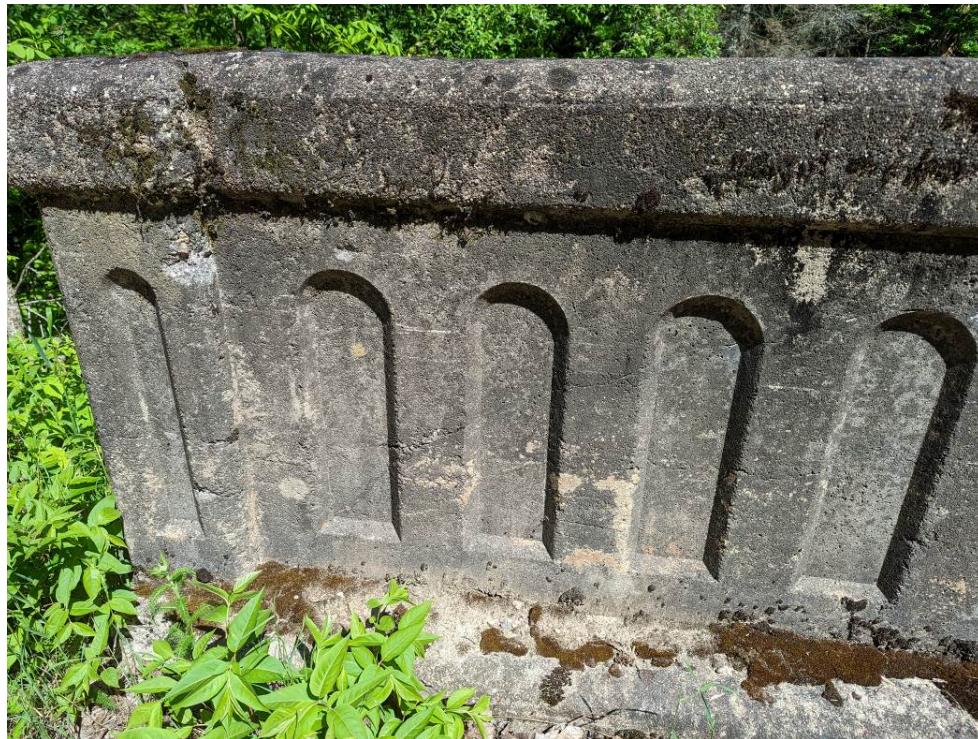
Photo 9 Light to moderate scaling and discoloration noted on parapet wall

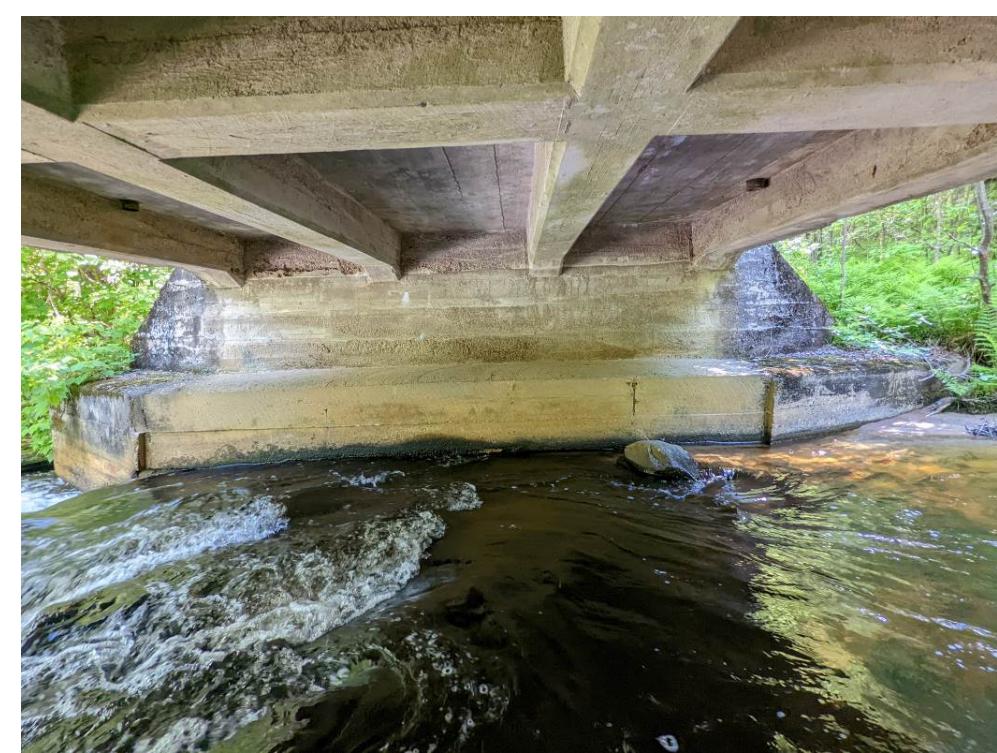
Photo 13 Typical east underside of structure

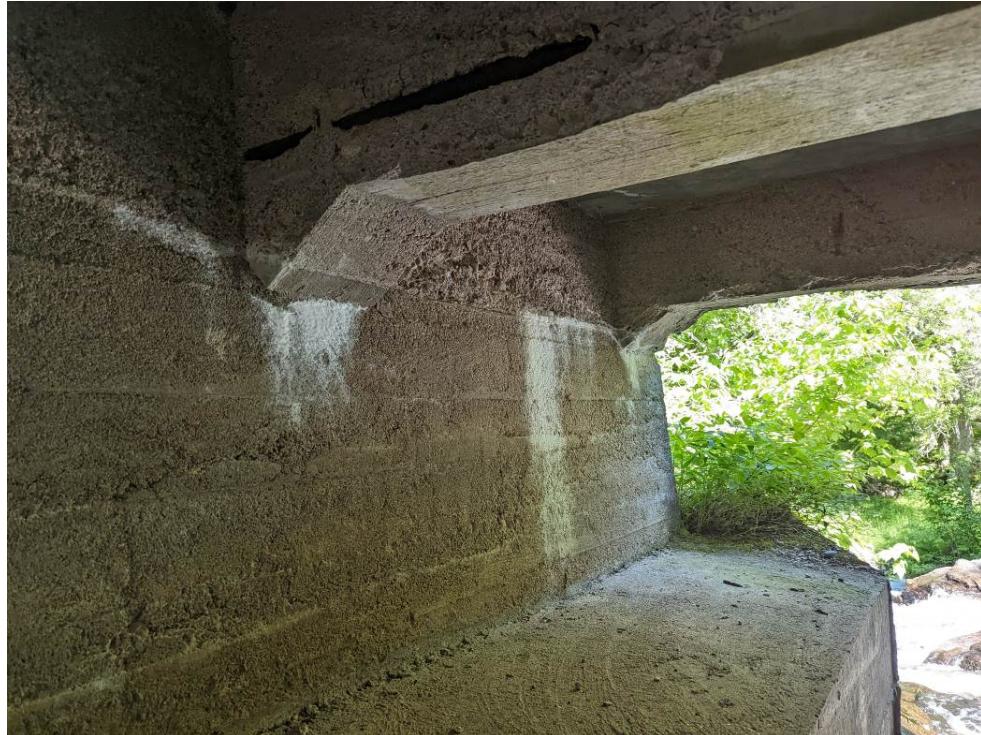
Photo 15 Moderate scaling and efflorescence stains noted on abutment wall
