THE TOWNSHIP OF BONFIELD

BRIDGE MANAGEMENT STUDY REPORT (DRAFT)

6 BRIDGES / 10 CULVERTS

DECEMBER 2022

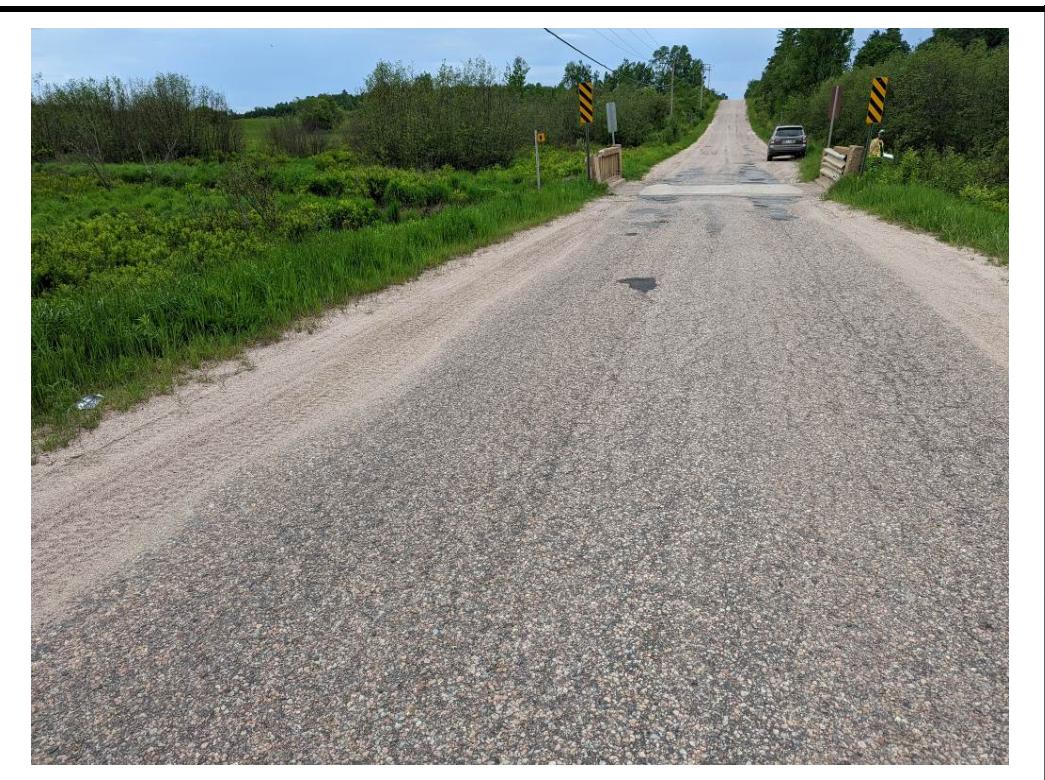
Photo 1 Structure from east approach

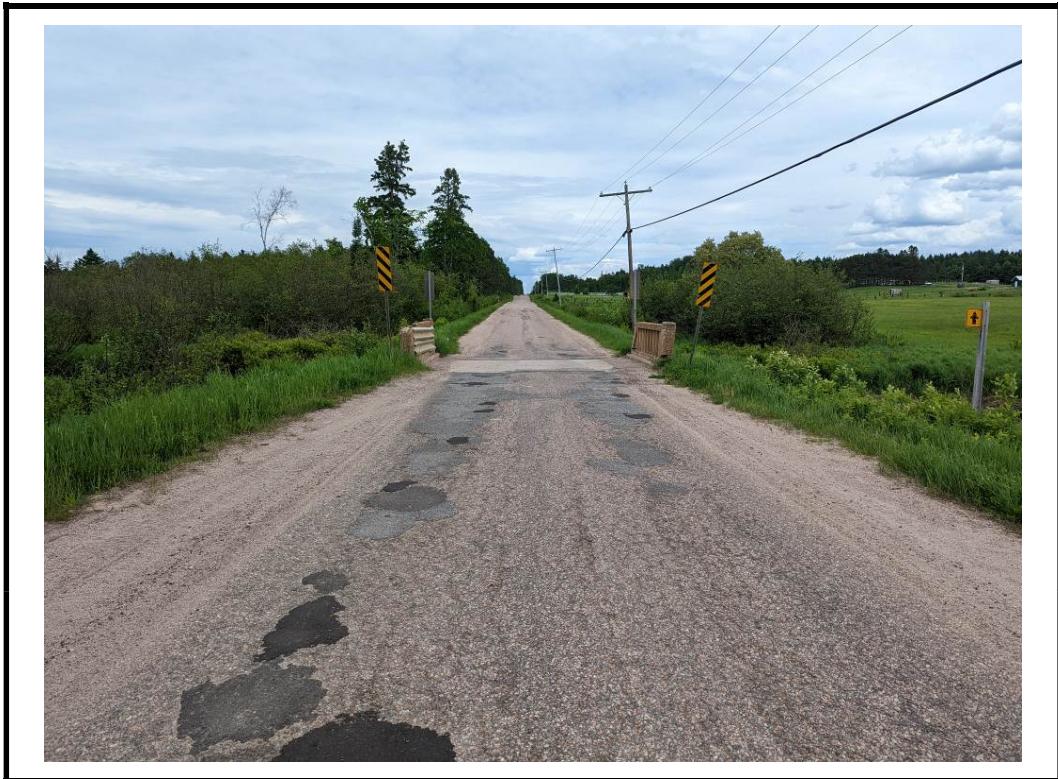
Photo 2 Structure from west approach

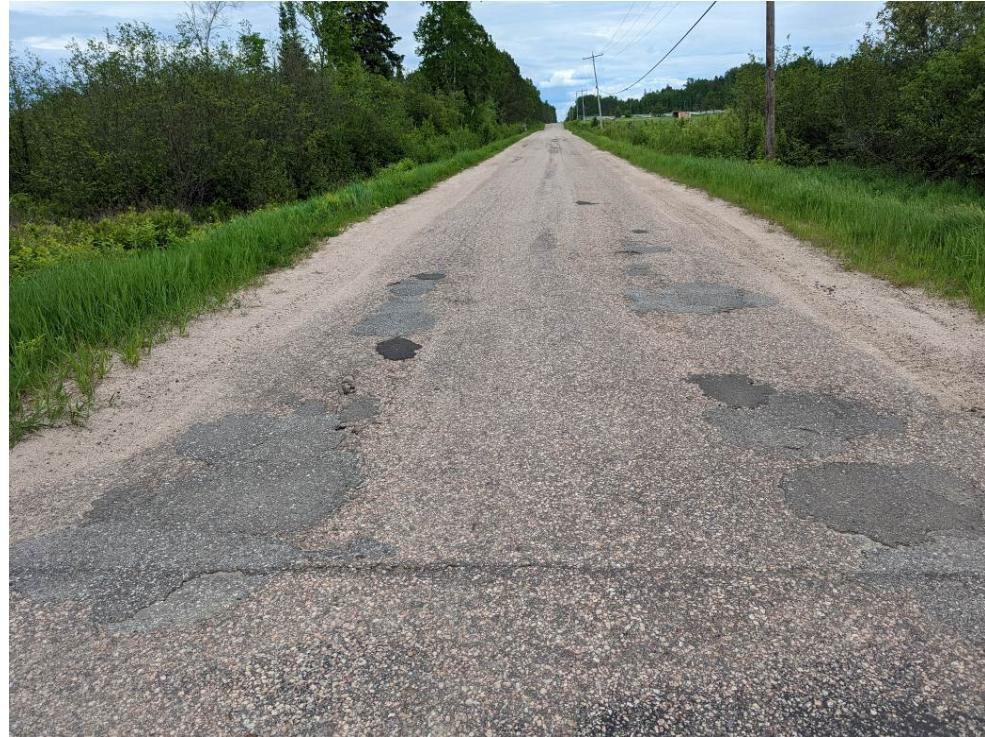
Photo 3 East approach from centre of structure

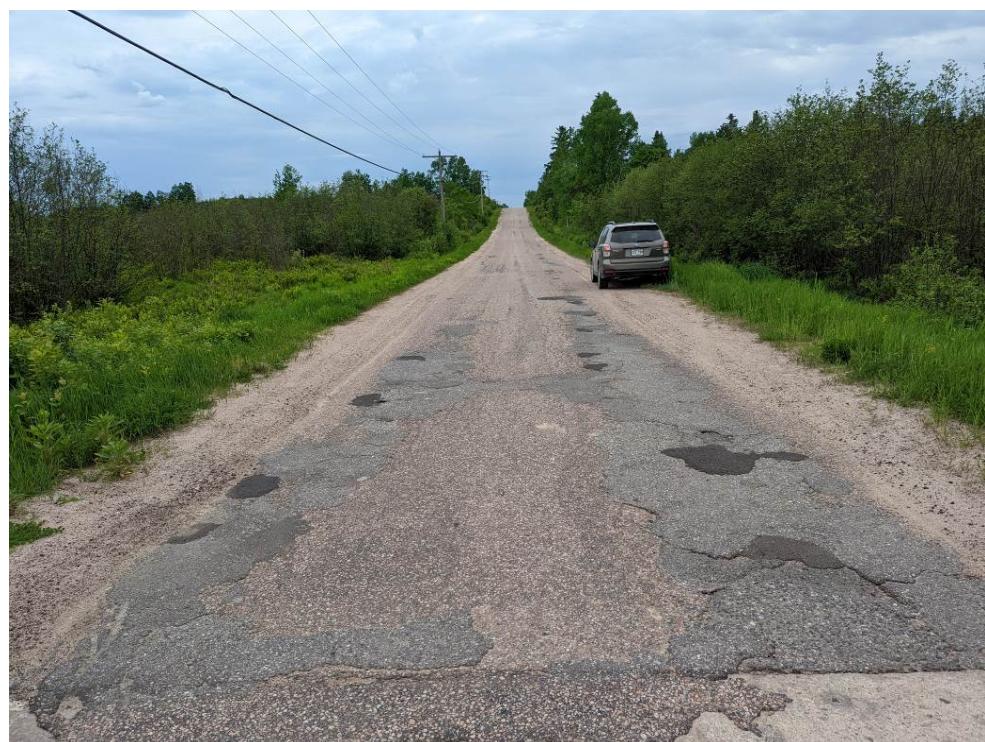
Photo 4 West approach from centre of structure

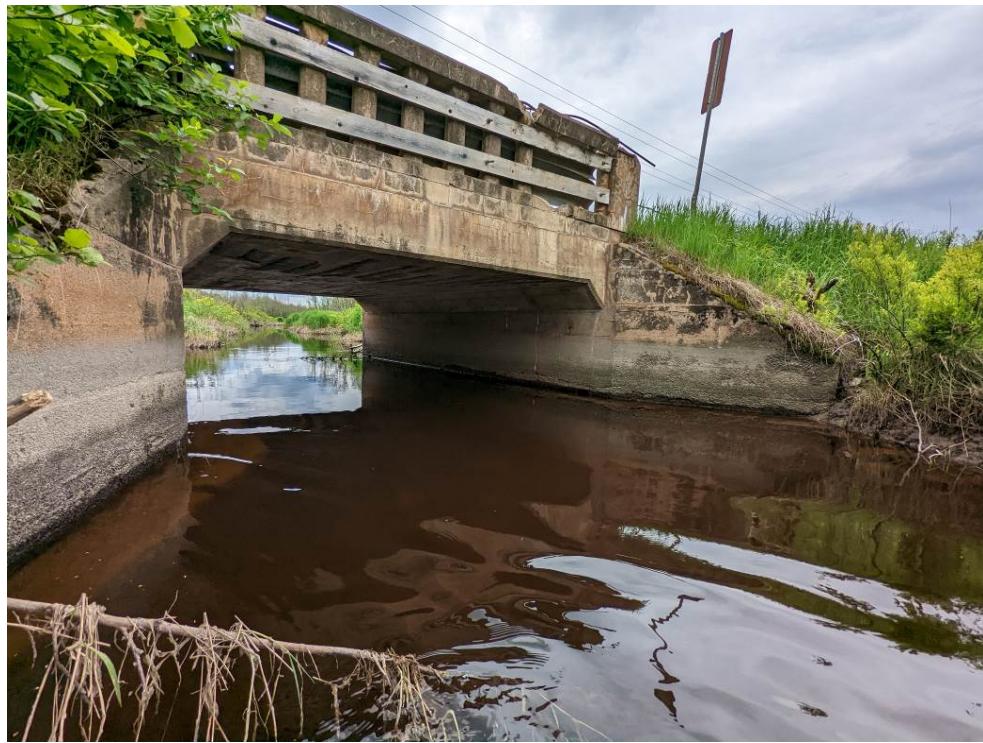
Photo 5 North elevation

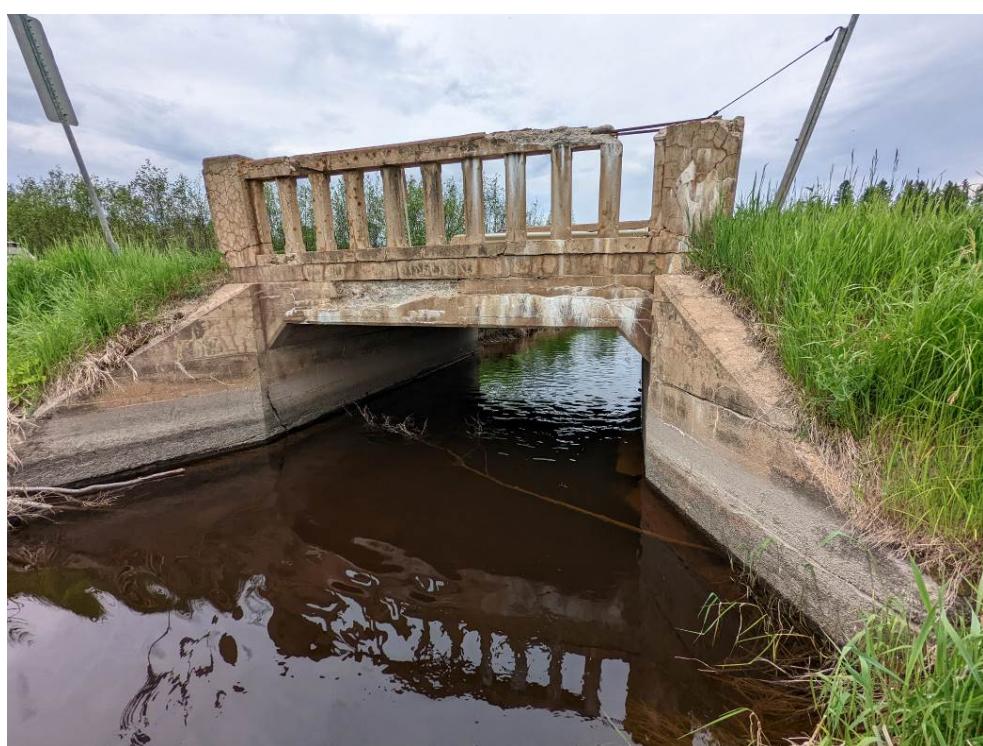
Photo 6 South elevation

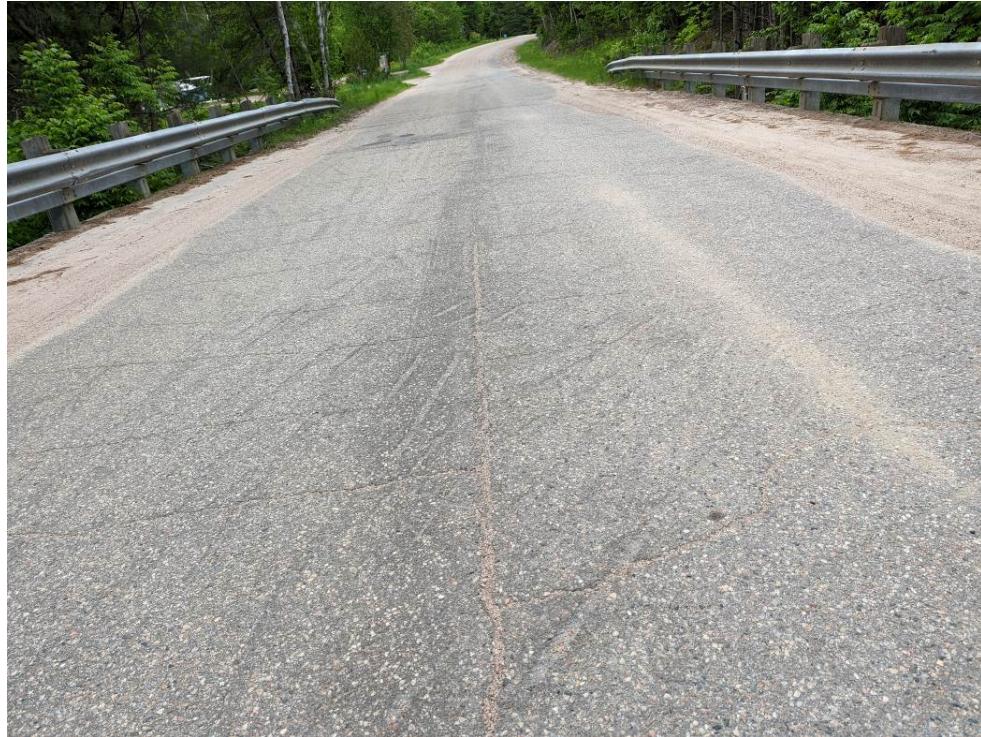
Photo 7 Wide longitudinal and transverse cracks noted on wearing surface

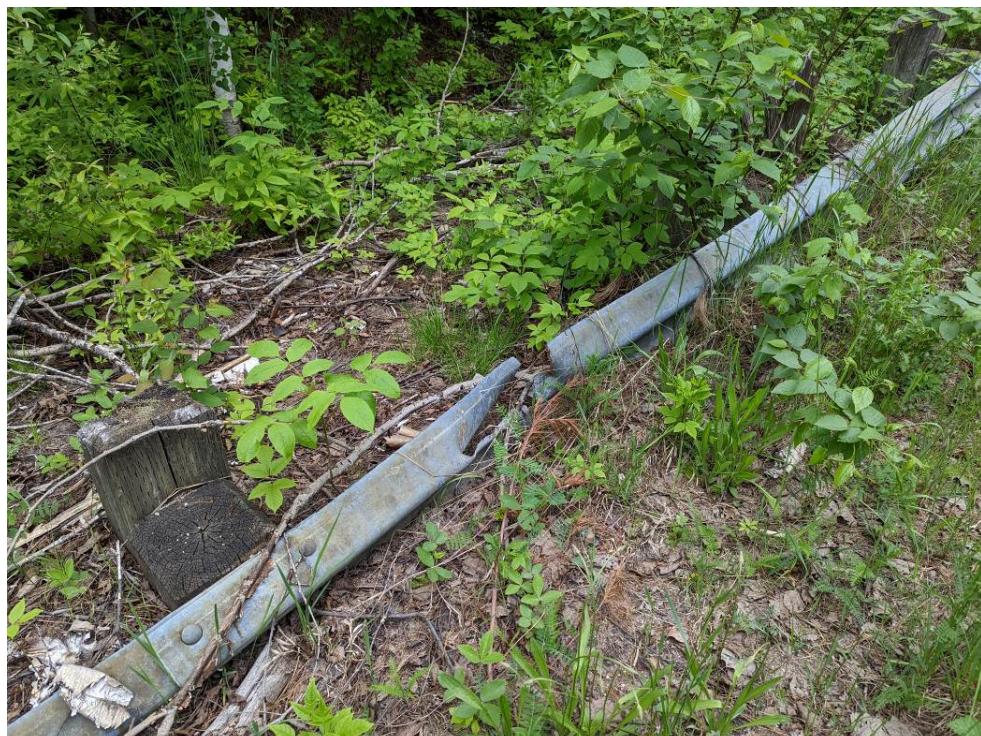
Photo 8 Damage observed on steel beam at southwest corner

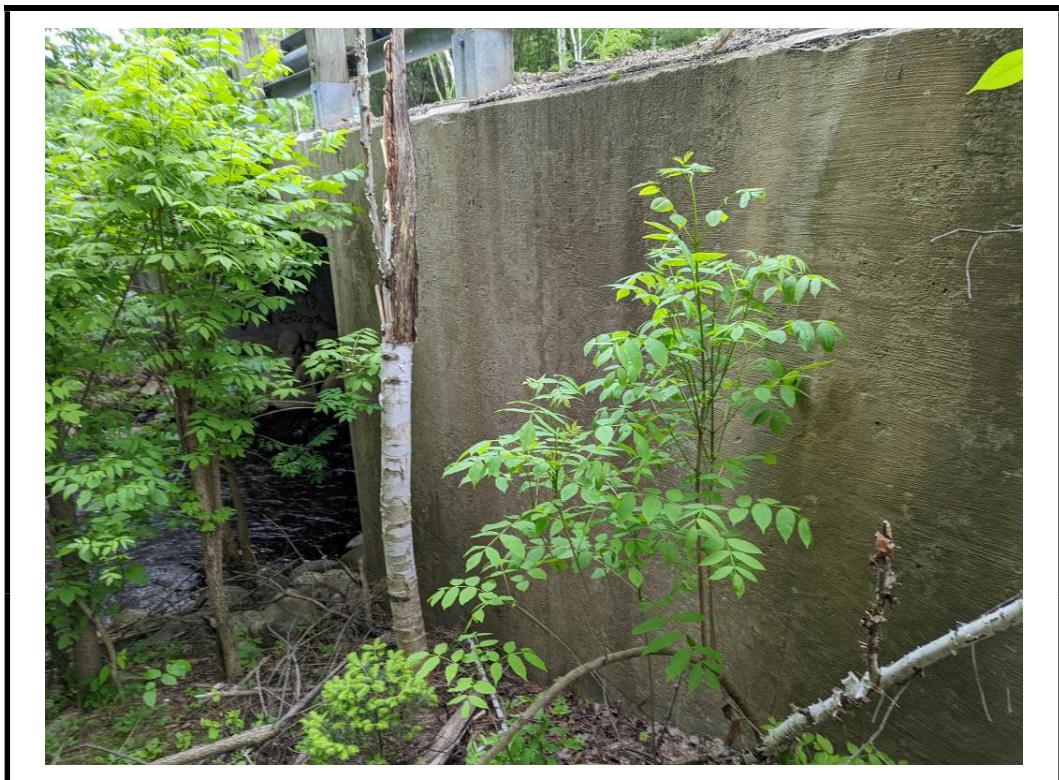
Photo 11 Typical northeast wingwall

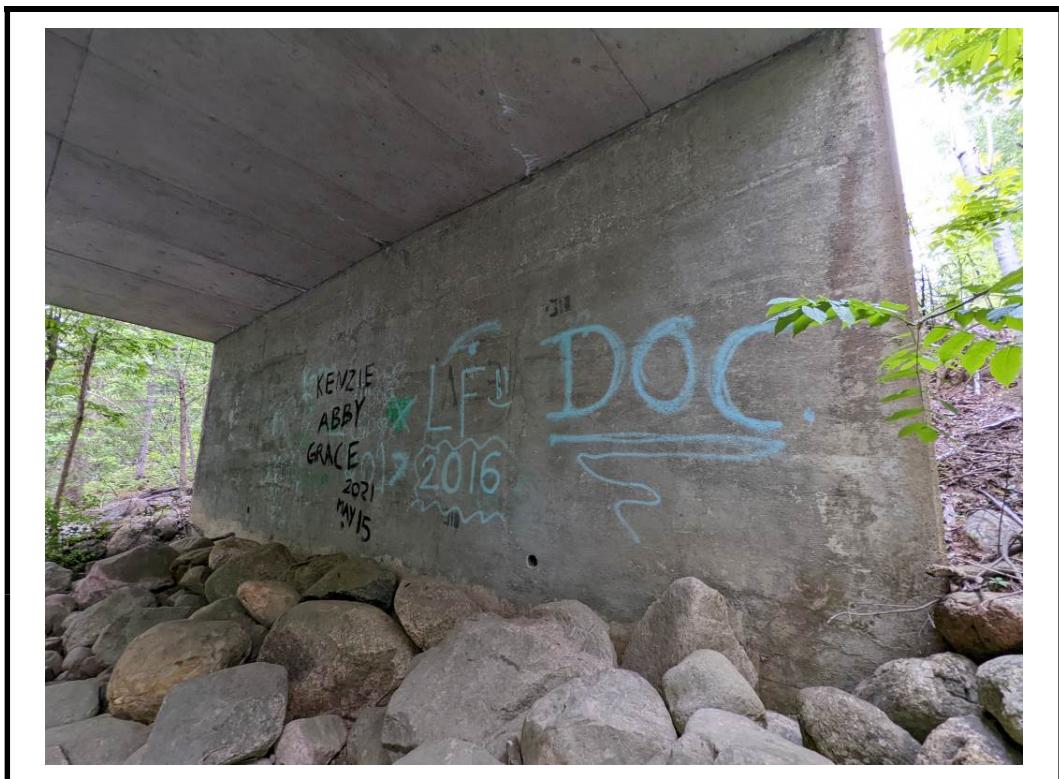
Photo 12 Typical north abutment wall

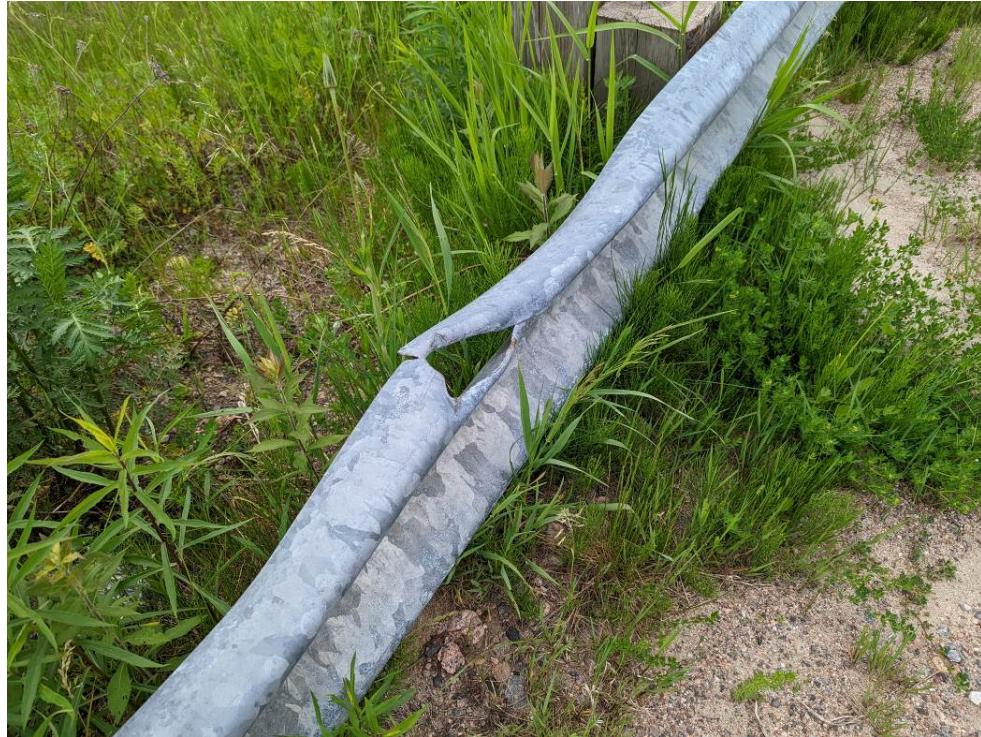
Photo 7 Collision damage noted on approach barrier at northeast corner

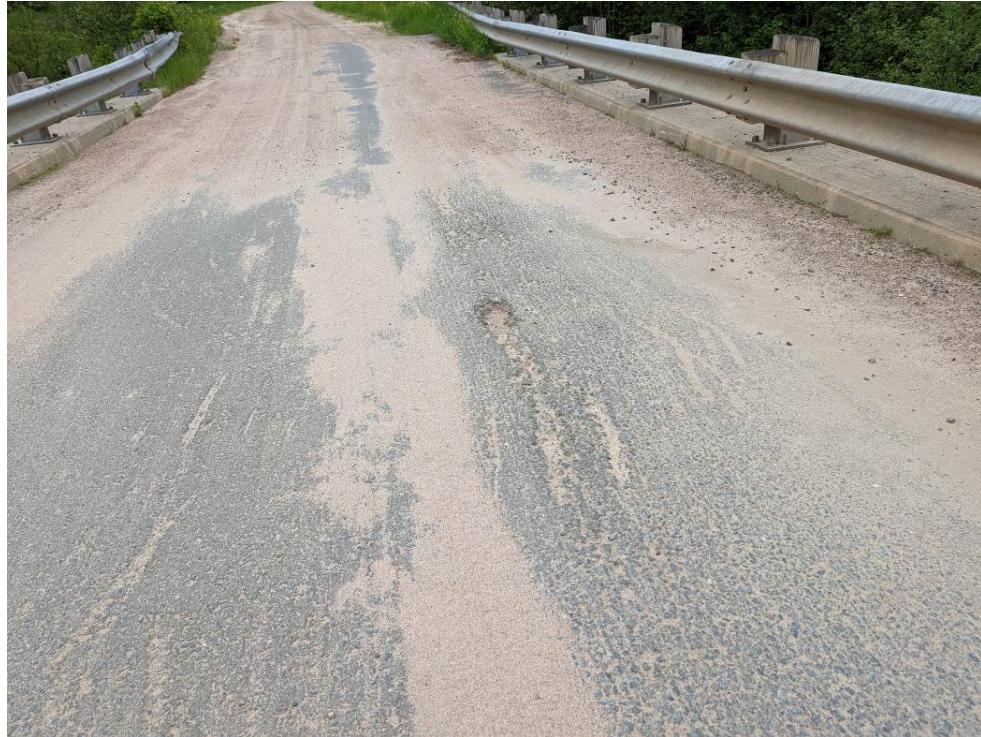
Photo 11 Minor scaling and small gouges noted in middle of deck wearing surface

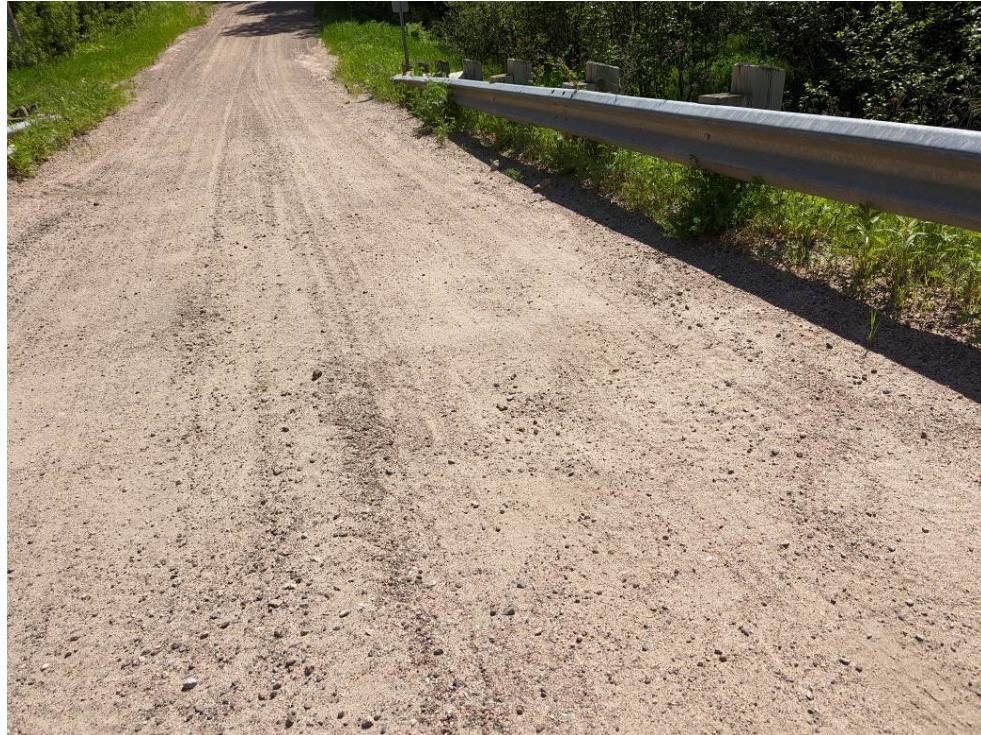
Photo 7 Tire rutting and loose gravel on east approach.

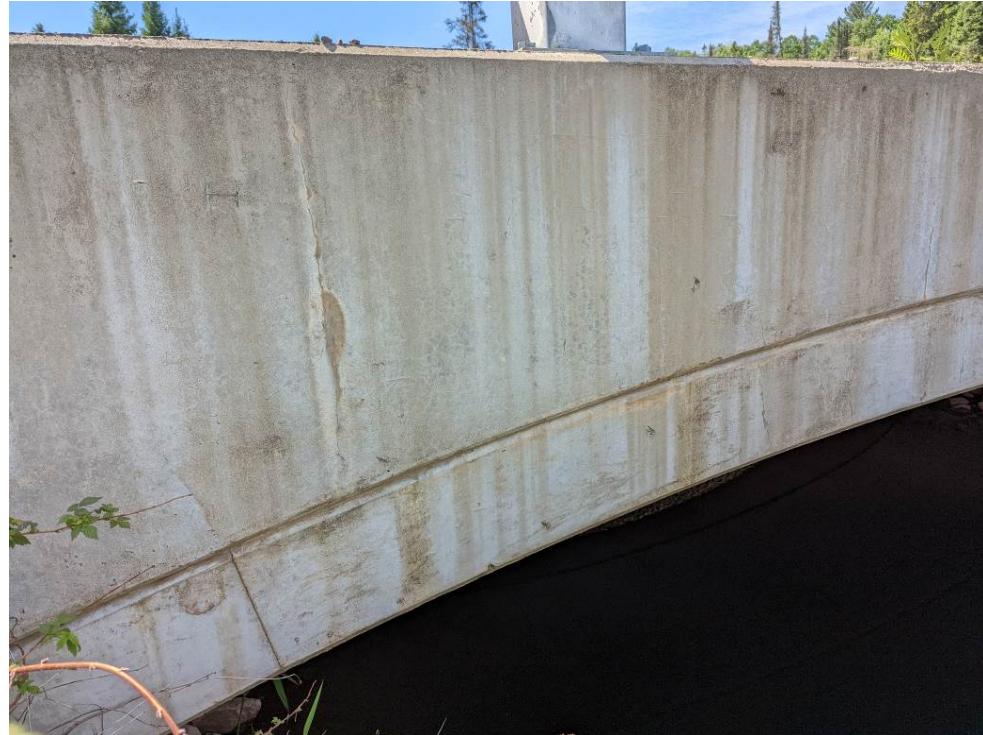
Photo 9 Stained map cracks noted on exterior face of soffit

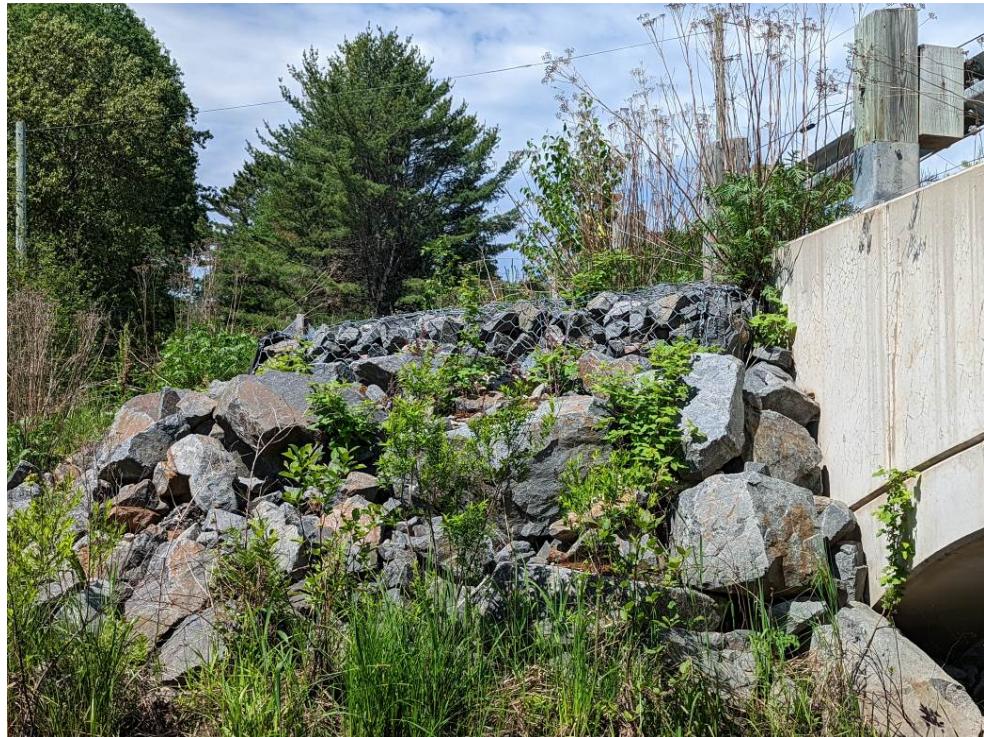
Photo 11 Typical view gabion basket wall and slope protection at southwest corner

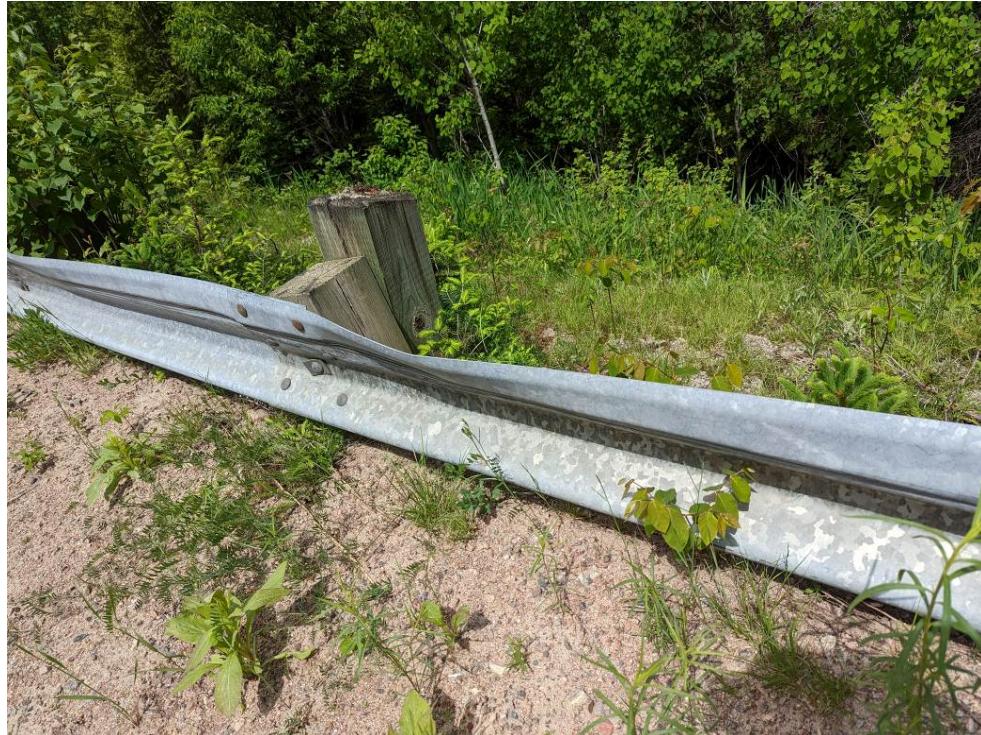
Photo 7 Collision damage noted on steel beam at north barrier

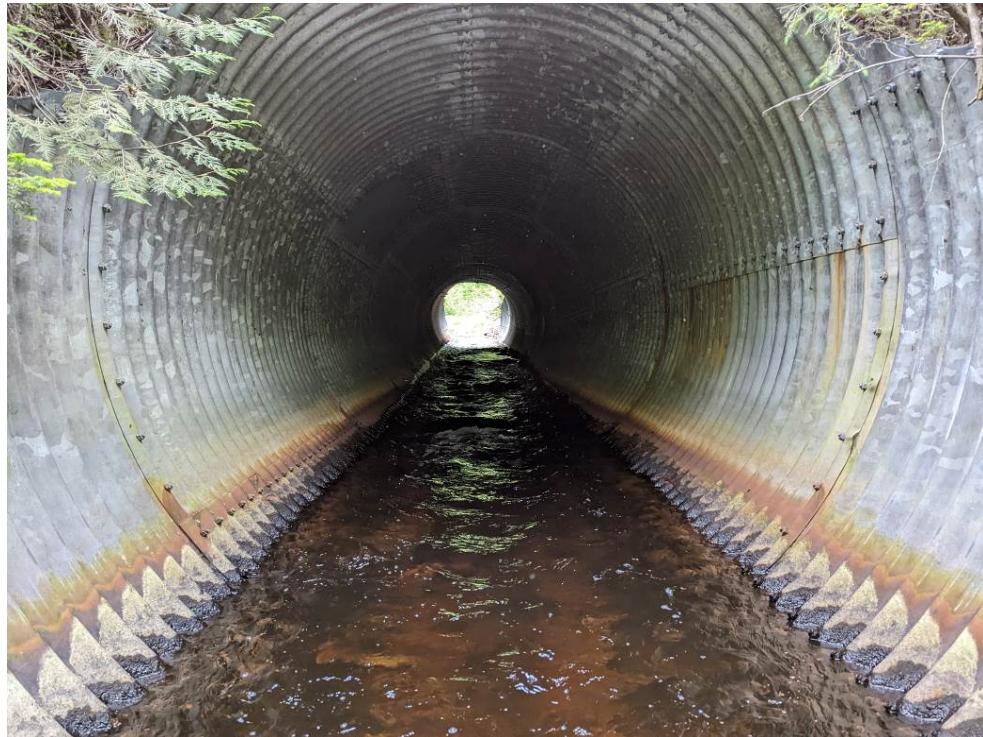
Photo 9 Typical view of interior barrel looking south

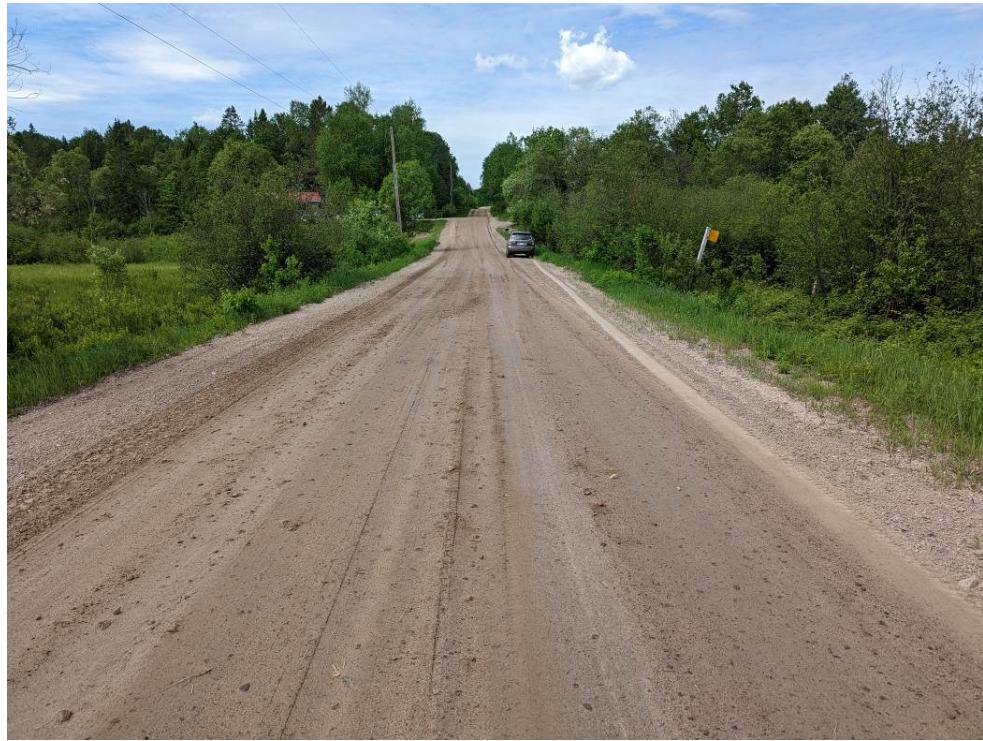
Photo 1 Structure from east approach

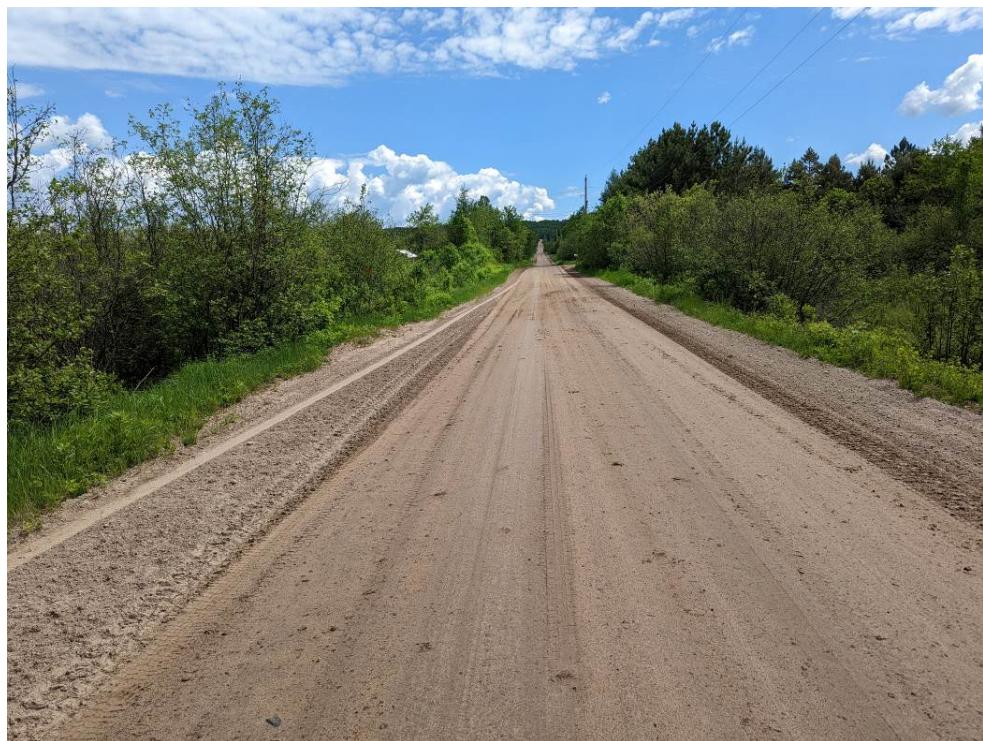
Photo 2 Structure from west approach

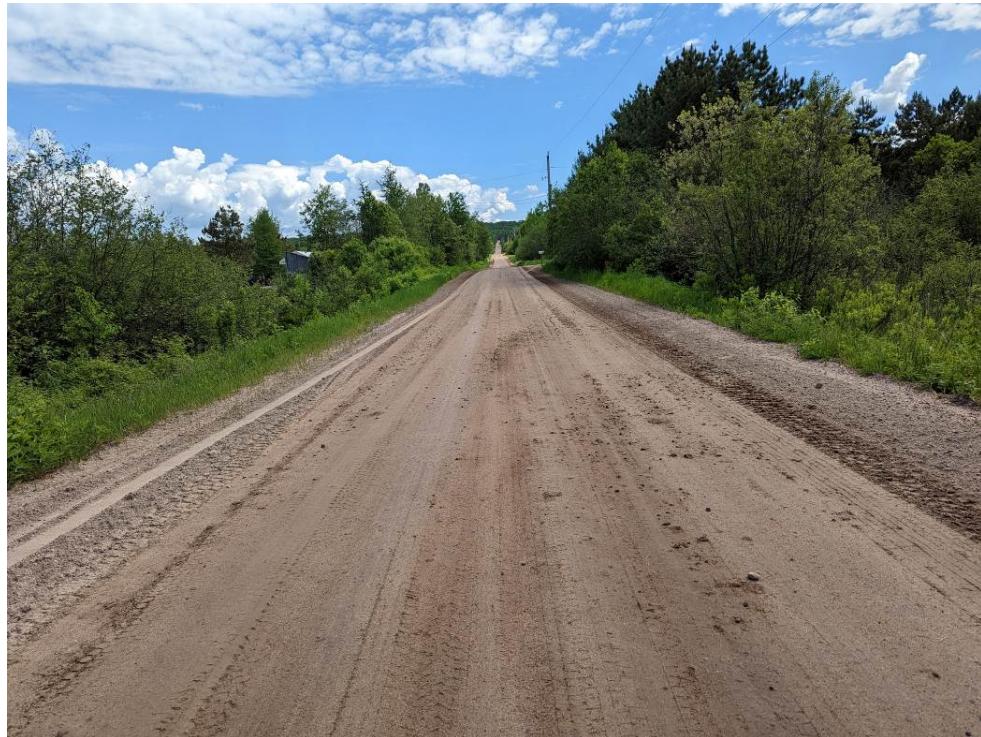
Photo 3 East approach from centre of structure

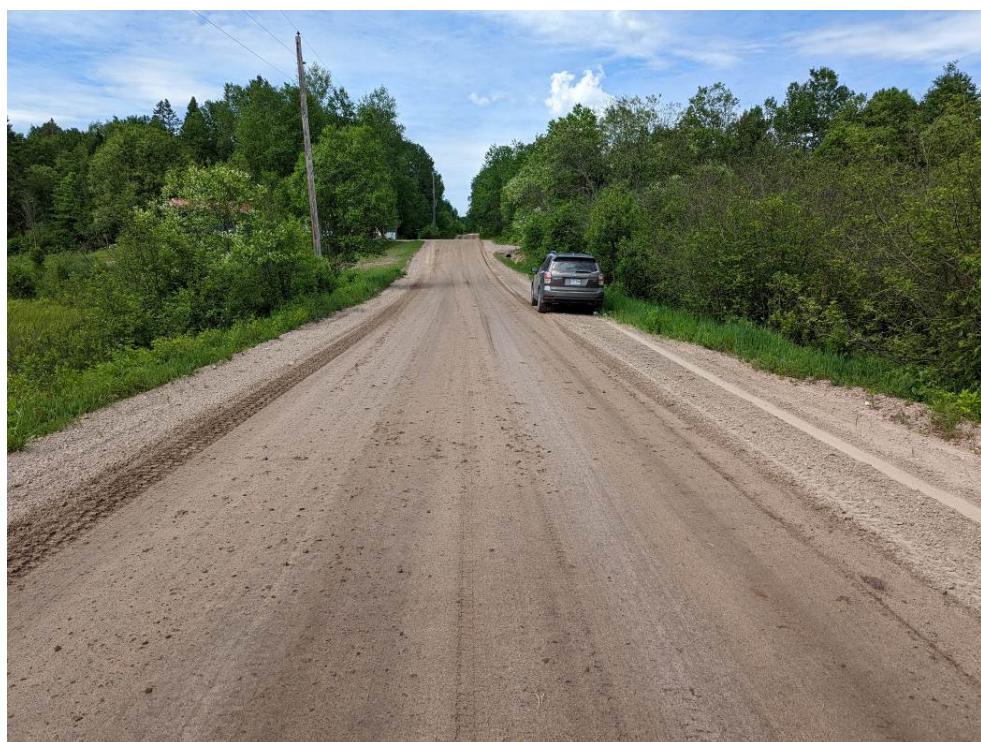
Photo 4 West approach from centre of structure

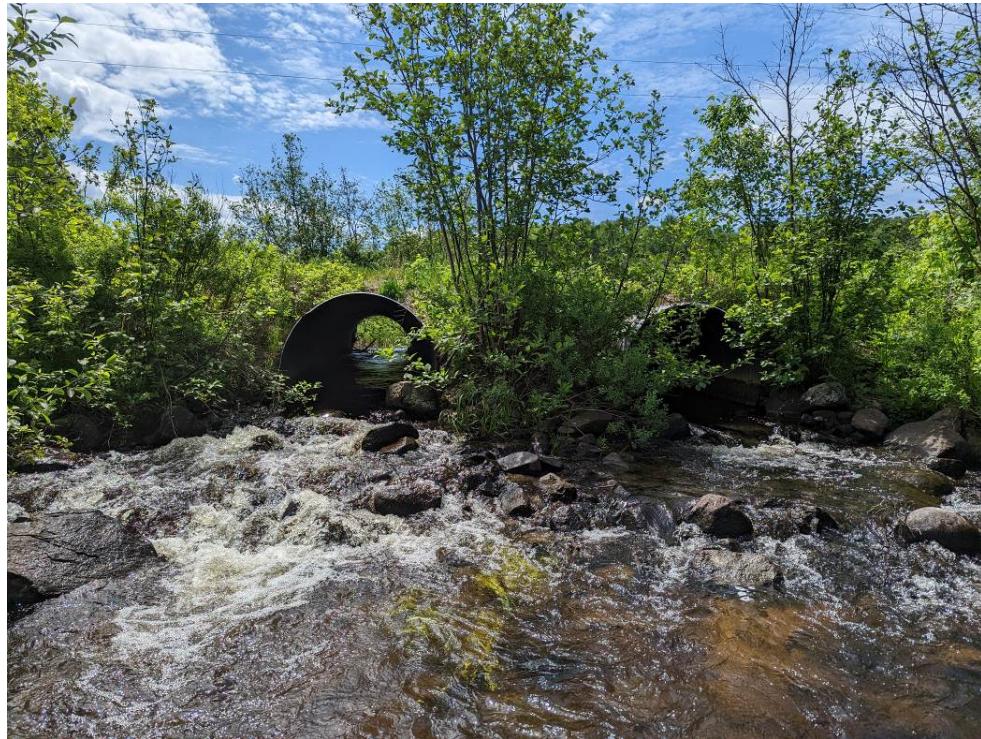
Photo 5 North elevation

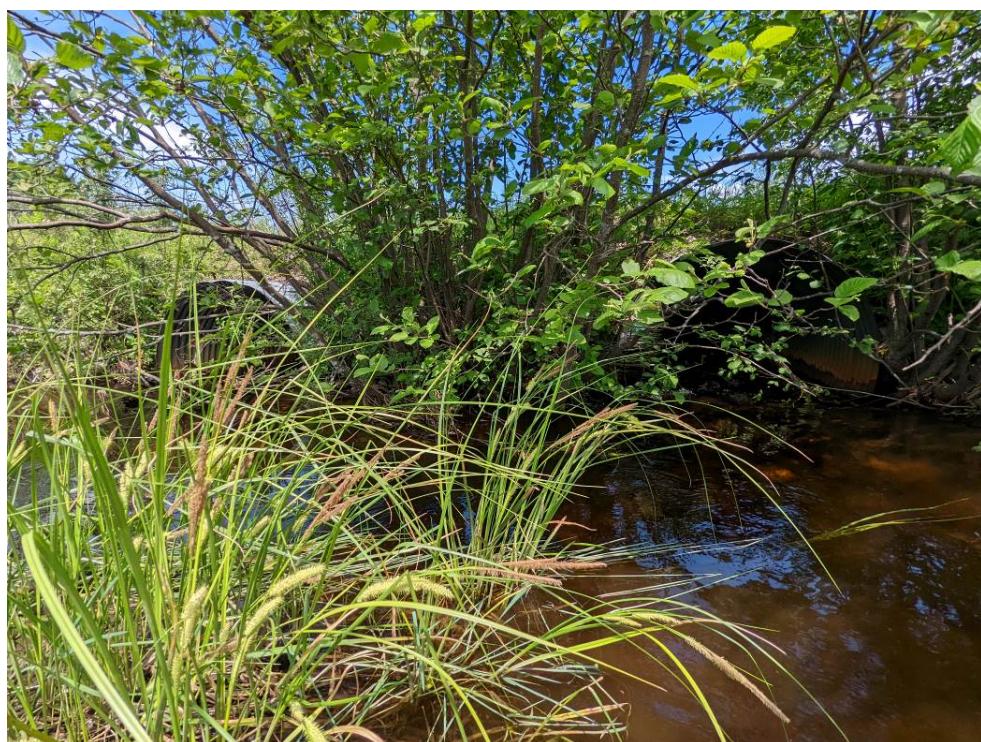
Photo 6 South elevation

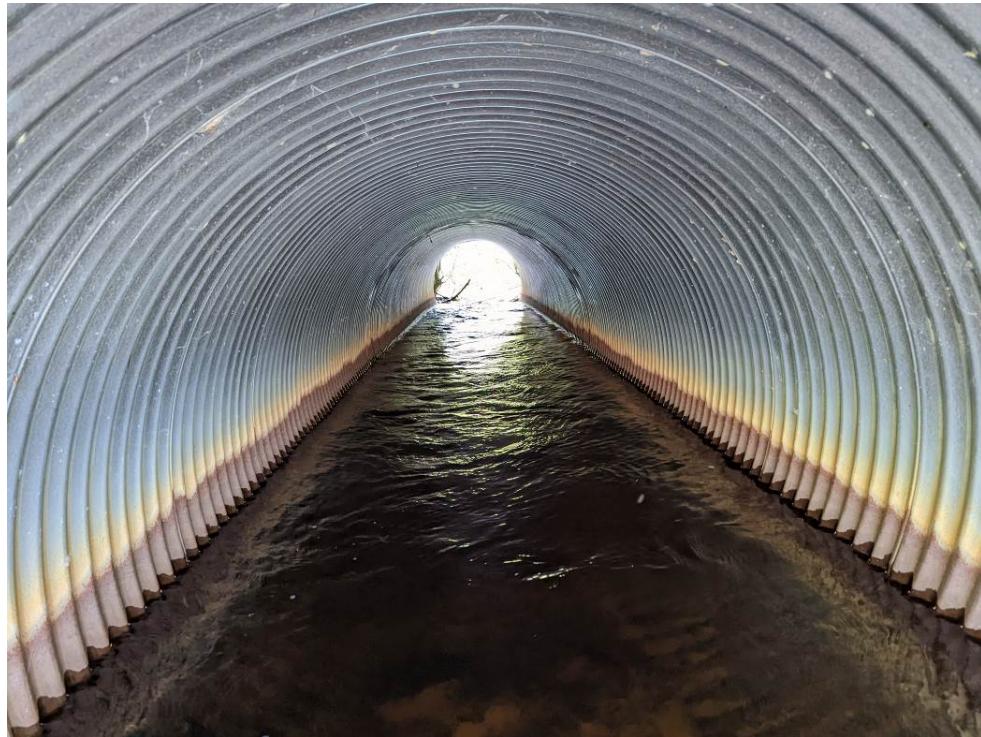
Photo 7 Typical view of east interior barrel looking south

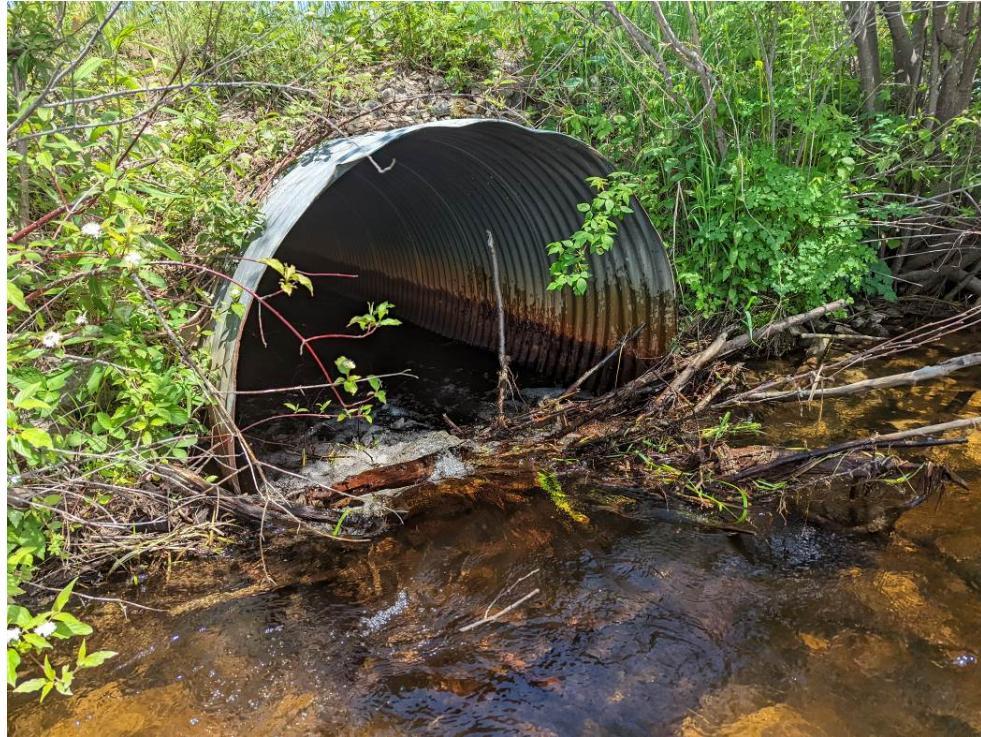
| Comments: Moderate to high volume and high flow from south to north. Vegetation at upstream and some rocks at outlet causing minor flow obstruction. Beaver dam noted at south side of east barrel. | | | | | | |

Photo 9 Beaver dam observed at south end of east barrel

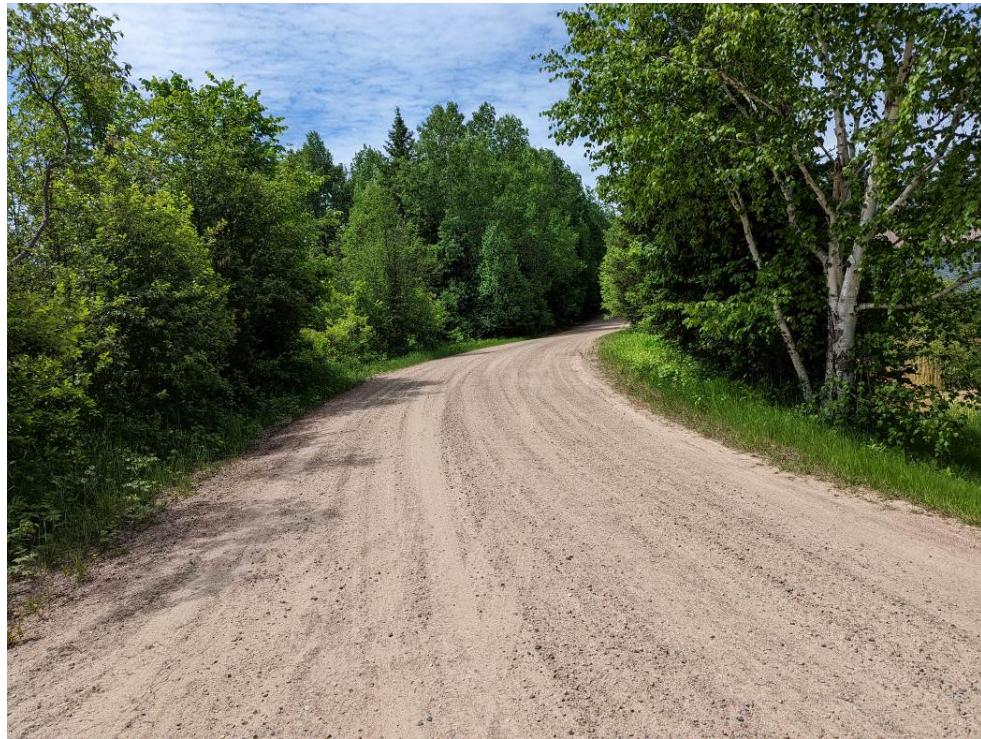
Photo 1 Structure from east approach

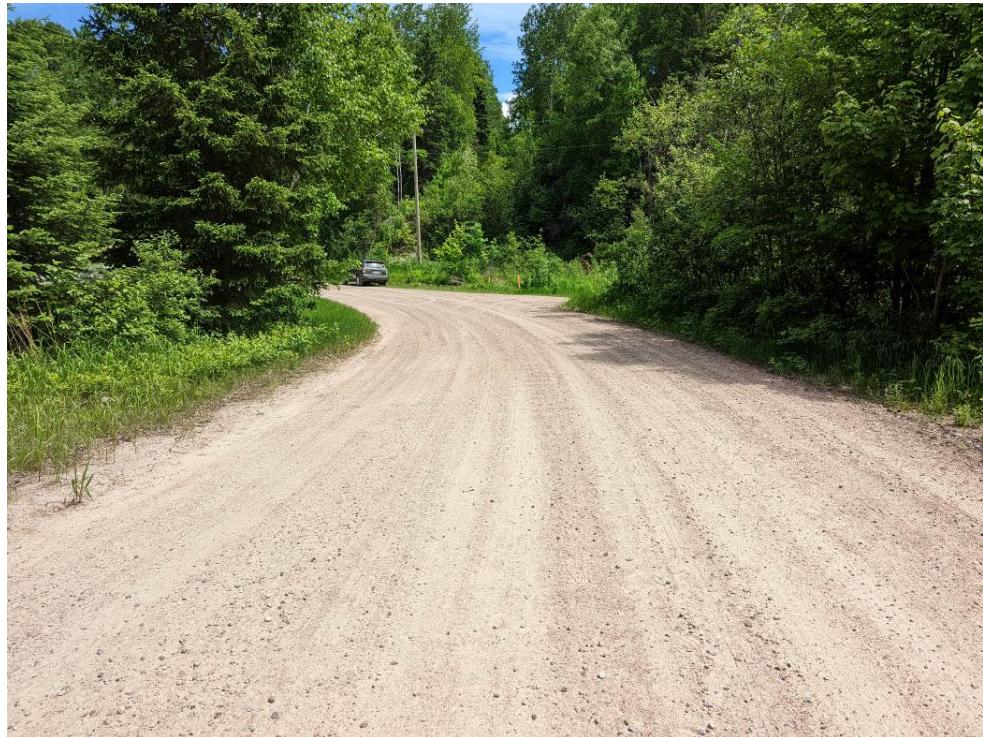
Photo 3 East approach from centre of structure

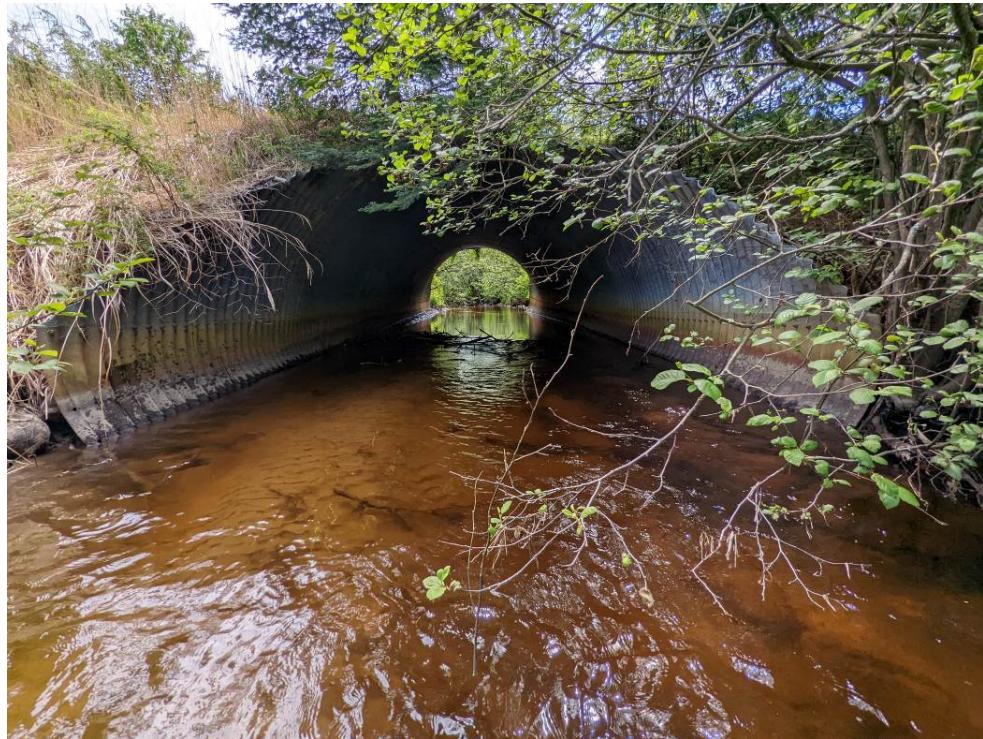
Photo 5 North elevation

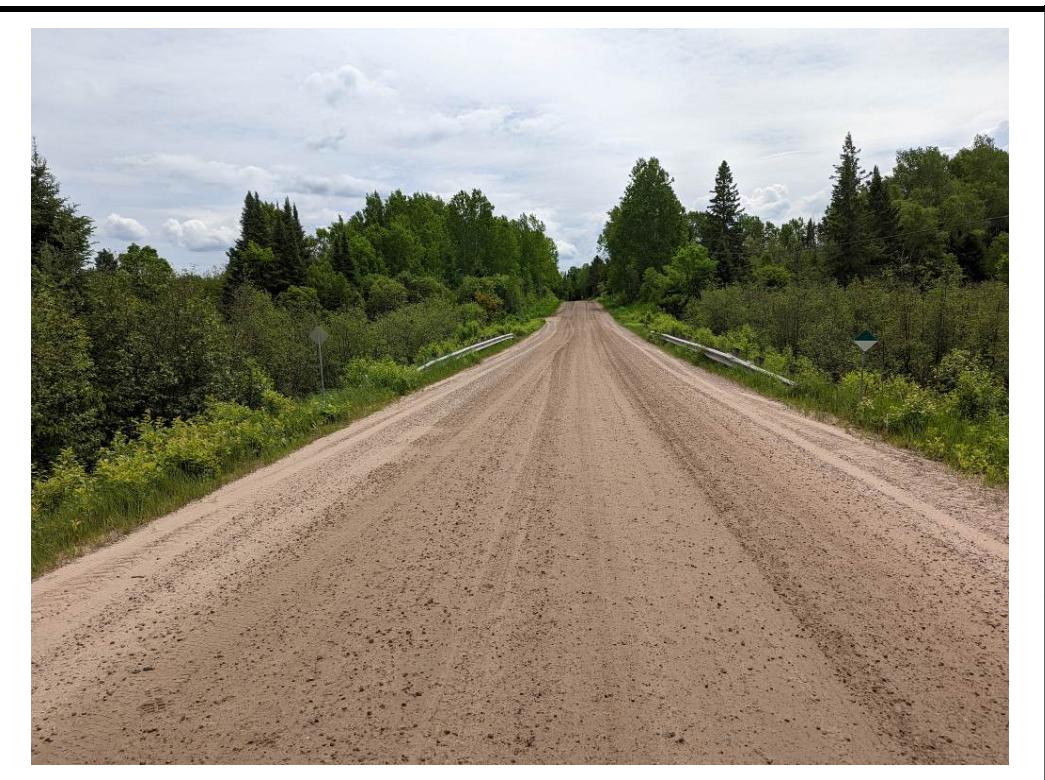
Photo 1 Structure from north approach

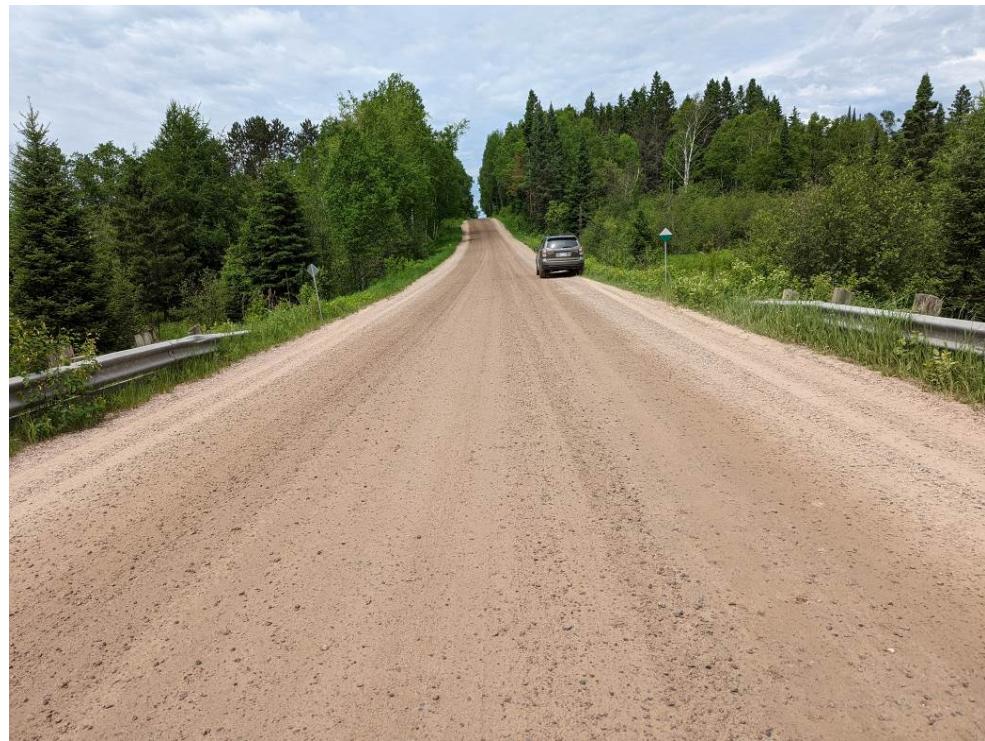
Photo 3 North approach from centre of structure
