THE TOWNSHIP OF BONFIELD

BRIDGE MANAGEMENT STUDY REPORT (DRAFT)

6 BRIDGES / 10 CULVERTS

DECEMBER 2022

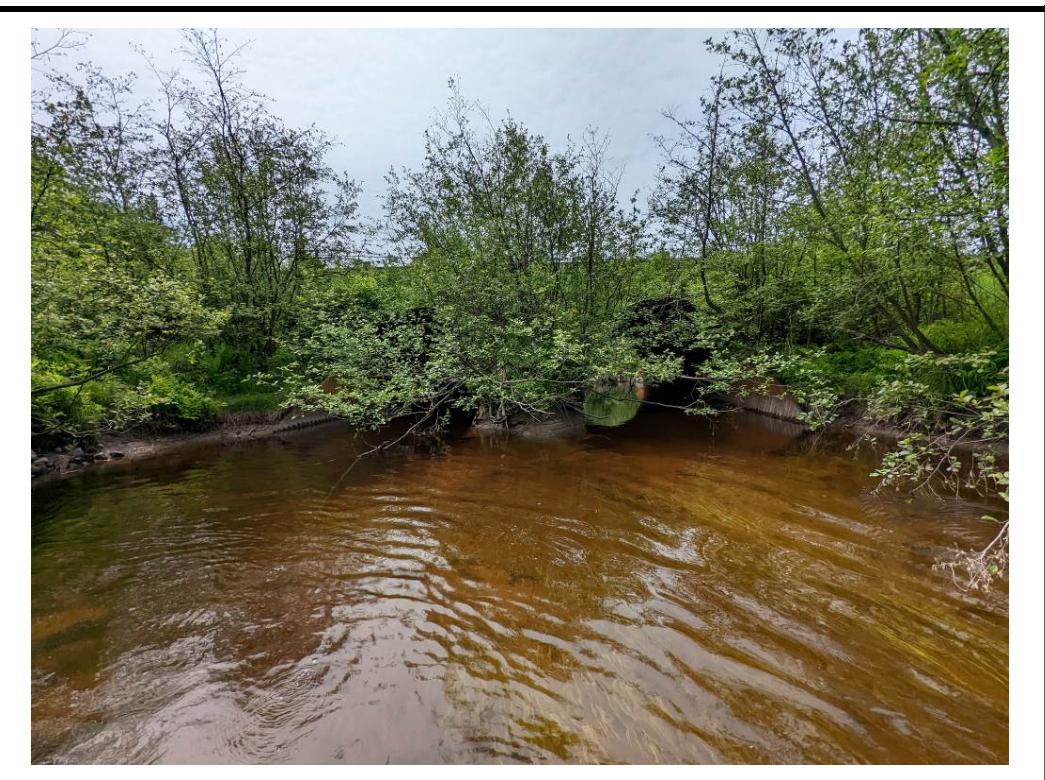
Photo 5 East elevation

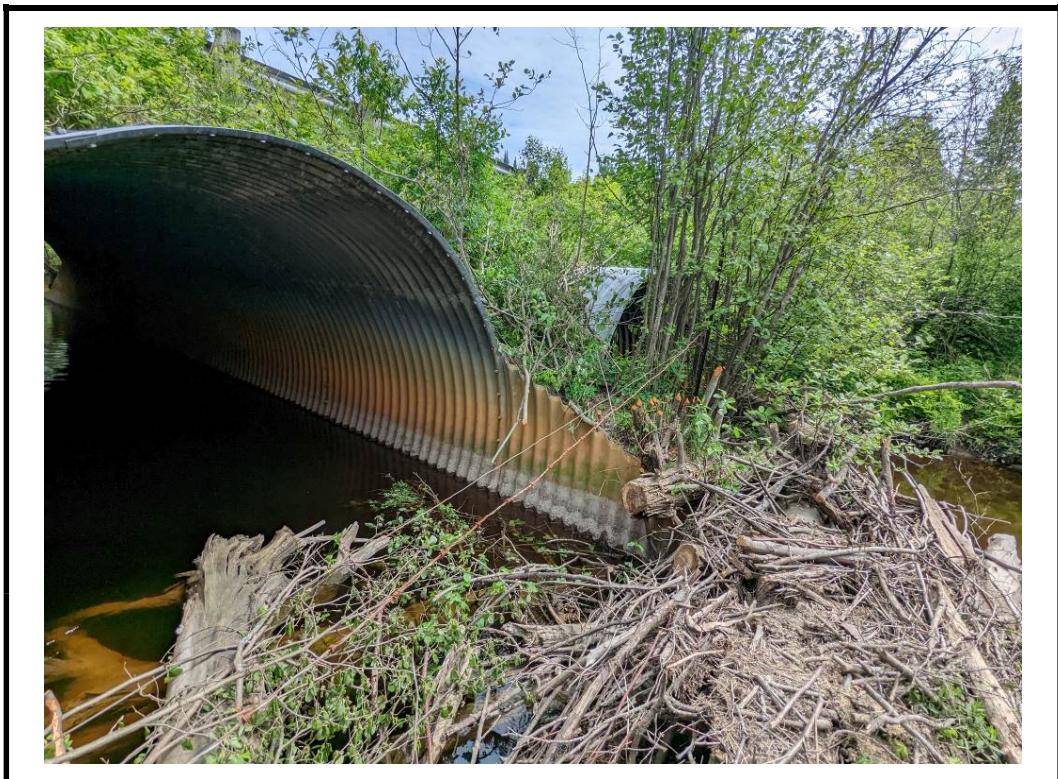
Photo 6 West elevation

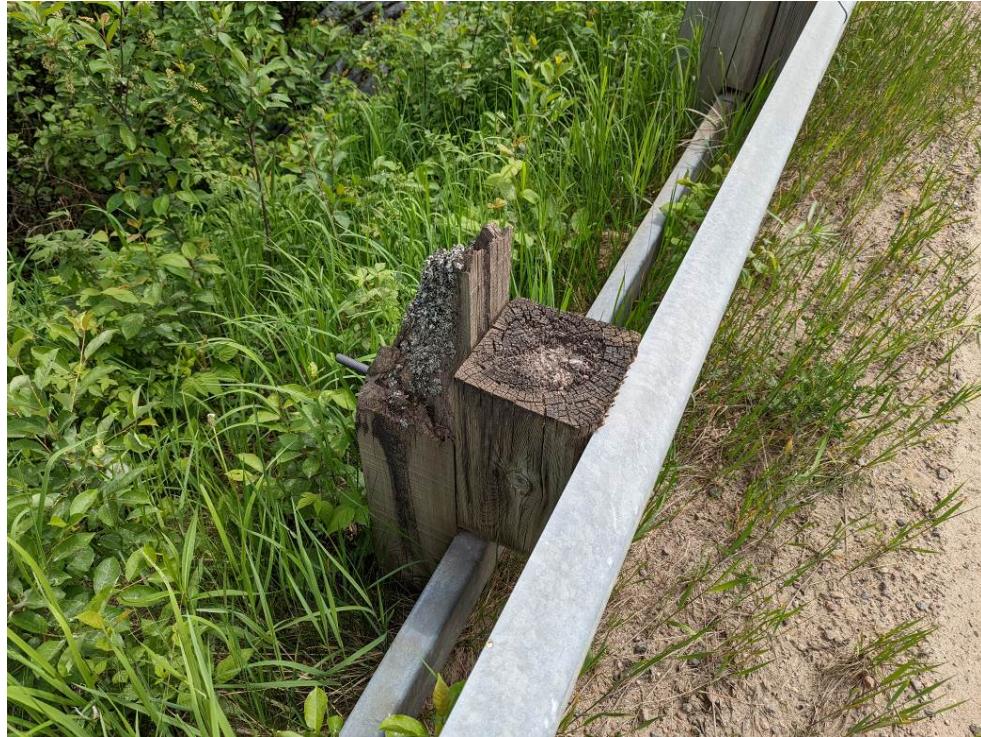
Photo 7 Rot, splits and checks on timber barrier posts

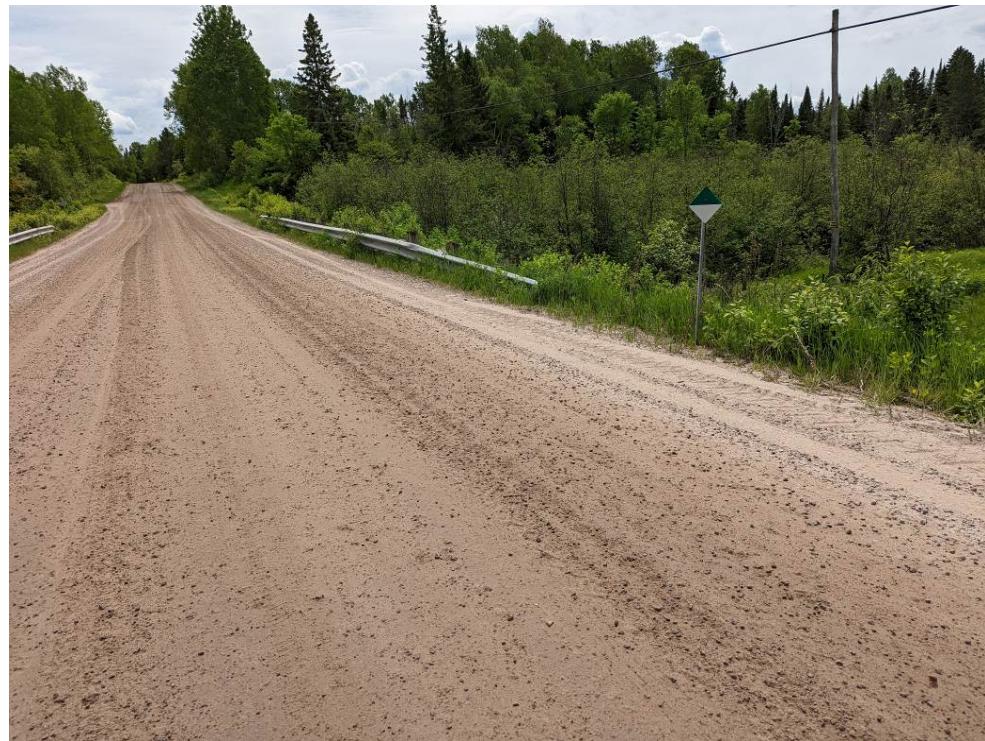
Photo 9 Gravel approach wearing surface

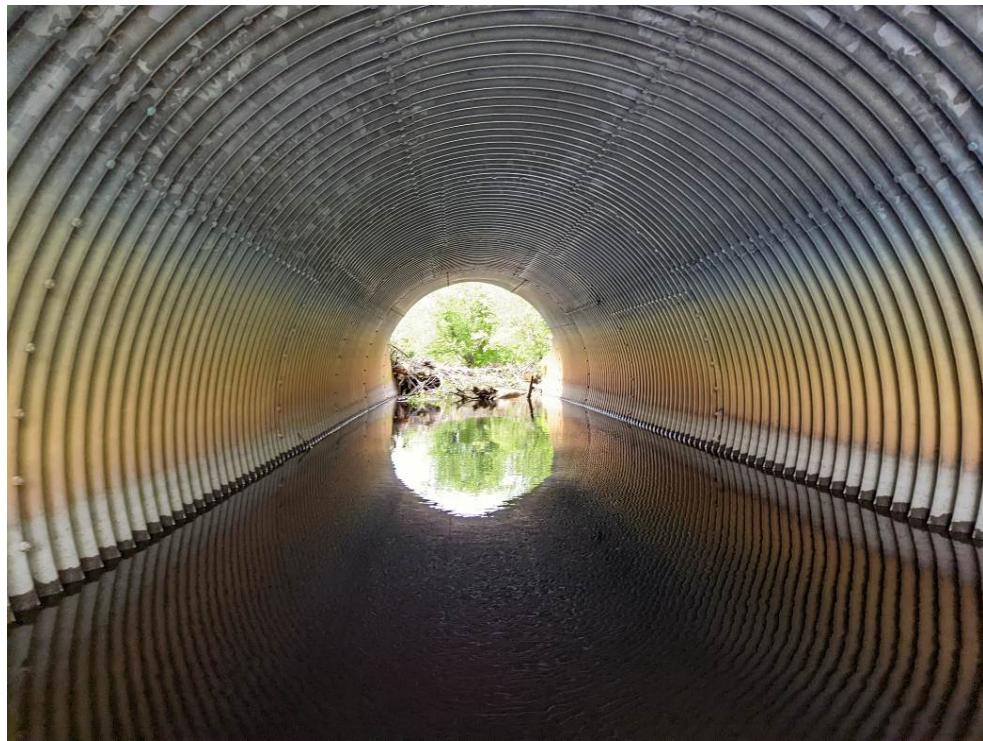
Photo 11 Typical view of south culvert barrel looking west

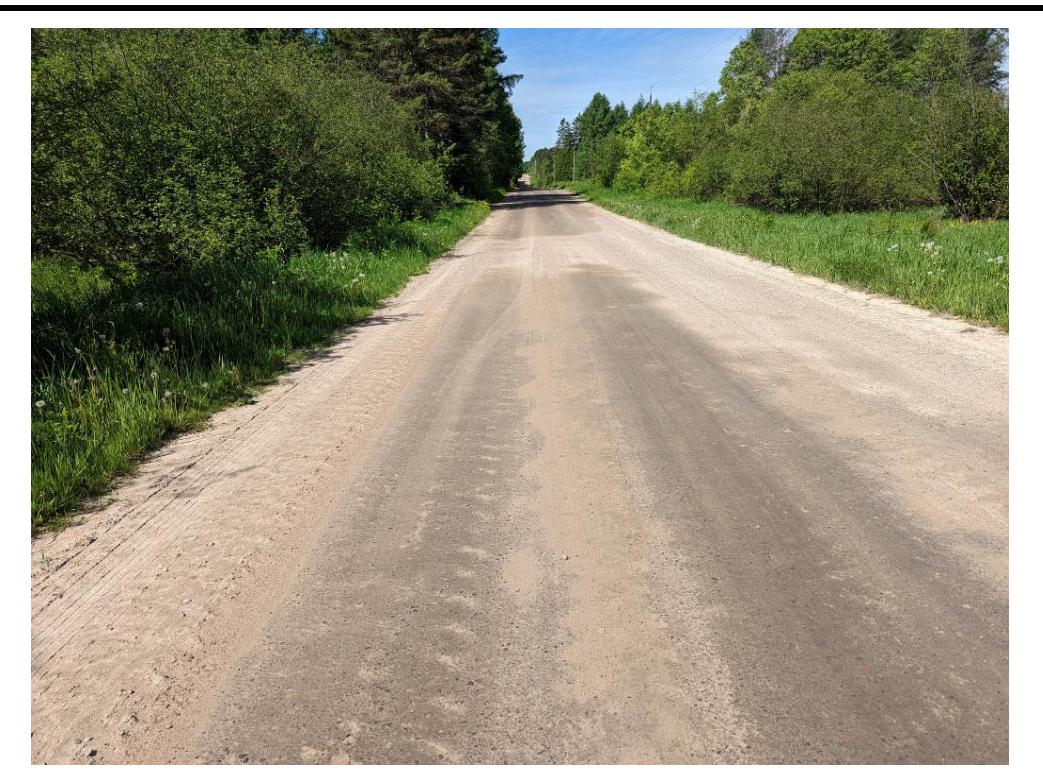
Photo 1 Structure from east approach

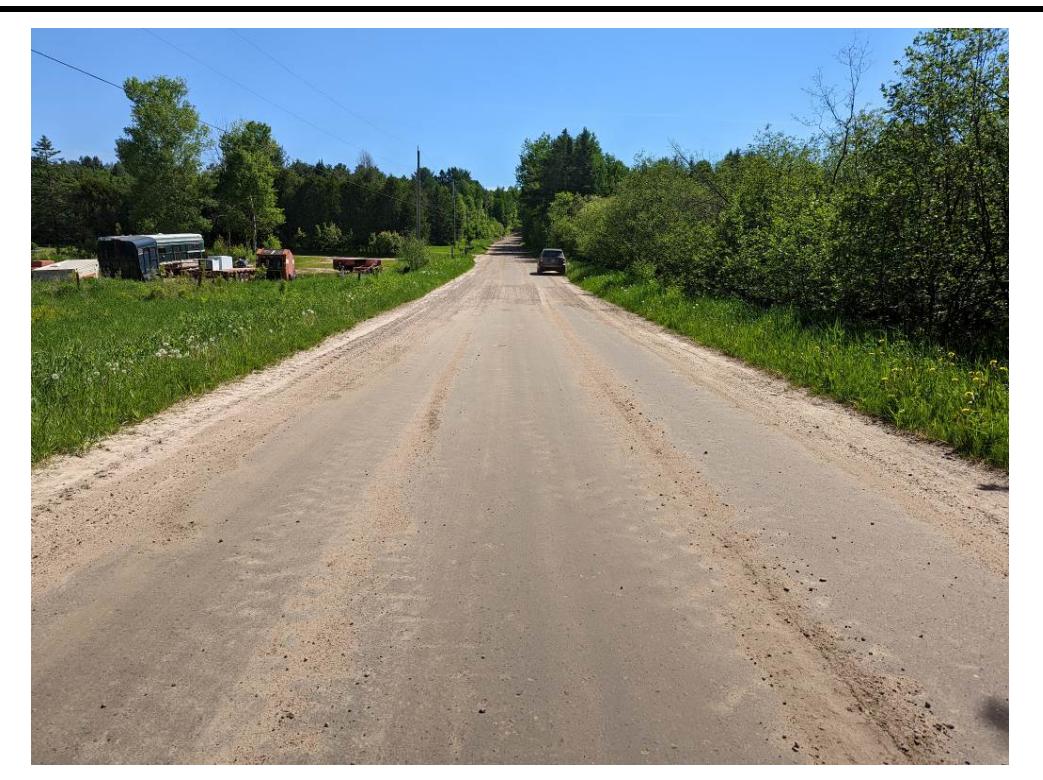
Photo 2 Structure from west approach

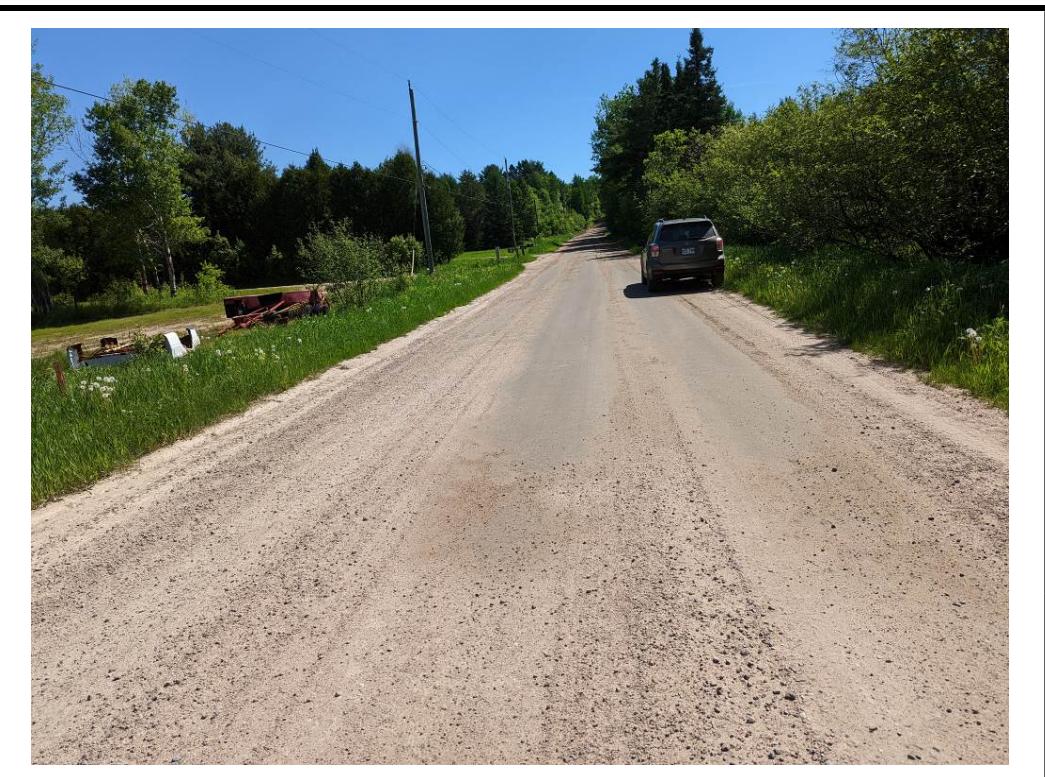
Photo 3 East approach from centre of structure

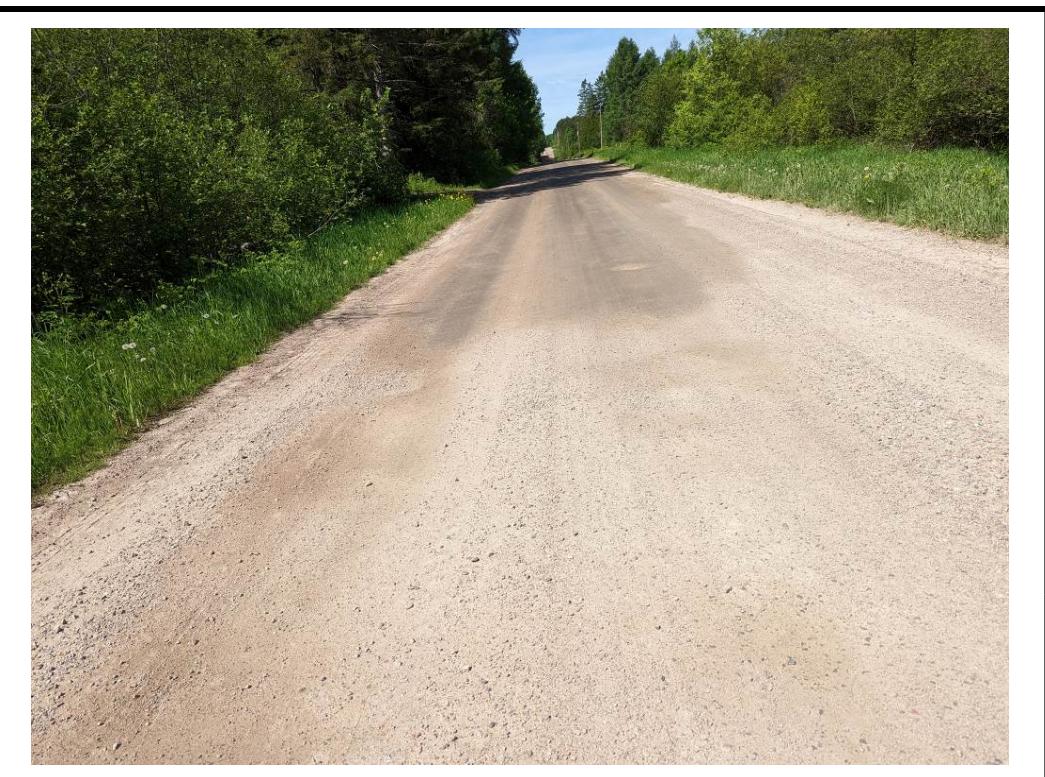
Photo 4 West approach from centre of structure

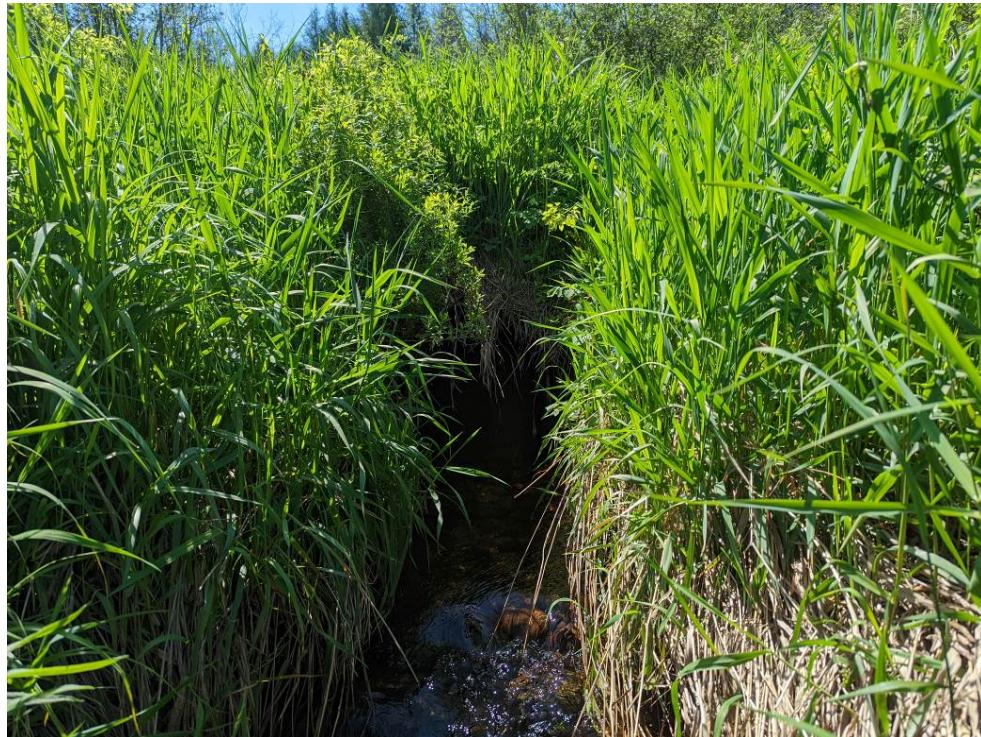
Photo 5 Heavy vegetation grown at north side of barrel

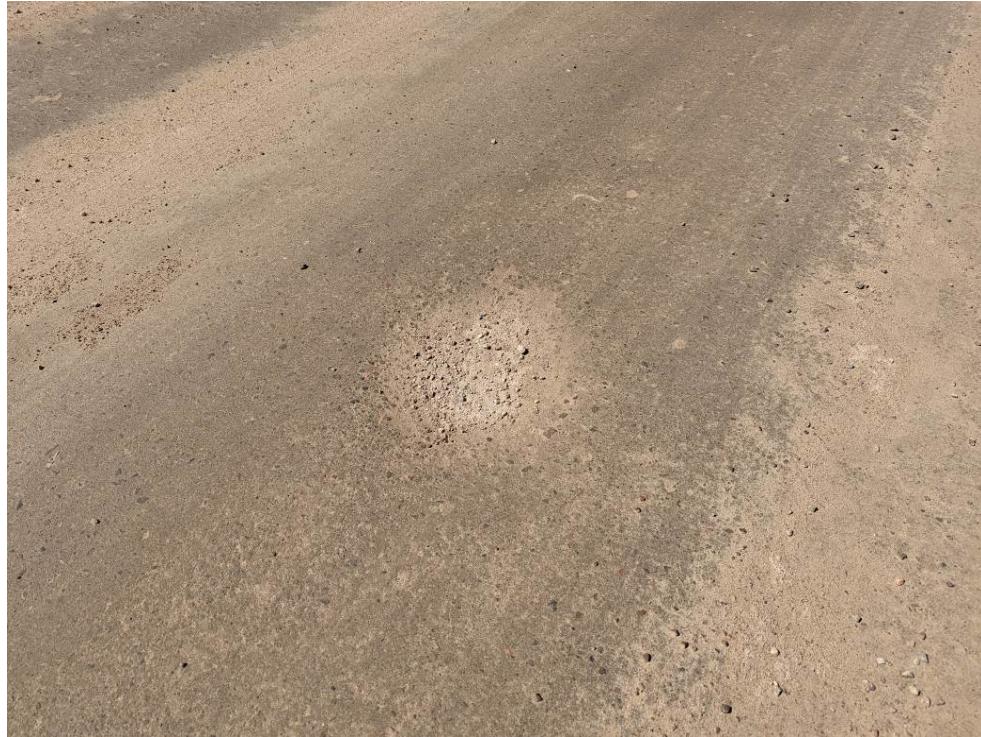
Photo 7 Several small potholes on west approach

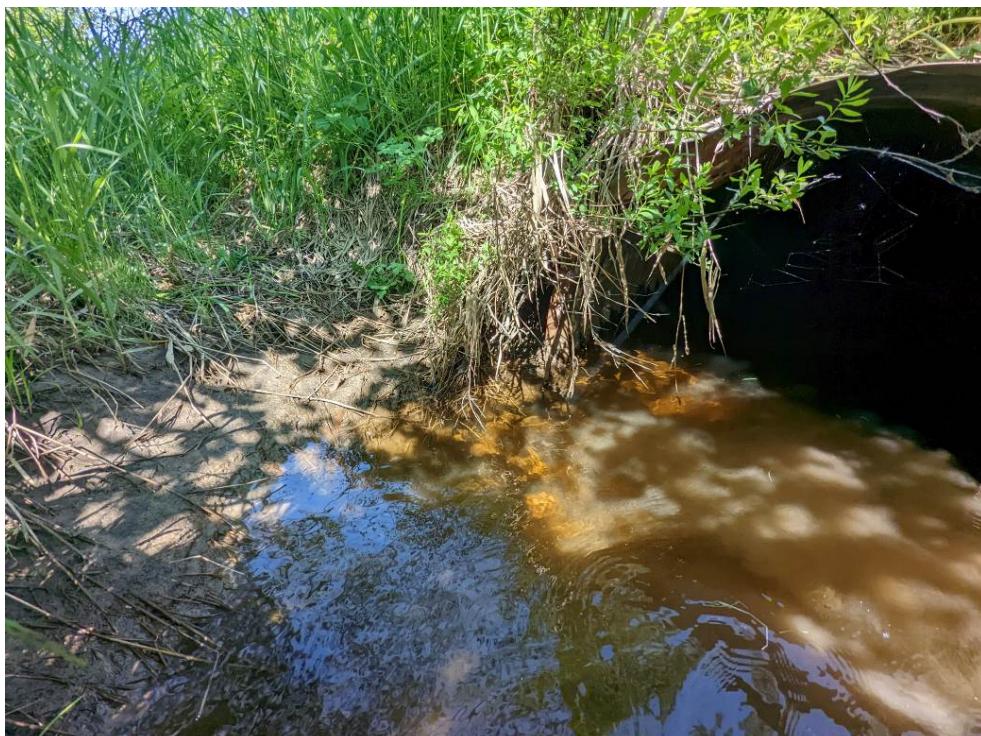
Photo 8 Minor erosion of embankment noted at south end of structure

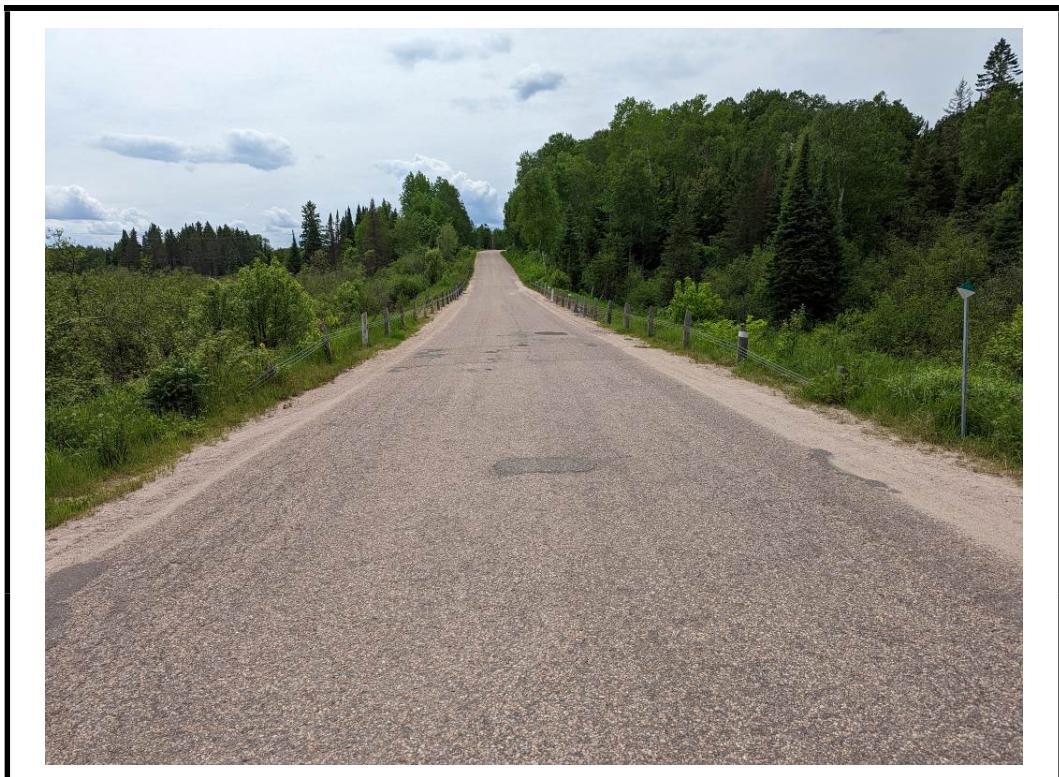
Photo 1 Structure from east approach

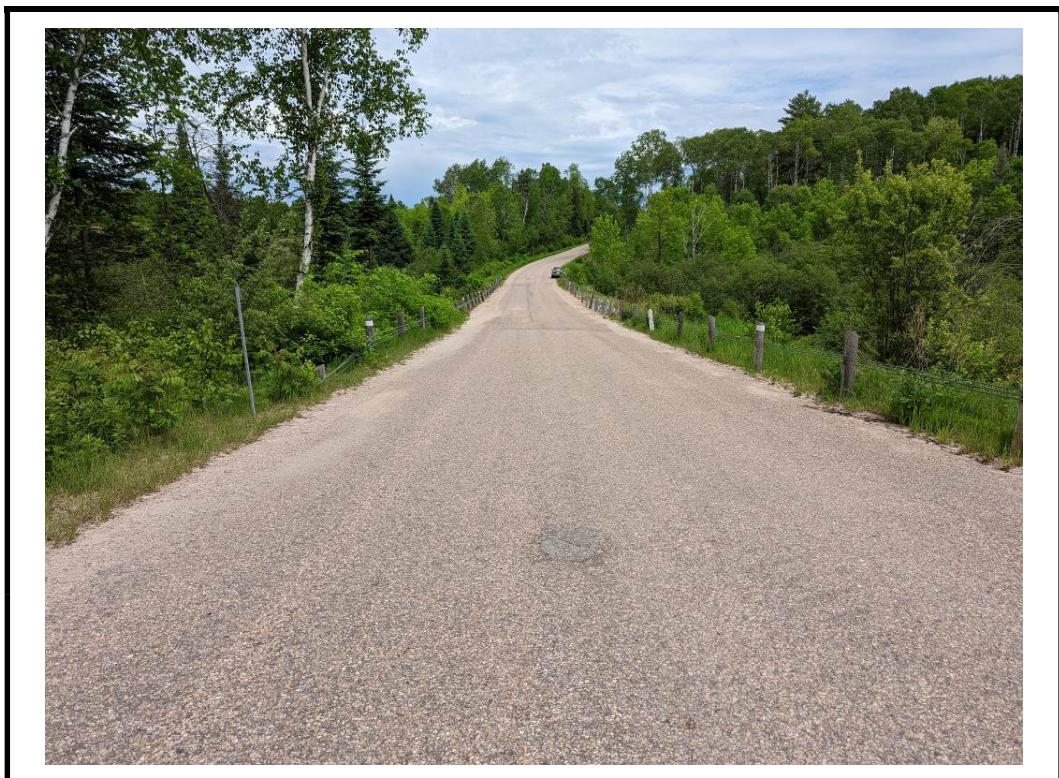
Photo 2 Structure from west approach

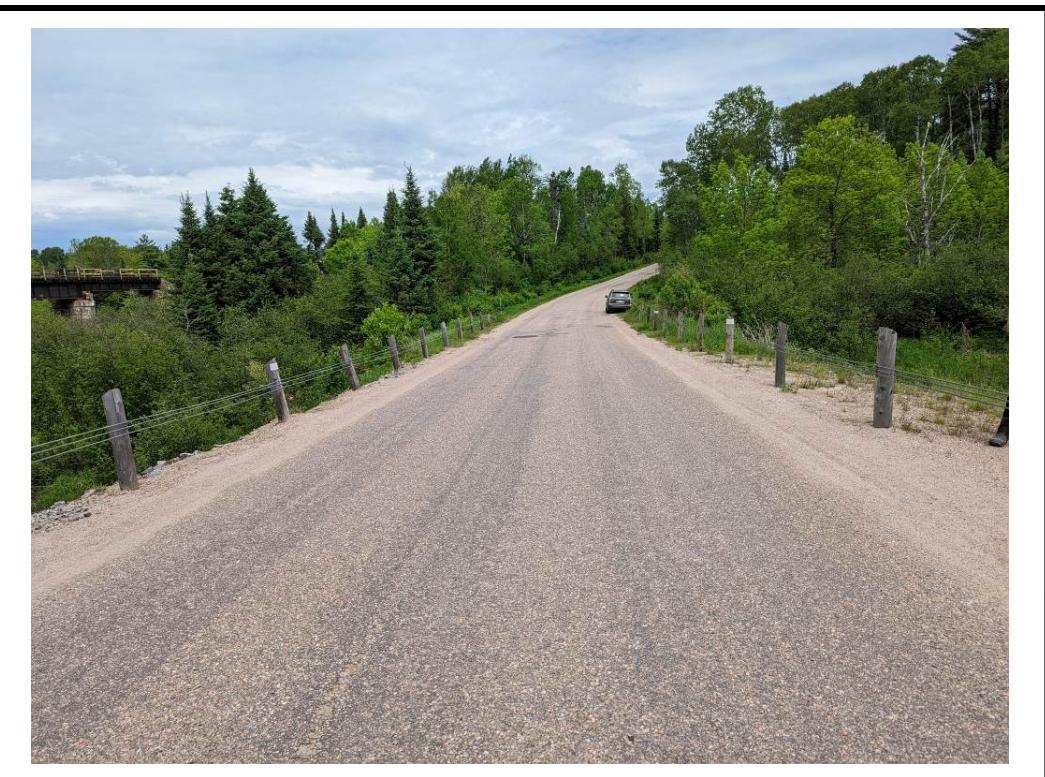
Photo 3 East approach from centre of structure

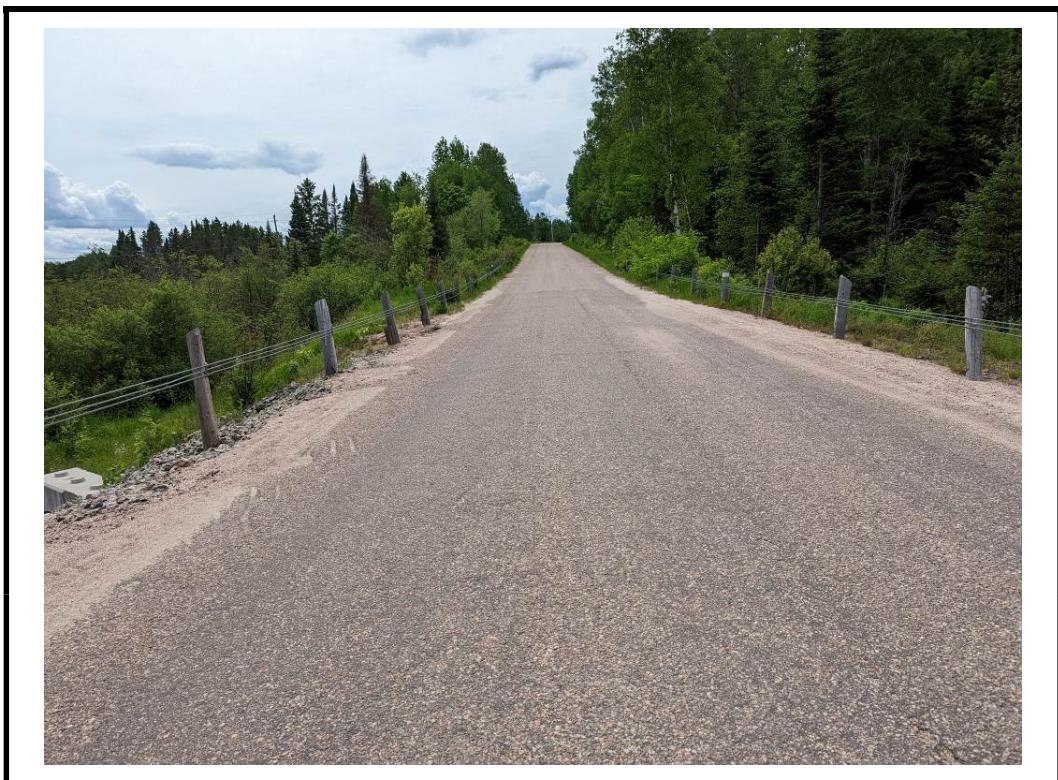
Photo 4 West approach from centre of structure

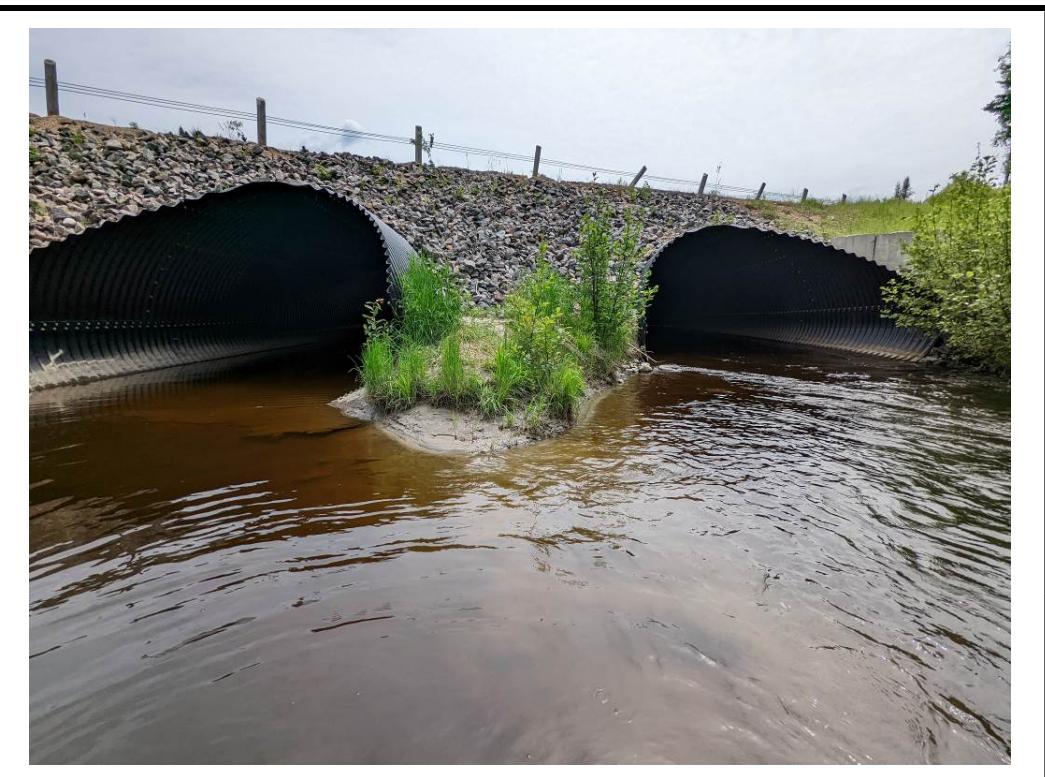
Photo 5 North elevation

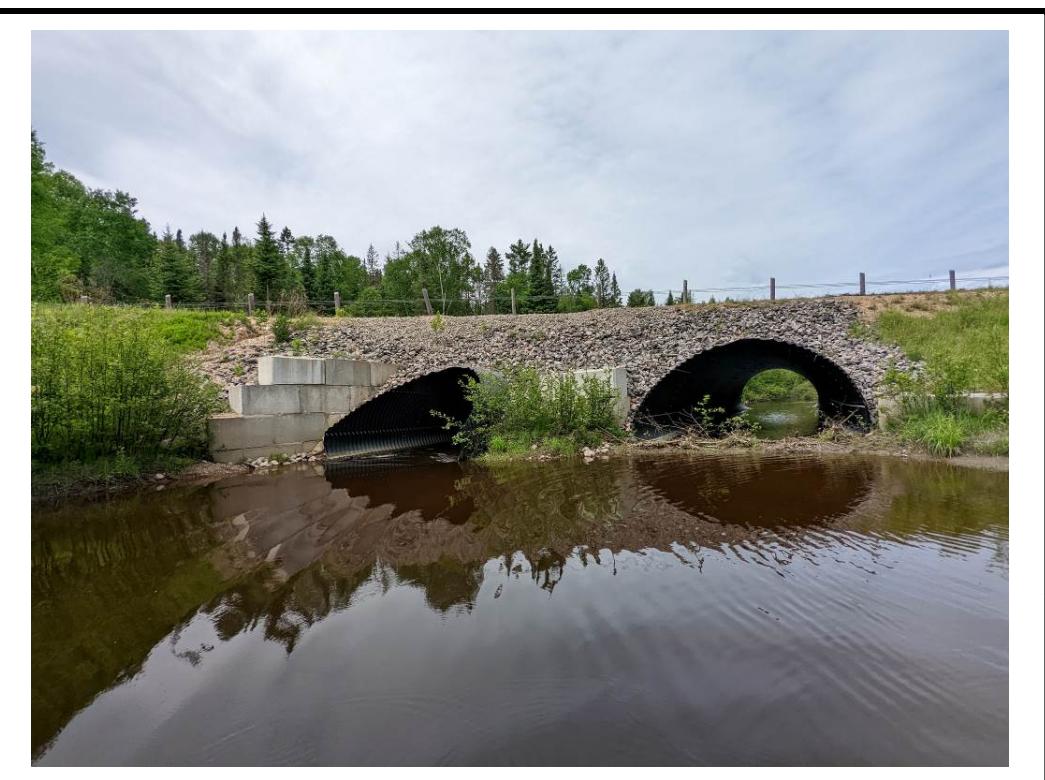
Photo 6 South elevation

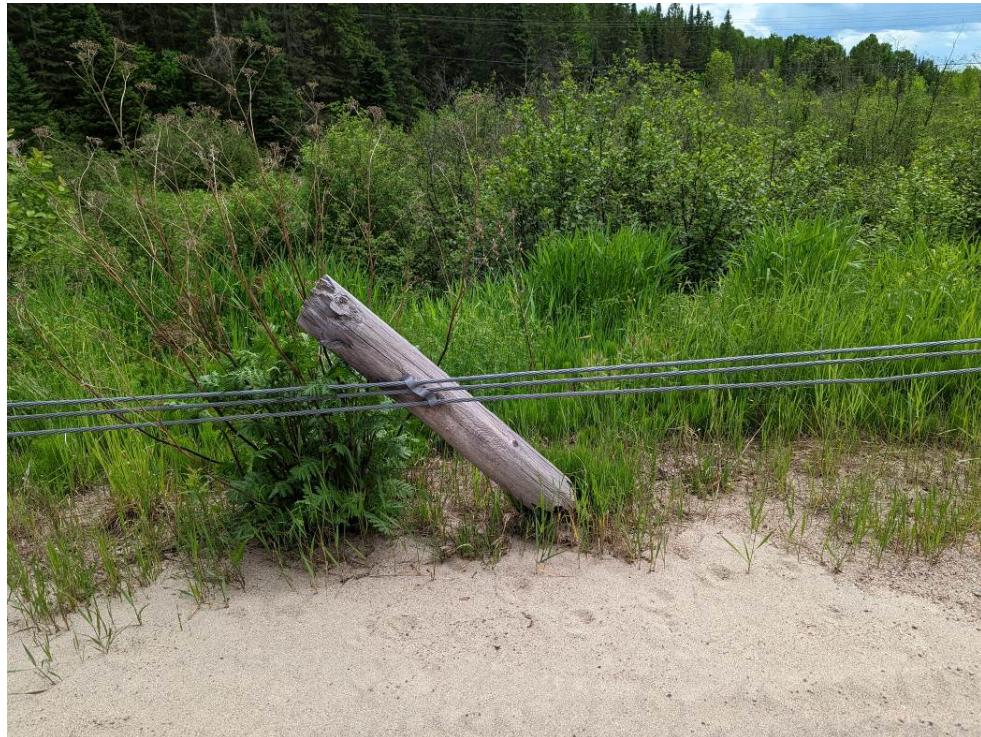
Photo 7 Broken post observed in north barrier

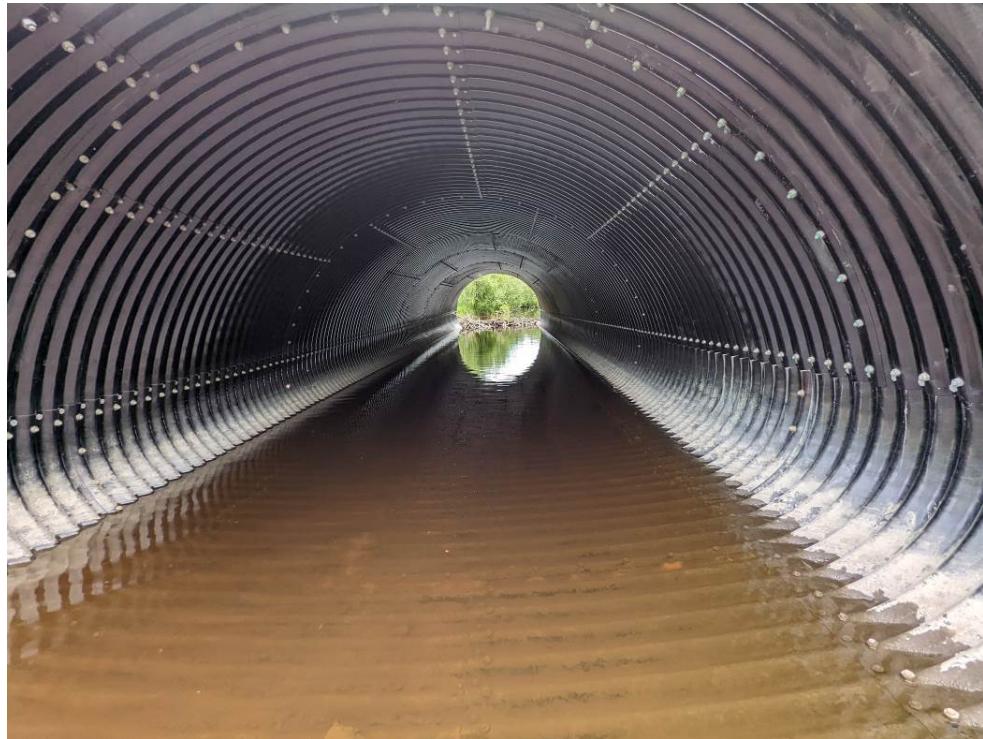
Photo 9 Interior of east culvert barrel looking south

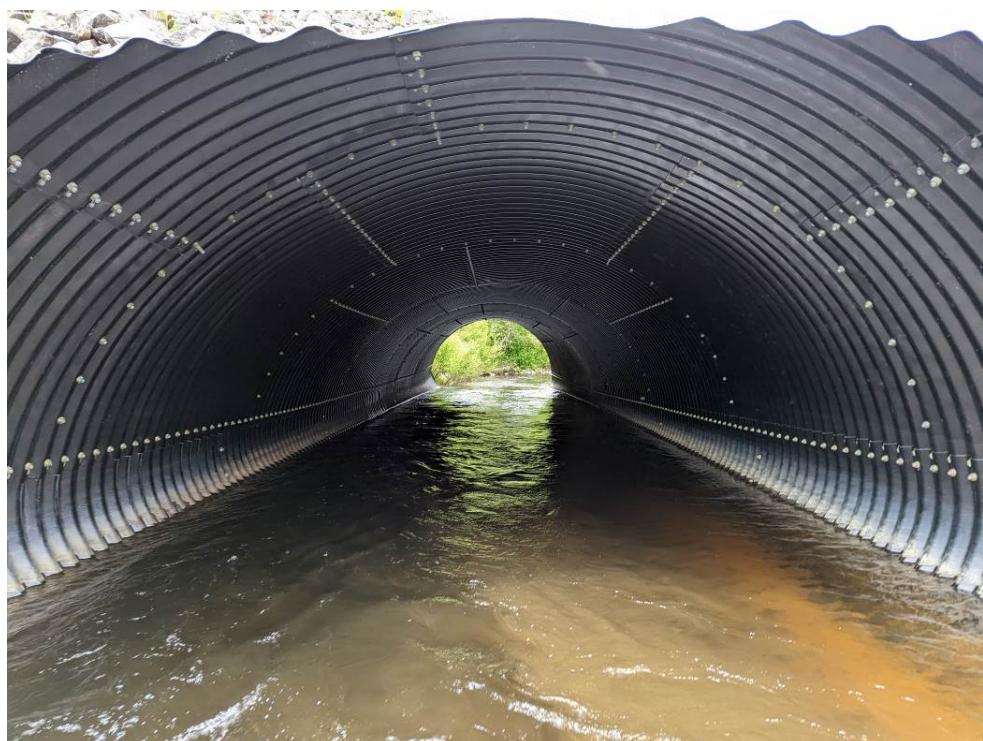
Photo 10 Typical west culvert barrel looking north

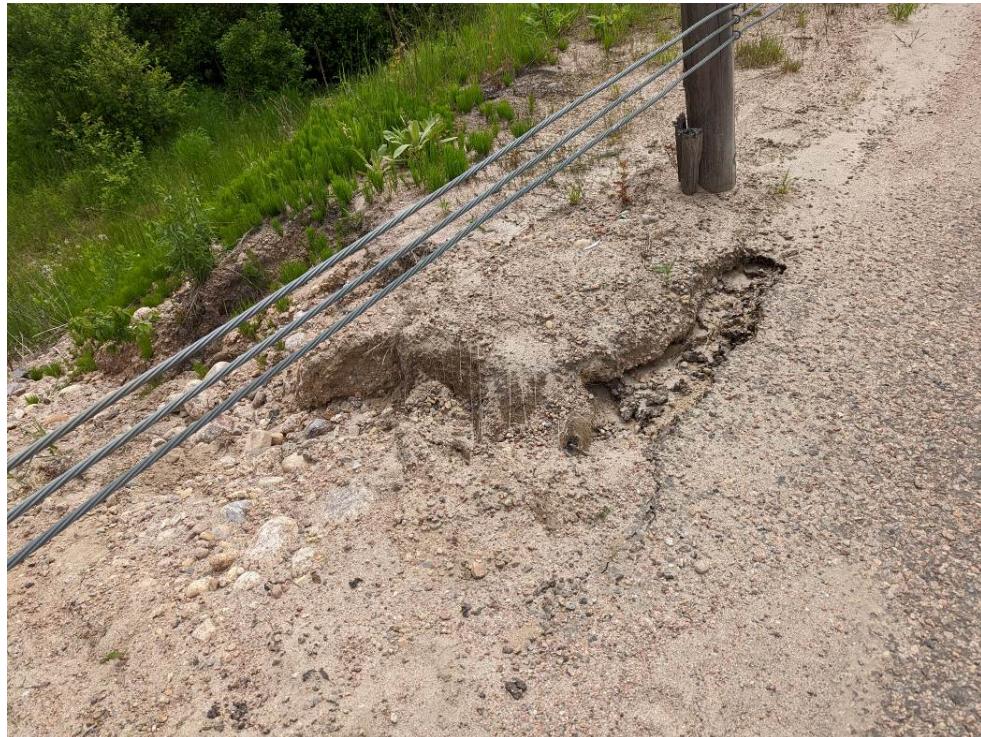
Photo 11 Heavy washout noted at southwest corner over structure

| Comments: Generally in good condition with loose gravel observed on edges approach roadway. Washout observed at east and west sides of wearing surface near culvert. | | | | | | |

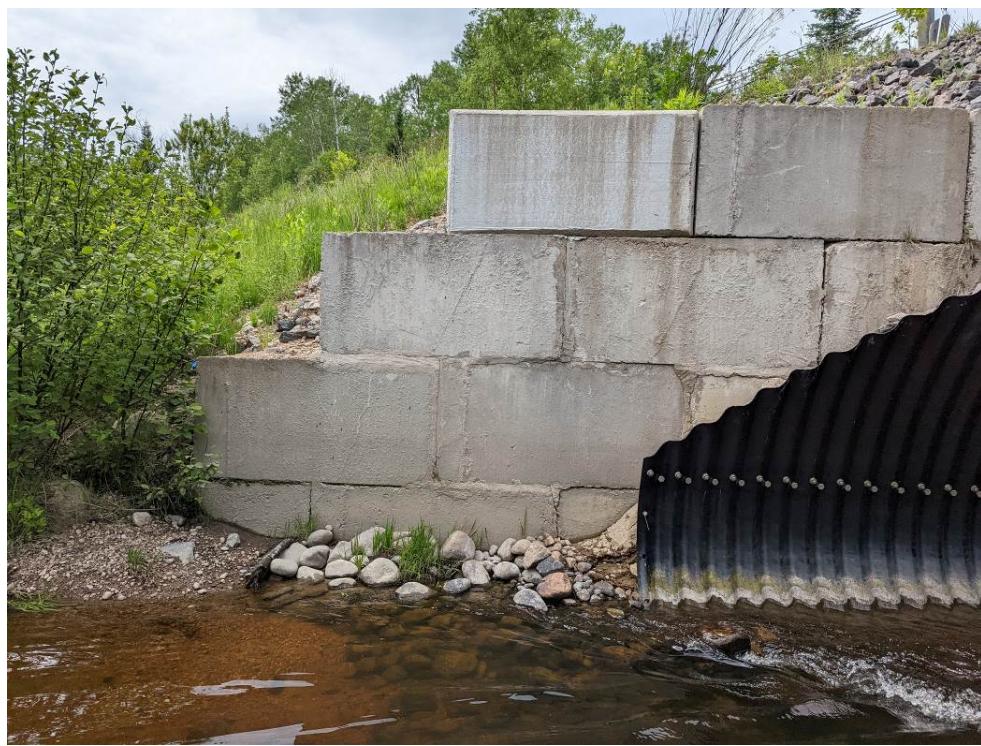
Photo 12 Typical pre-cast concrete block retaining wall at southwest corner of culvert

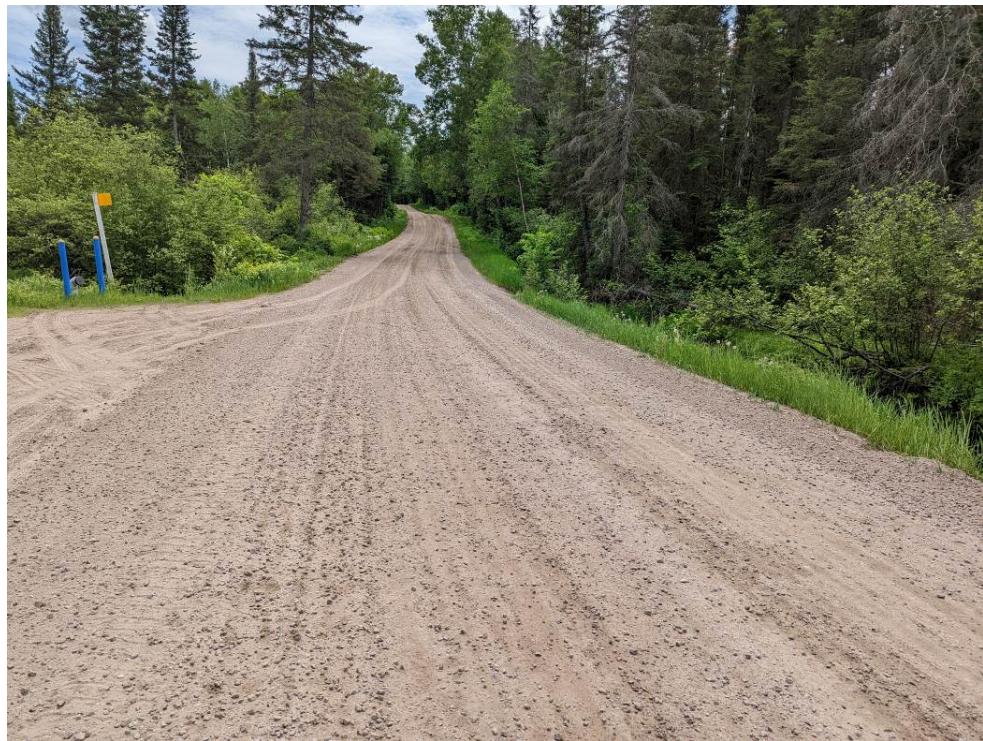
Photo 1 Structure from north approach

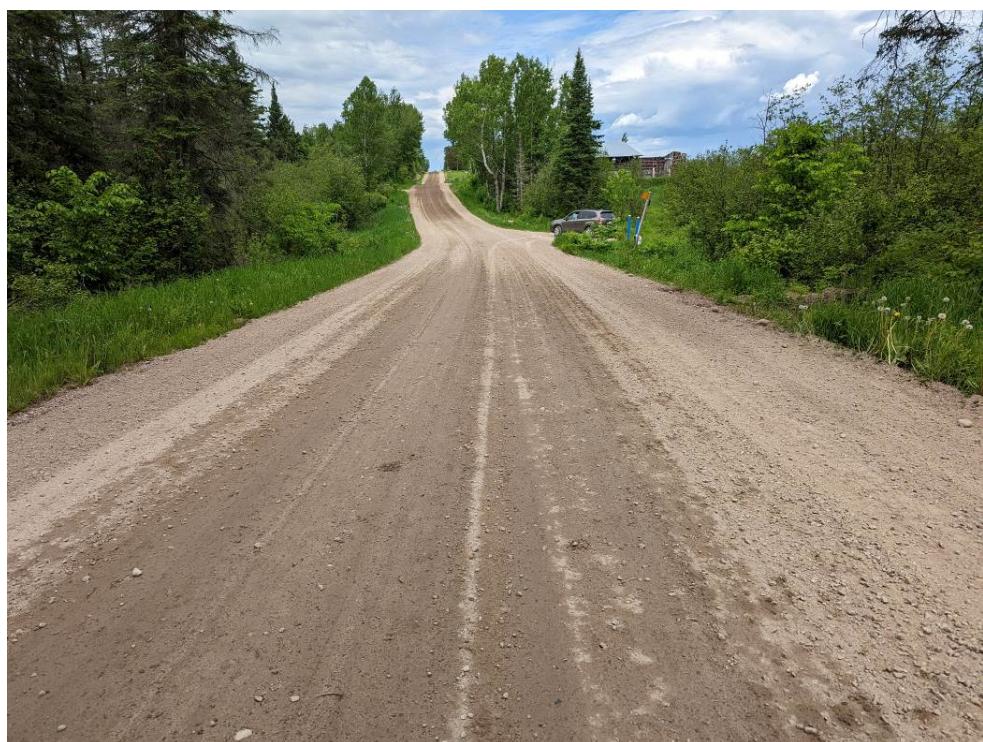
Photo 2 Structure from south approach

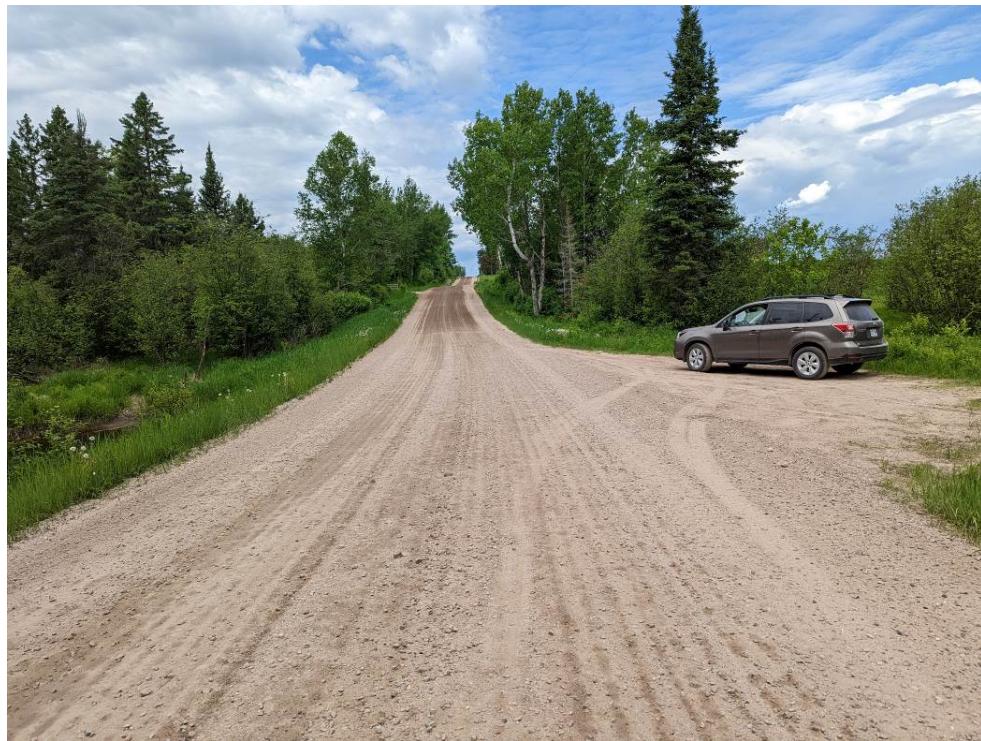
Photo 3 North approach from centre of structure

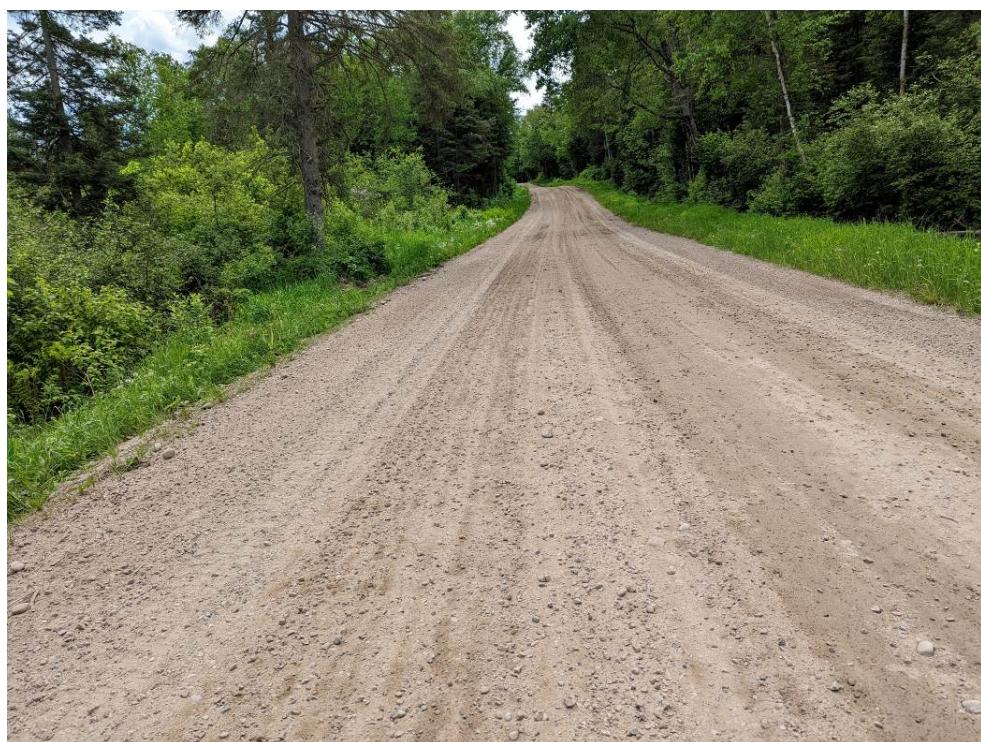
Photo 4 South approach from centre of structure

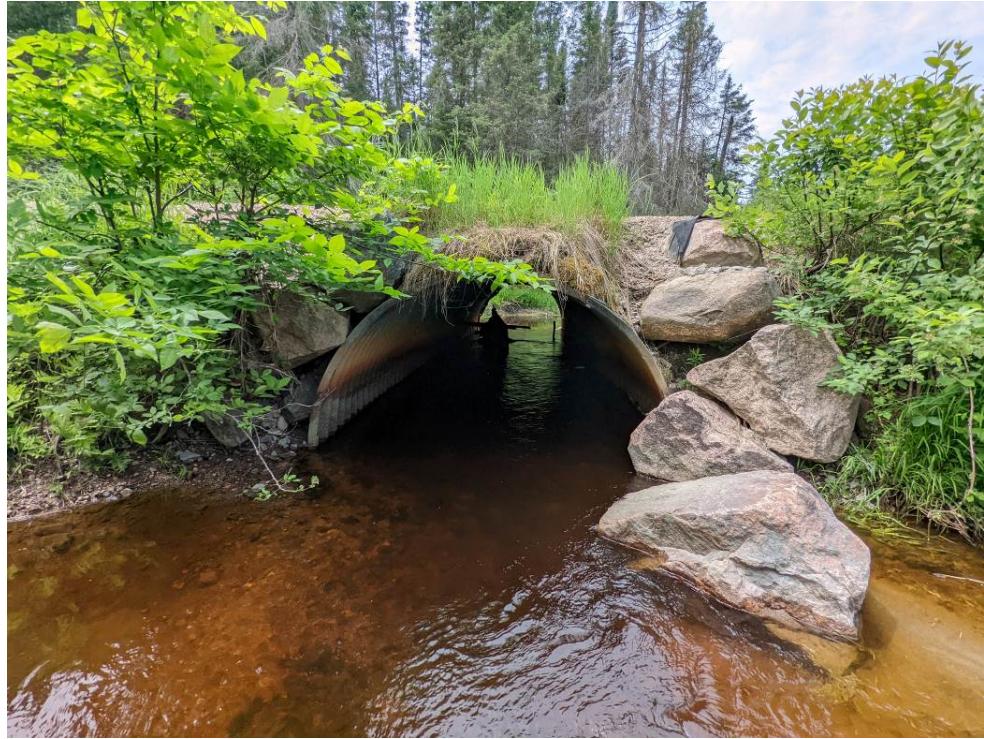
Photo 5 East elevation

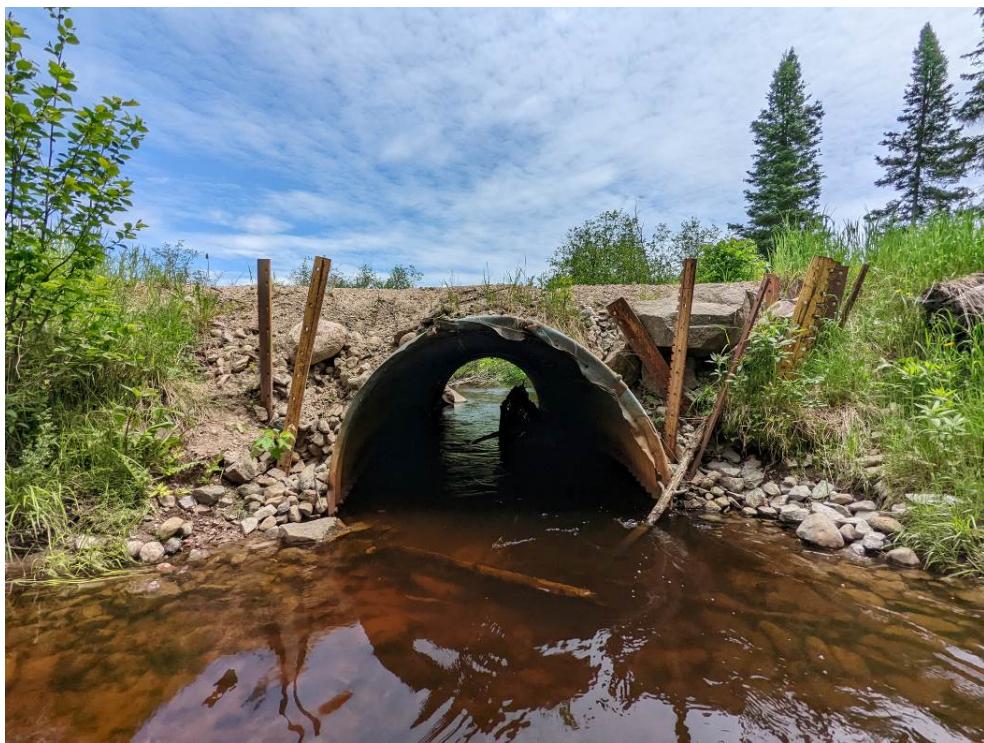
Photo 6 West elevation

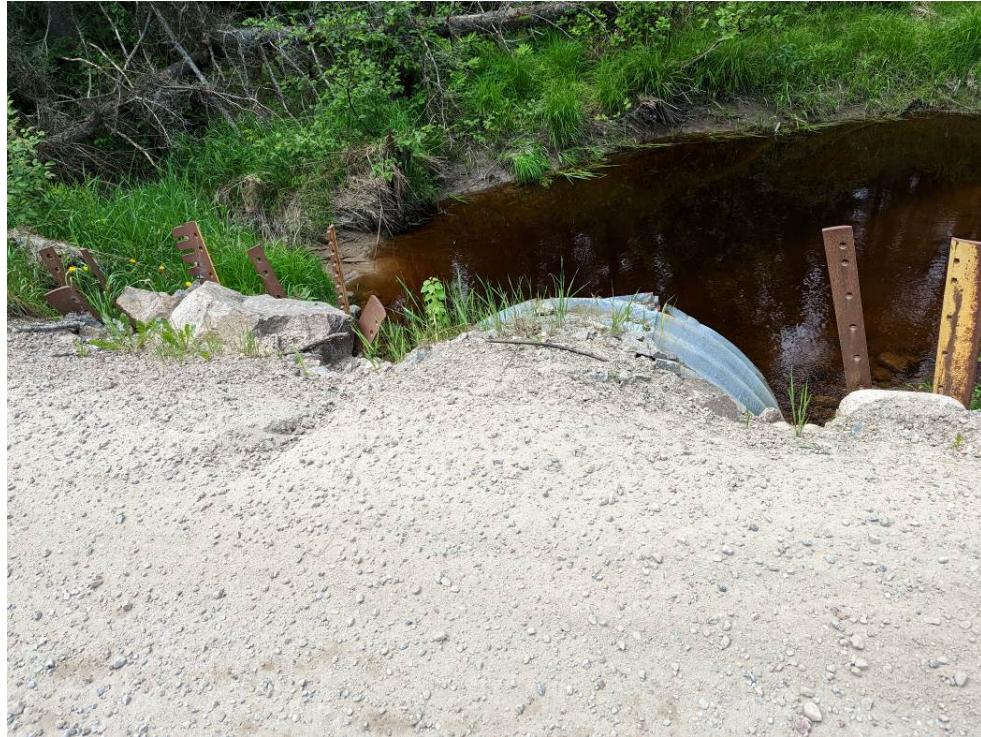
Photo 7 Erosion of edge of shoulder at west end of structure
