THE TOWNSHIP OF BONFIELD

BRIDGE MANAGEMENT STUDY REPORT (DRAFT)

6 BRIDGES / 10 CULVERTS

DECEMBER 2022

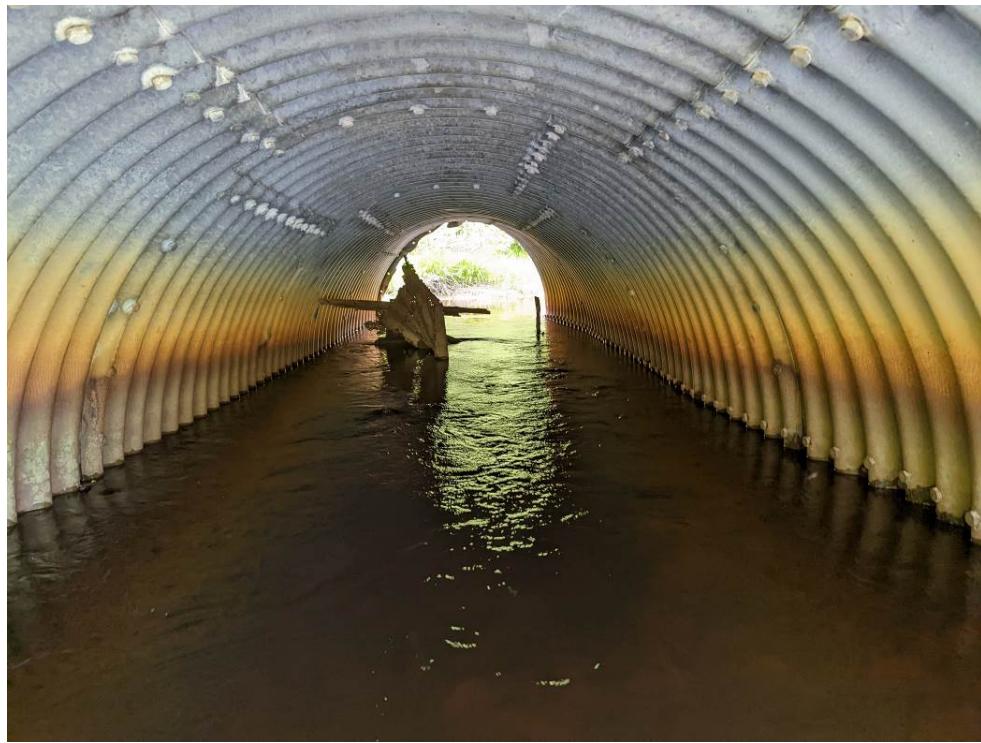
Photo 9 Typical view of culvert barrel looking west

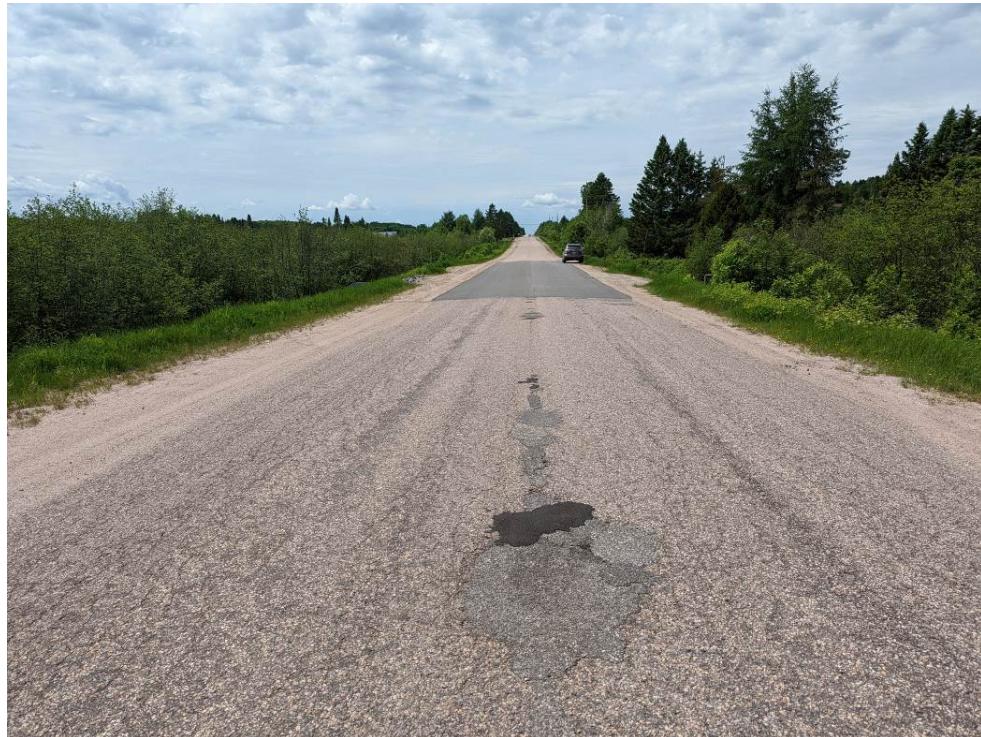
Photo 1 Structure from east approach

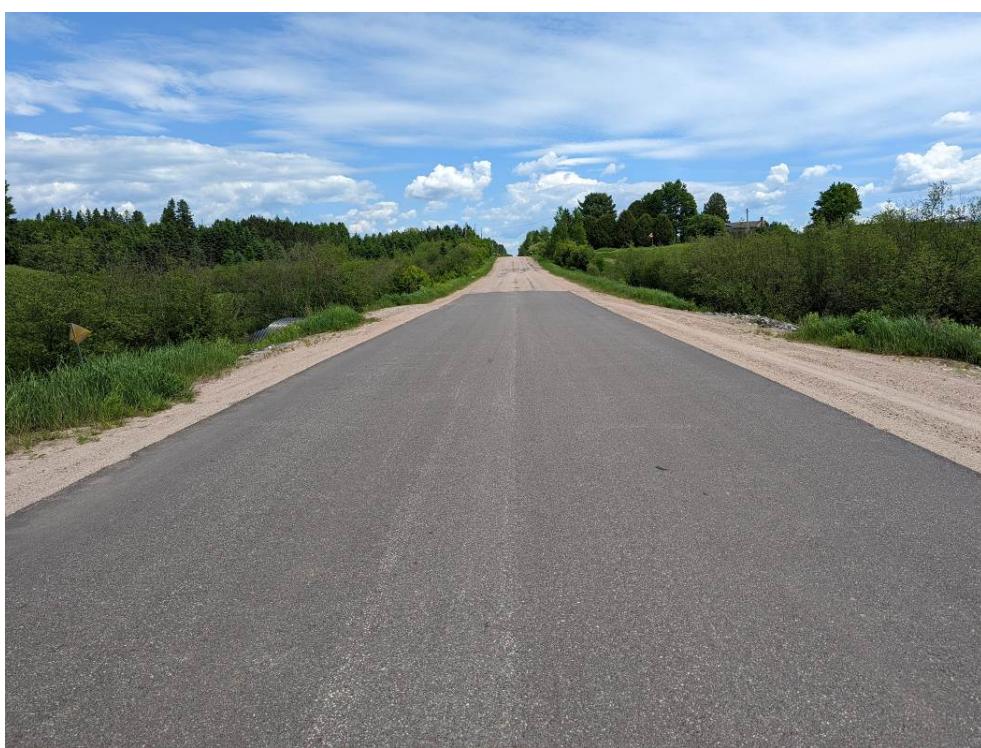
Photo 2 Structure from west approach

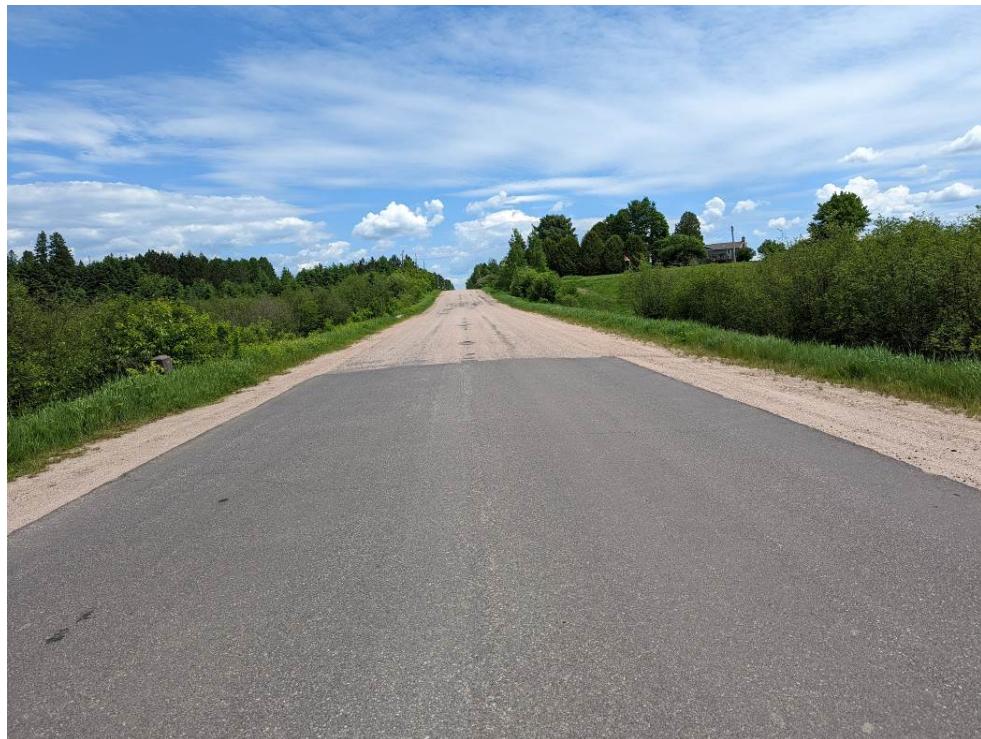
Photo 3 East approach from centre of structure

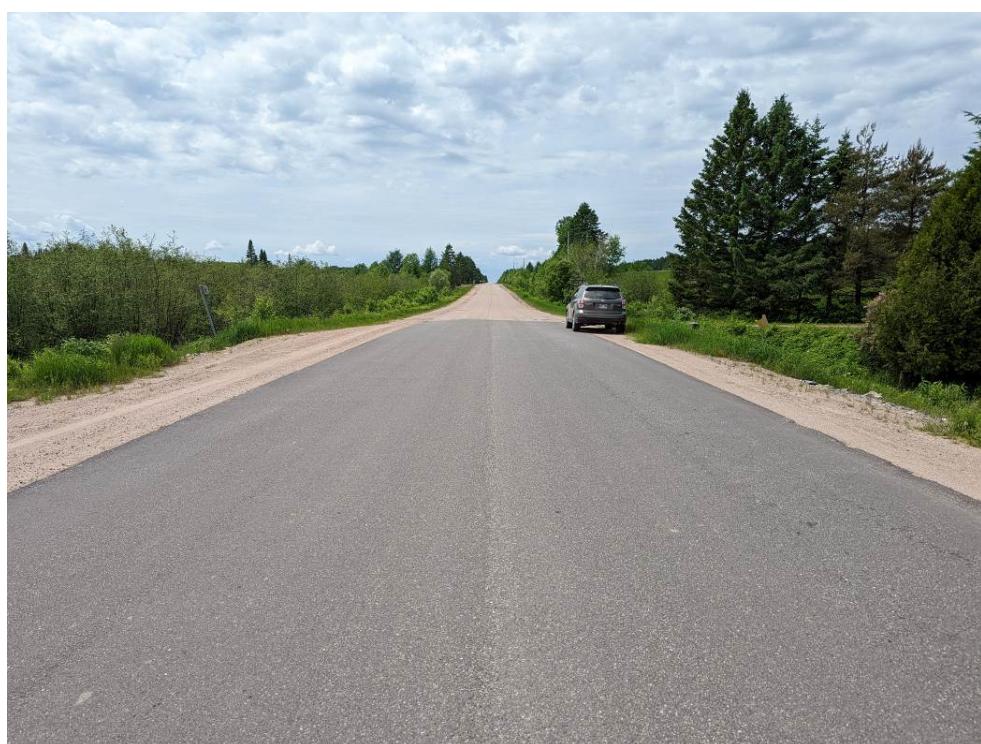
Photo 4 West approach from centre of structure

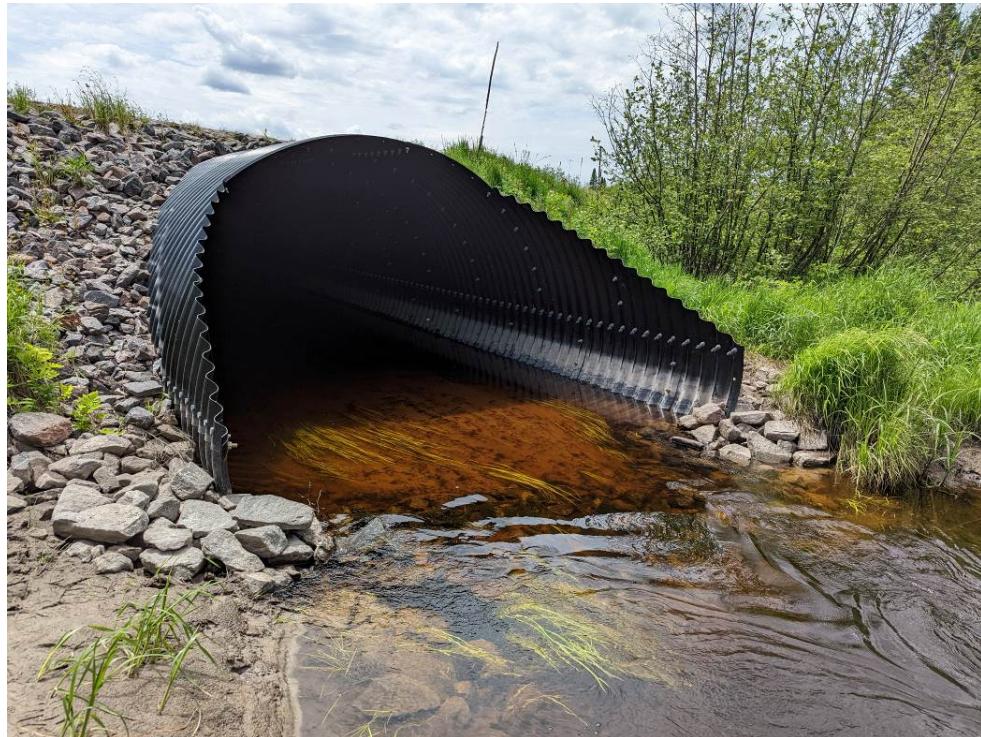
Photo 5 North elevation

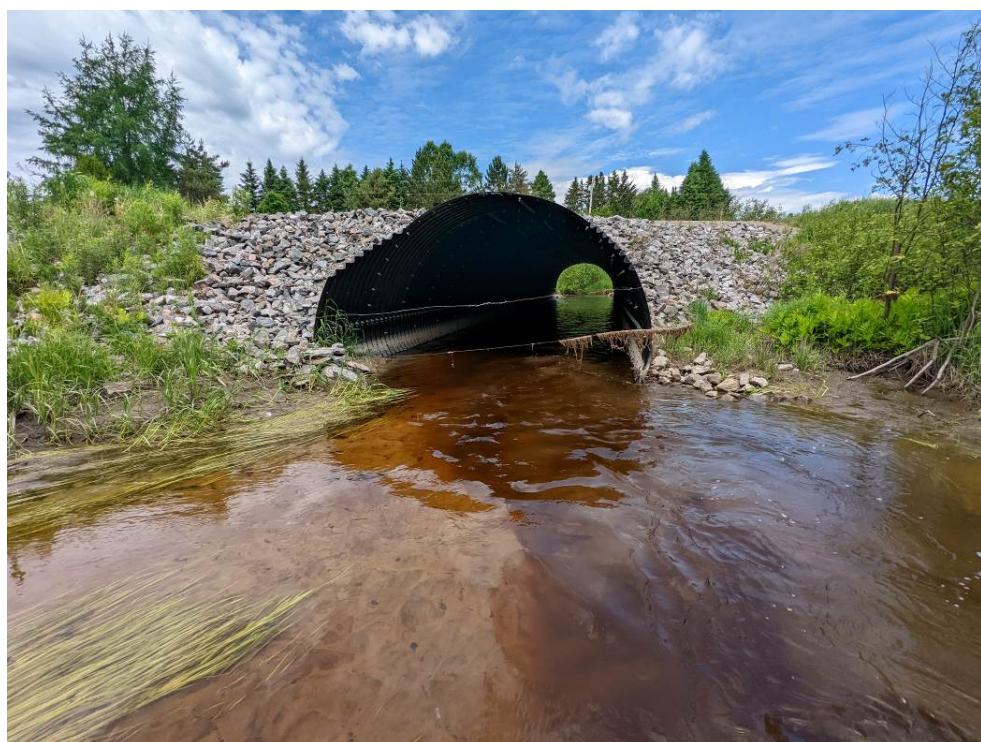
Photo 6 South elevation

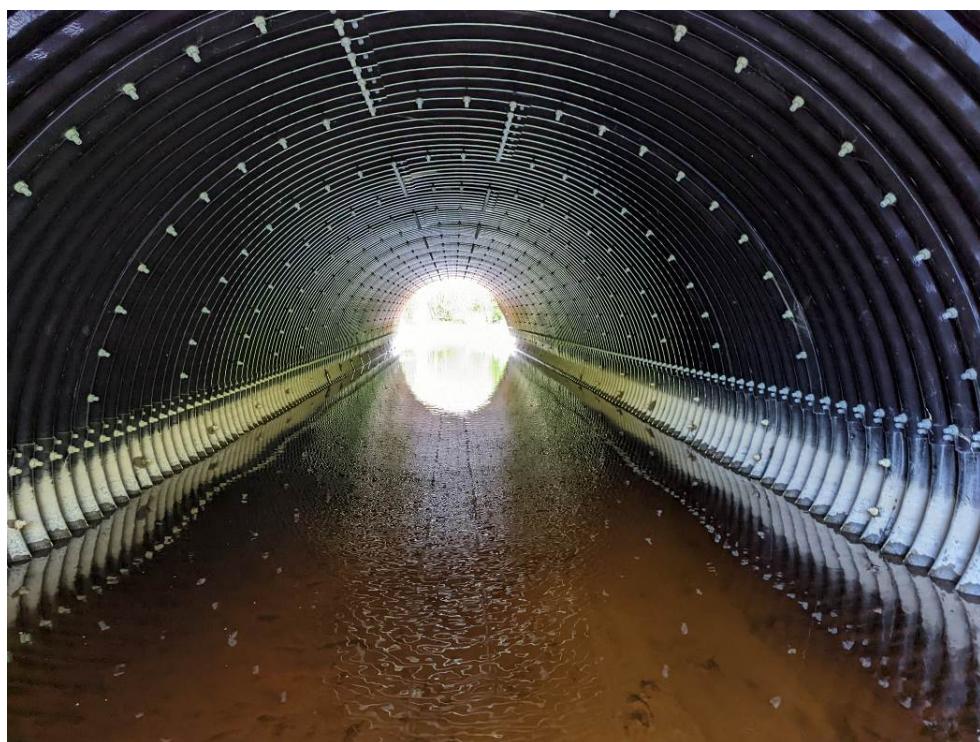
Photo 8 Typical view of culvert barrel looking south

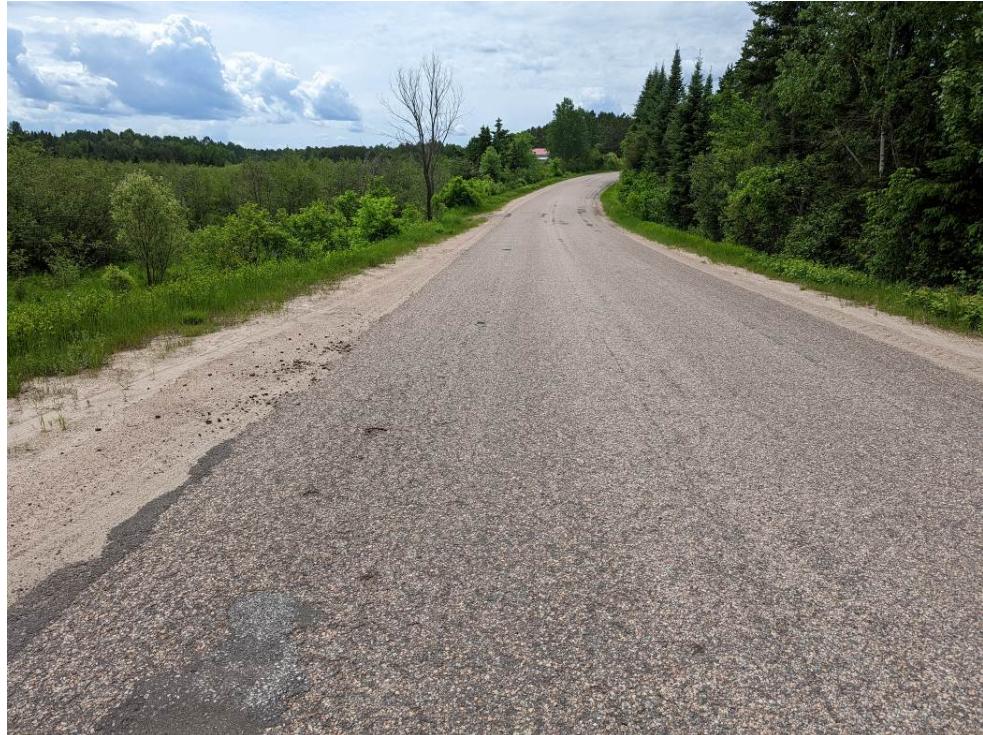
Photo 1 Structure from east approach

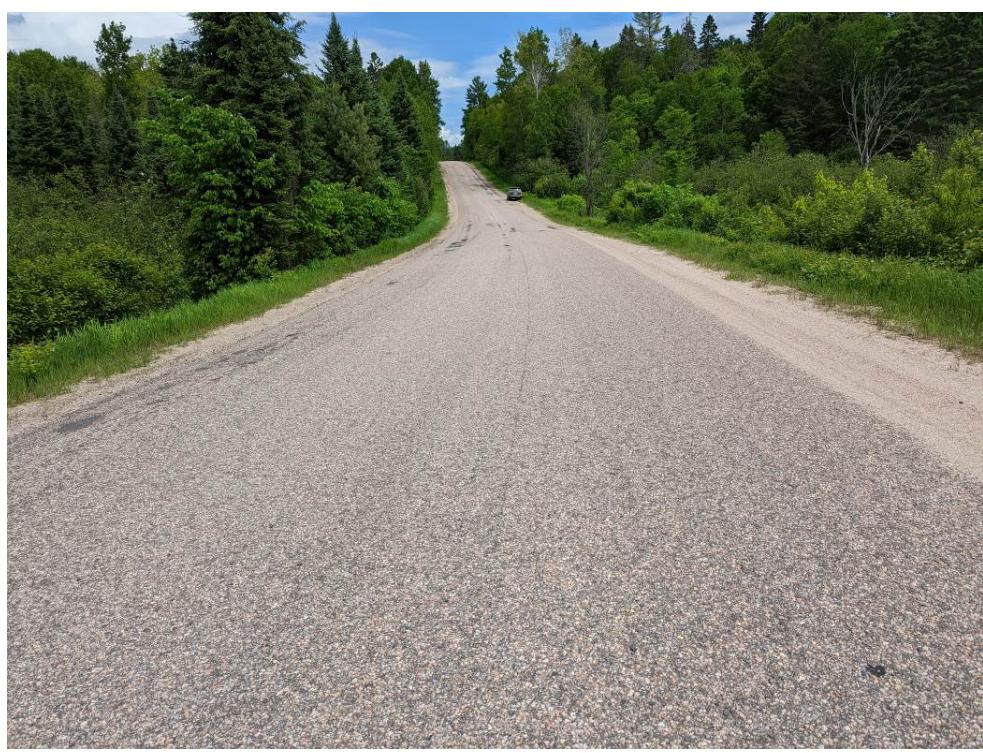
Photo 2 Structure from west approach

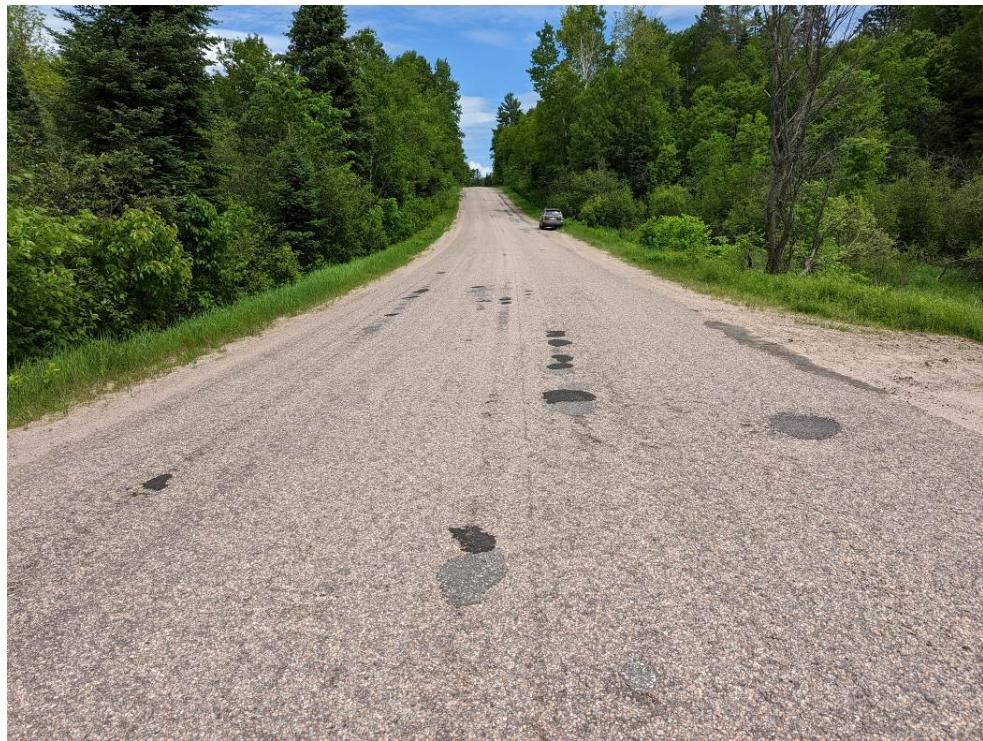
Photo 3 East approach from centre of structure

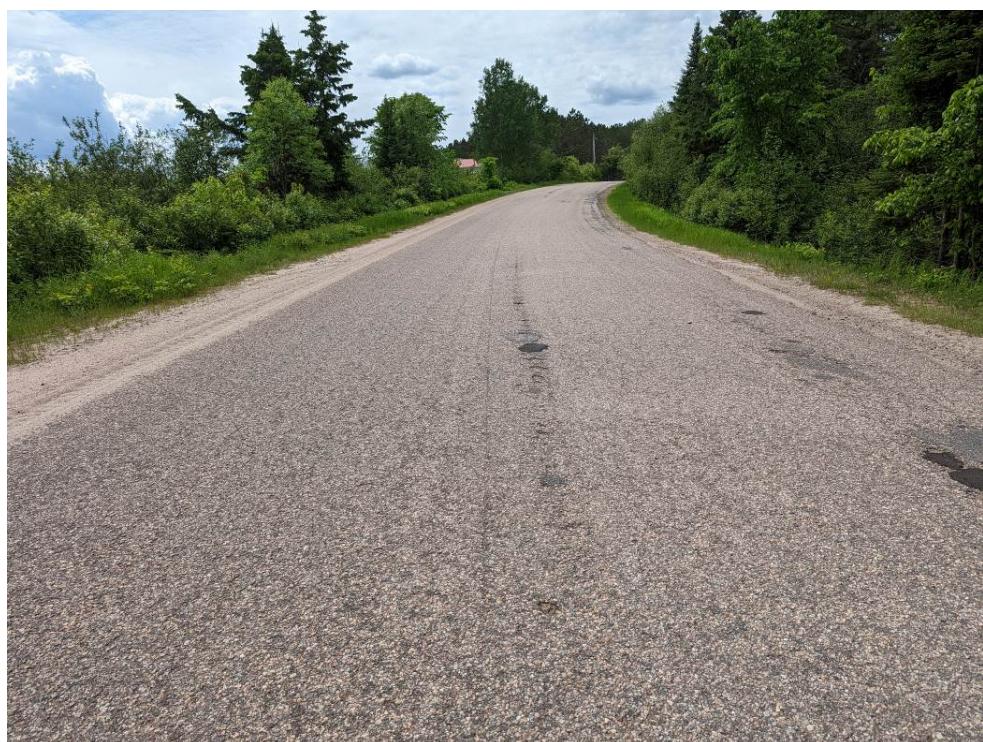
Photo 4 West approach from centre of structure

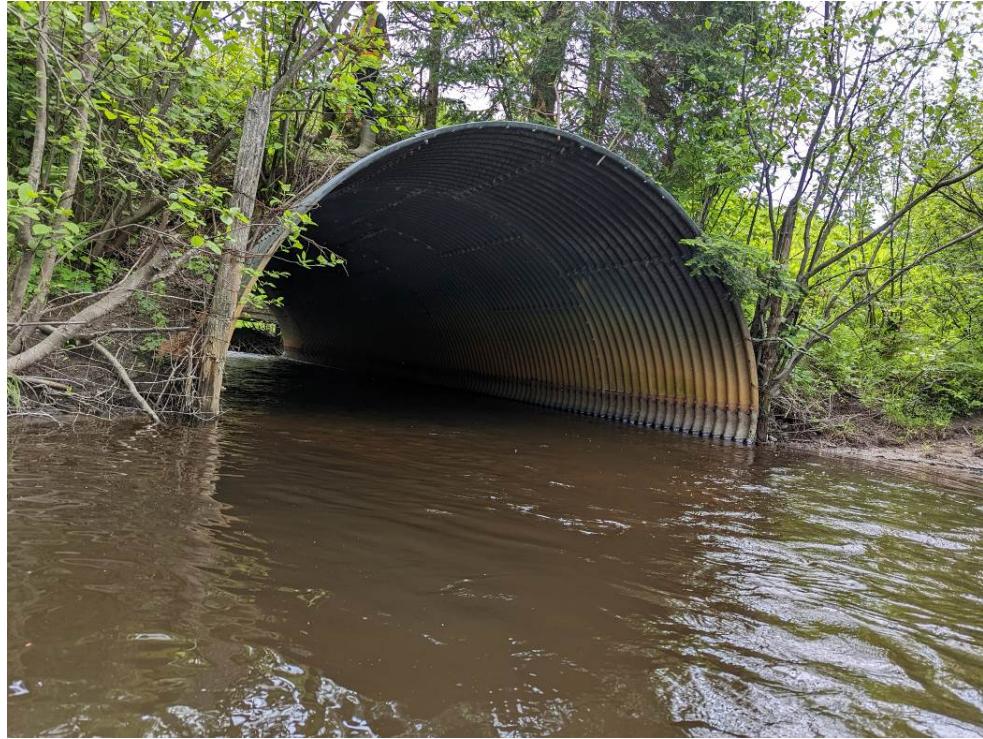
Photo 5 North elevation

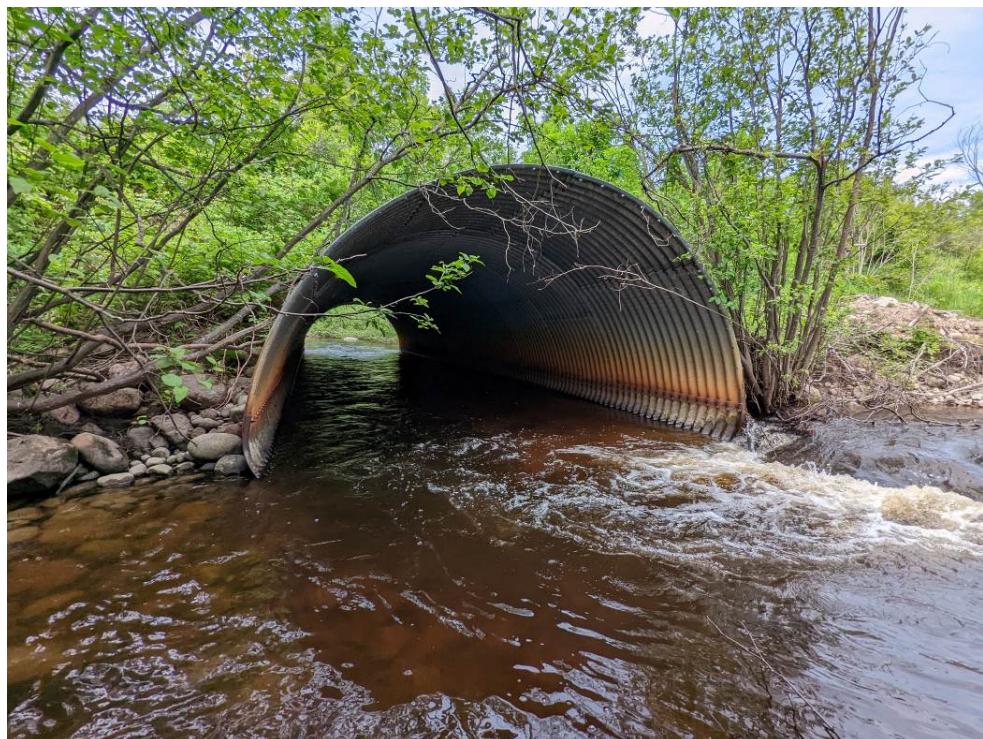
Photo 6 South elevation

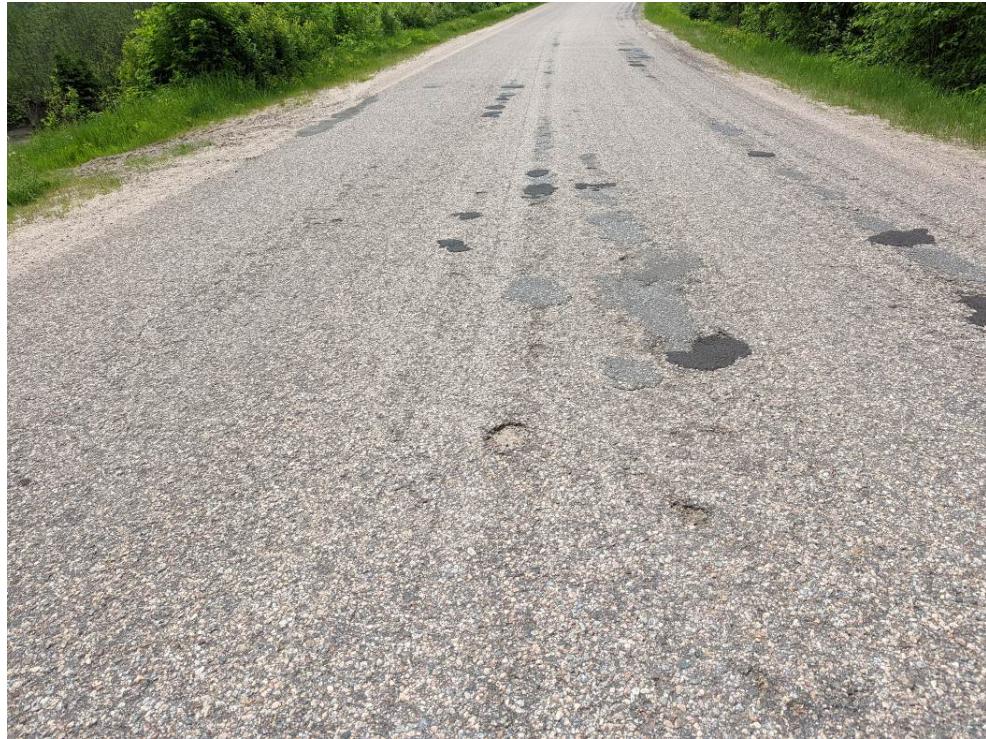
Photo 7 Previous patches, moderate raveling and potholes forming at west approach
